Bringing Innovation to Facility Management

Defining Reference Service Life: An Open Innovation Approach

Trip to Sunshine Coast Queensland
September 2004

Inspection at Schools

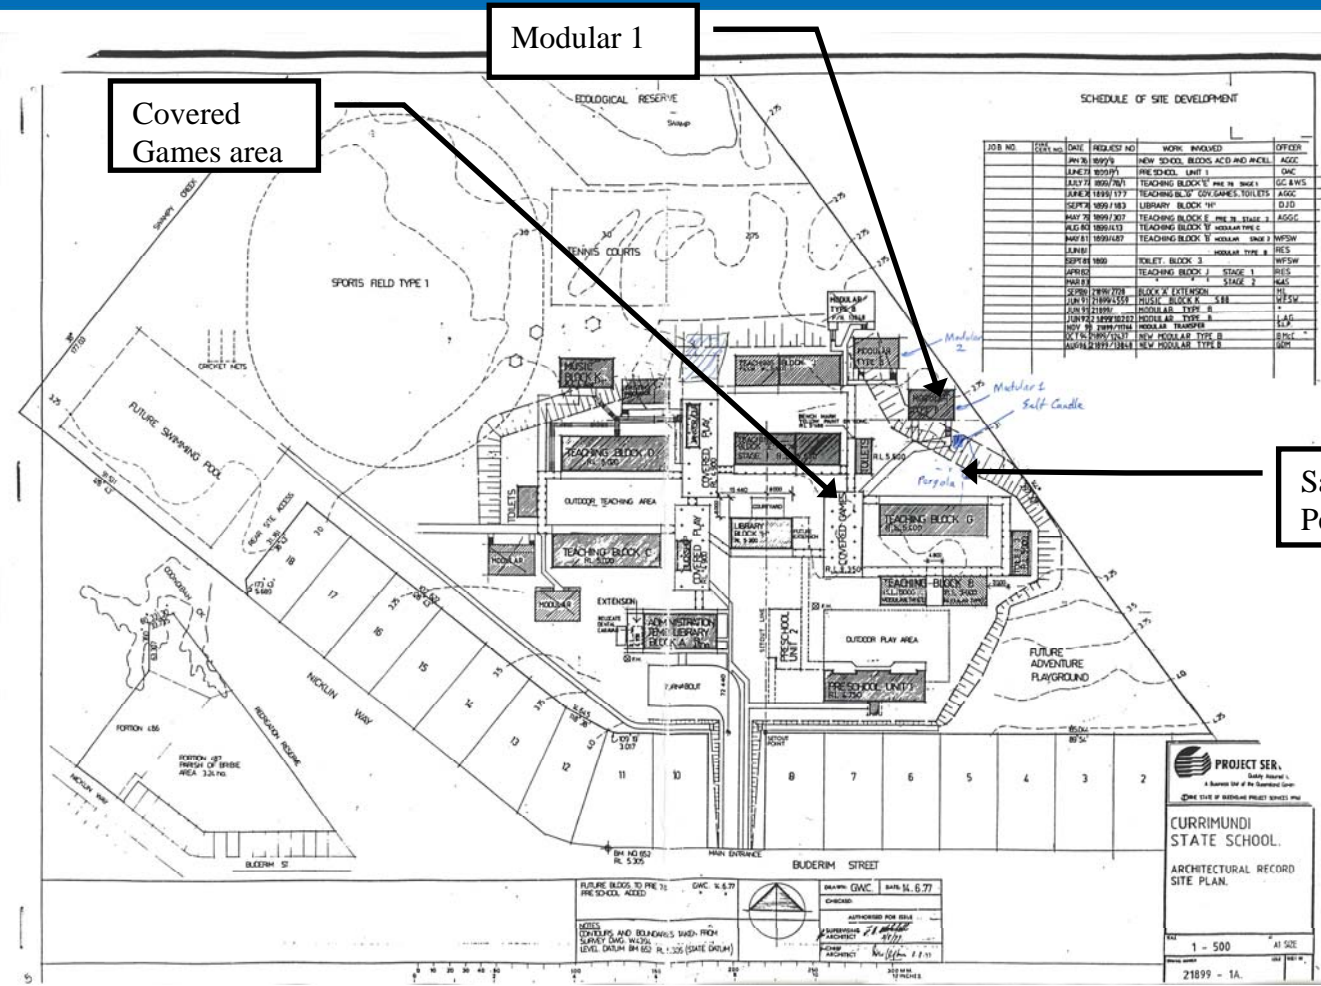
Salt Candle

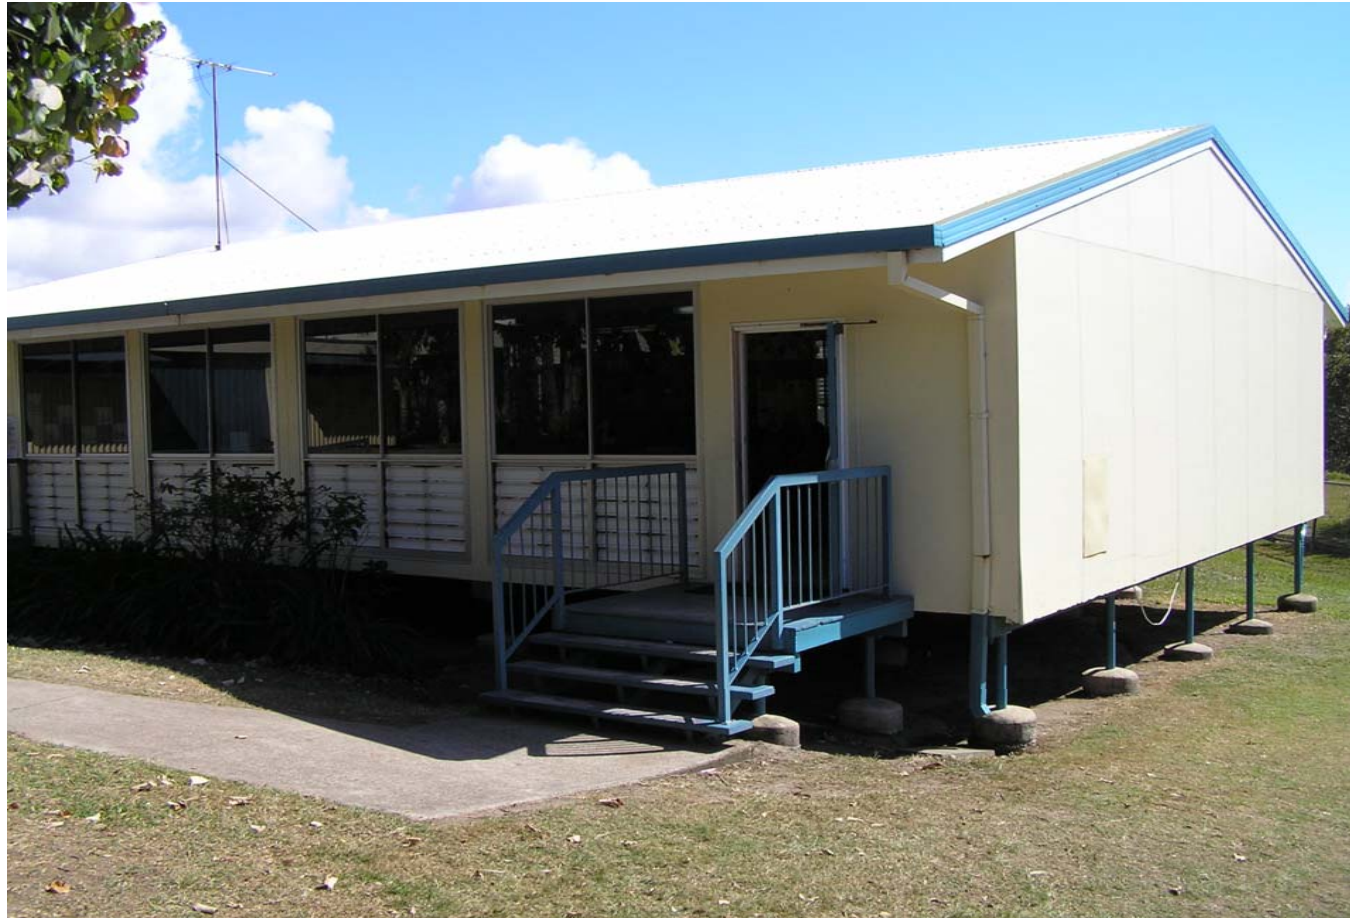
Modular 1 class room at Currimundi State School

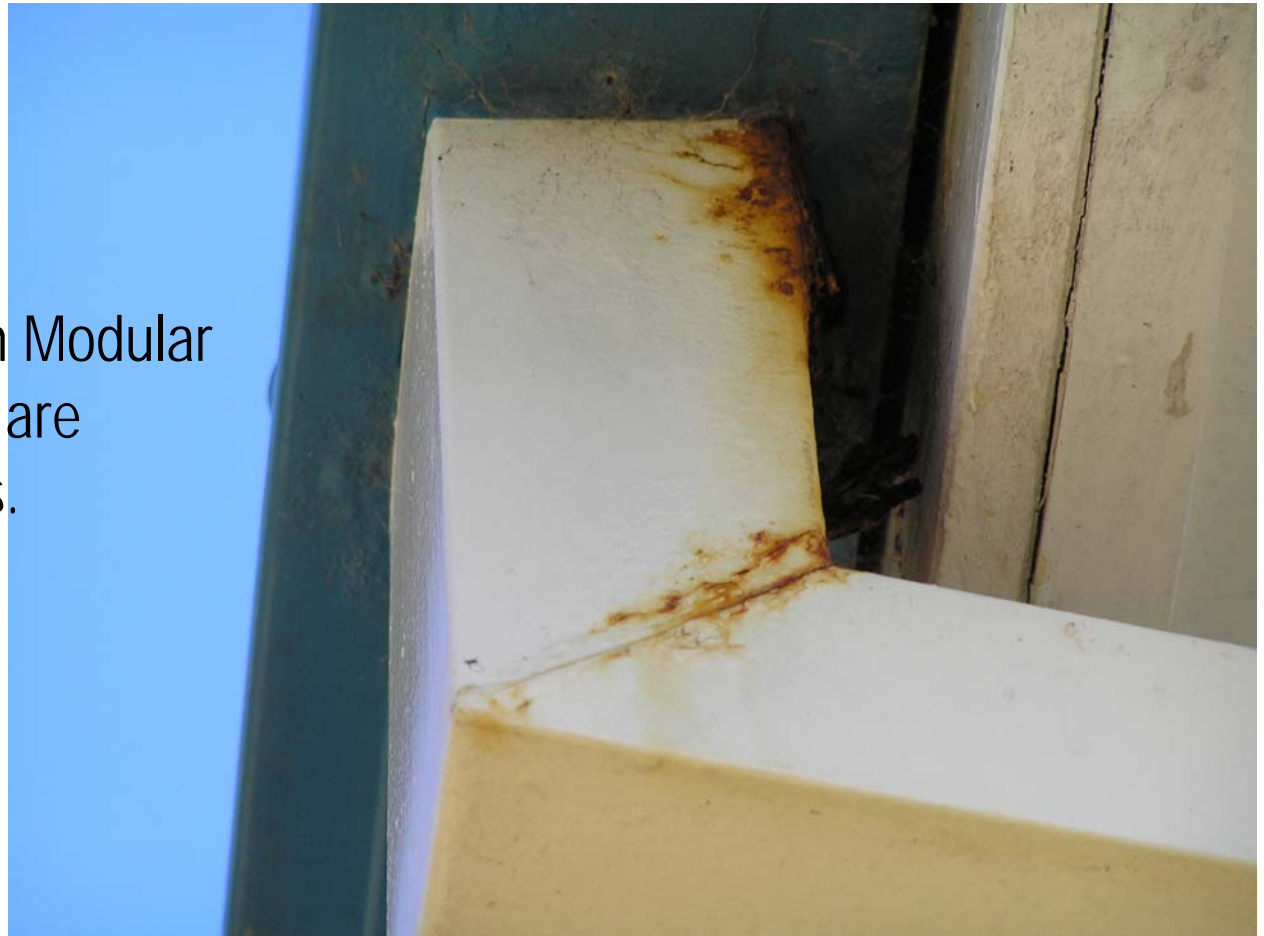
Close up of rusting and deterioration on gutter on Modular 1 showing that problems are associated with the joints.

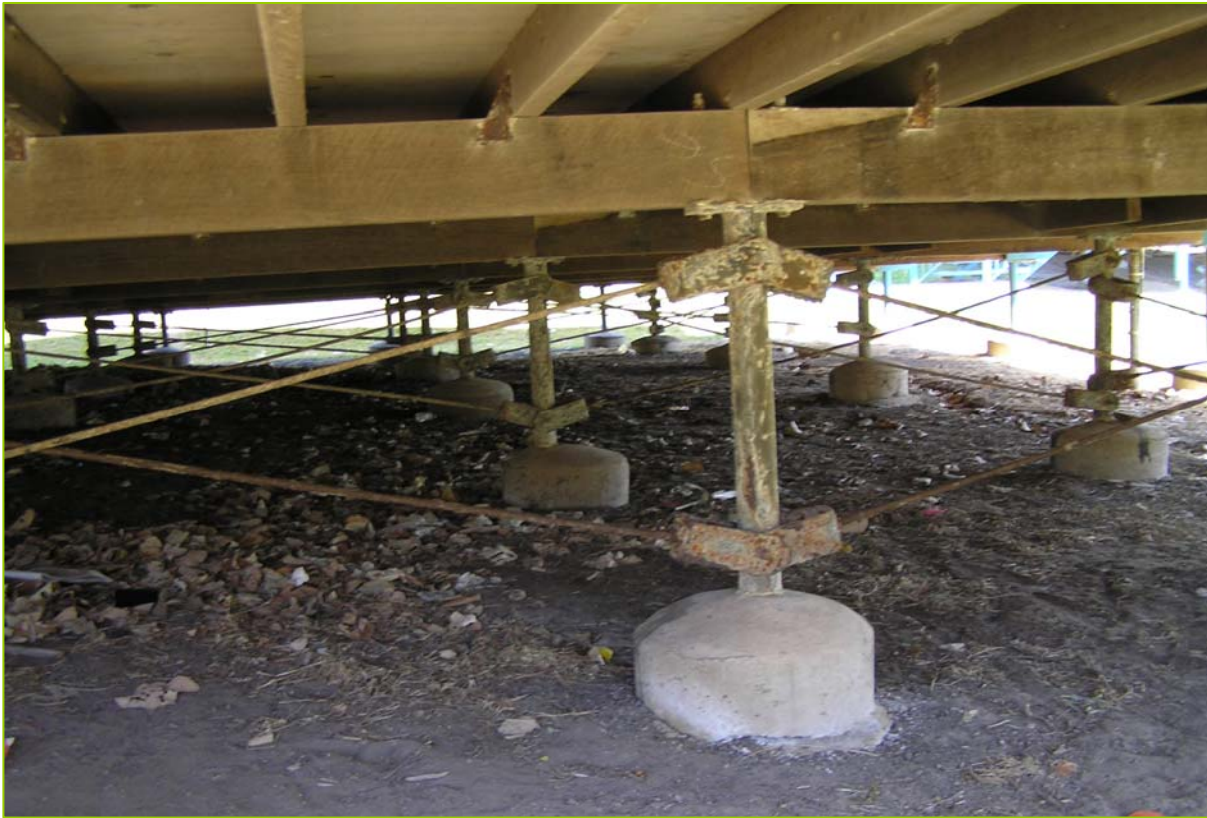
Sub-floor of Modular 1 showing significant deterioration of sub floor metallic components

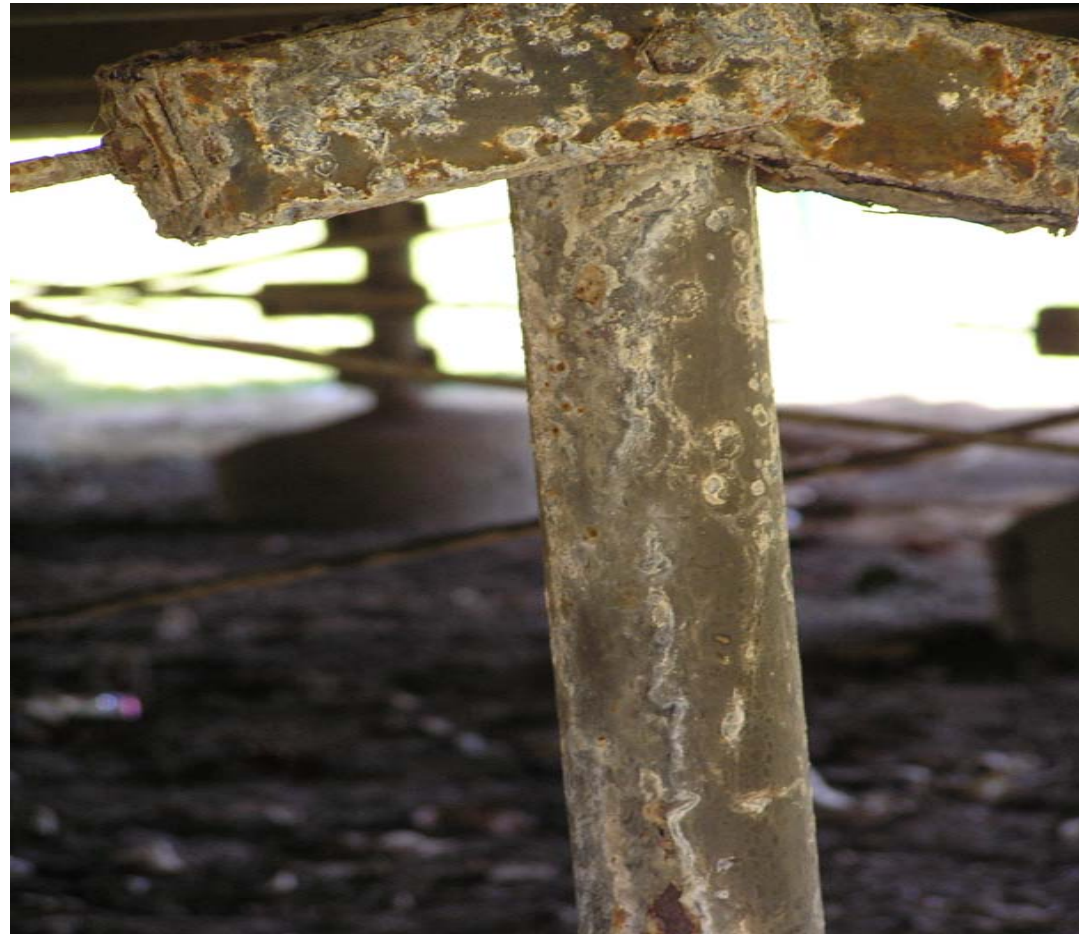
Stump support of
Modular 1

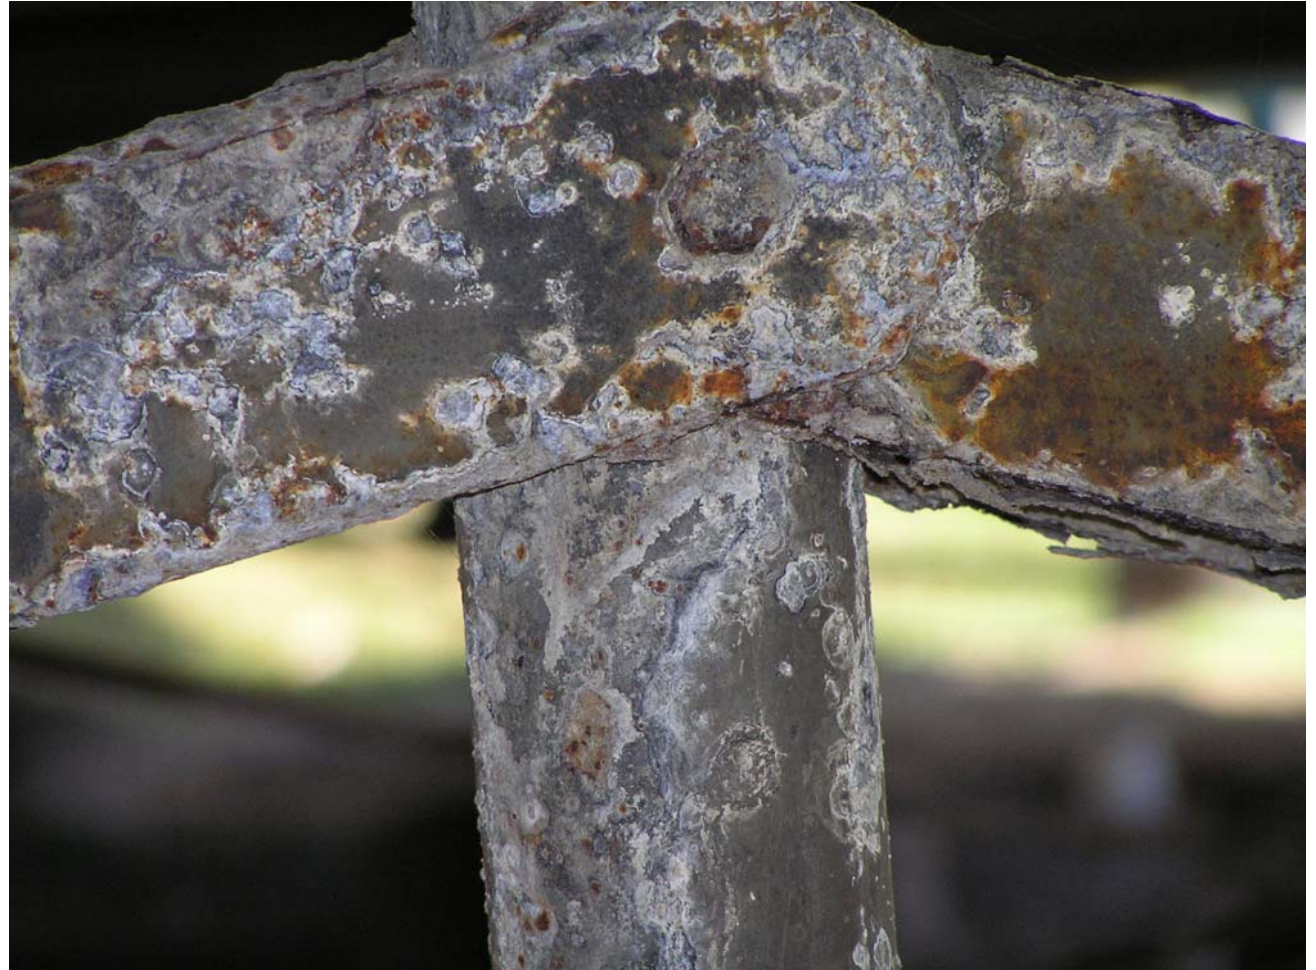
Close up of stump
of Modular 1

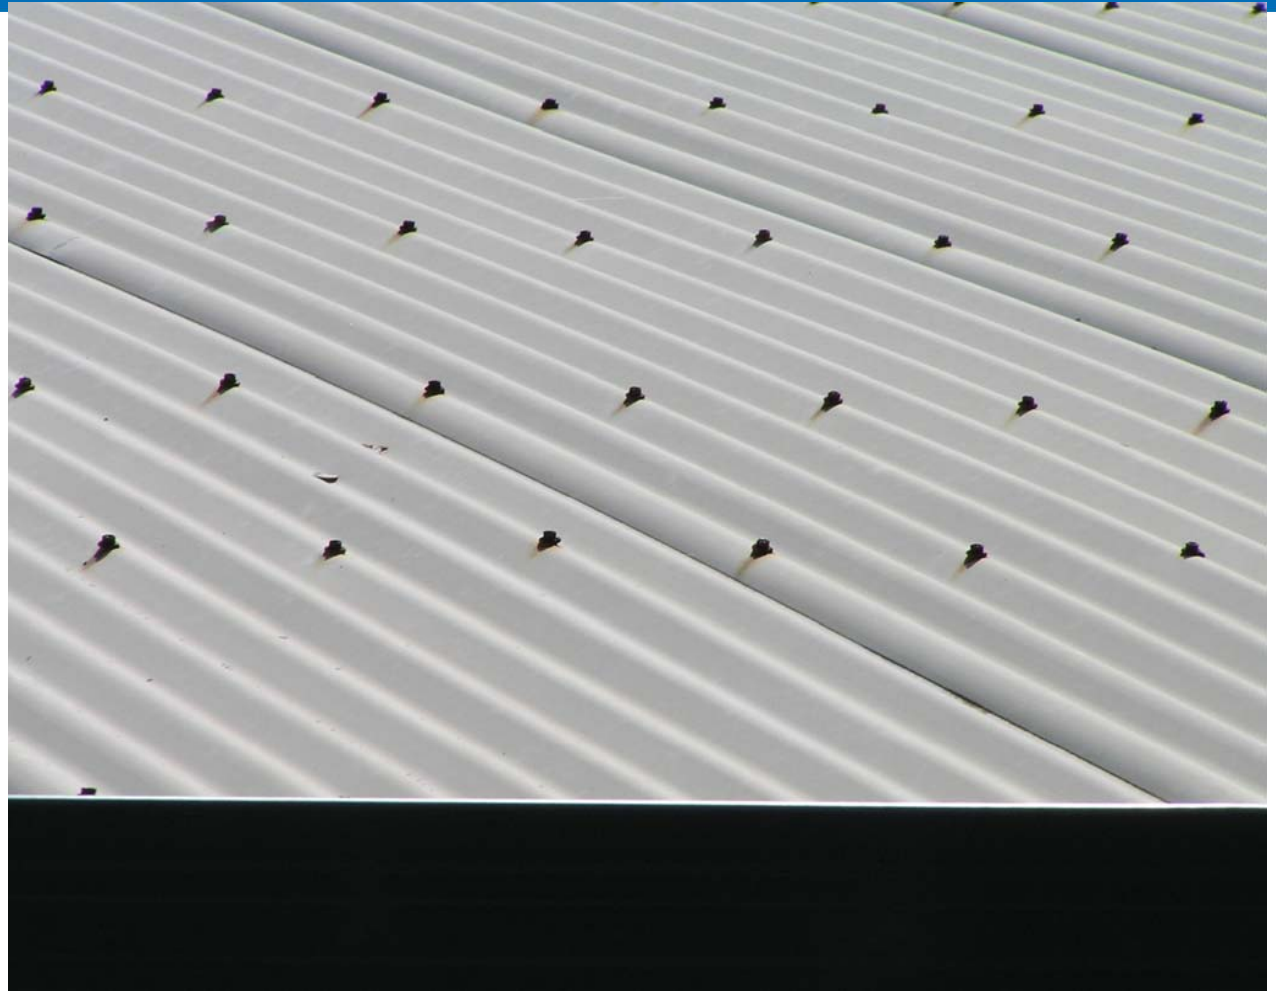
Fasteners on roof of
Modular 1 showing
rust staining on to
sheeting

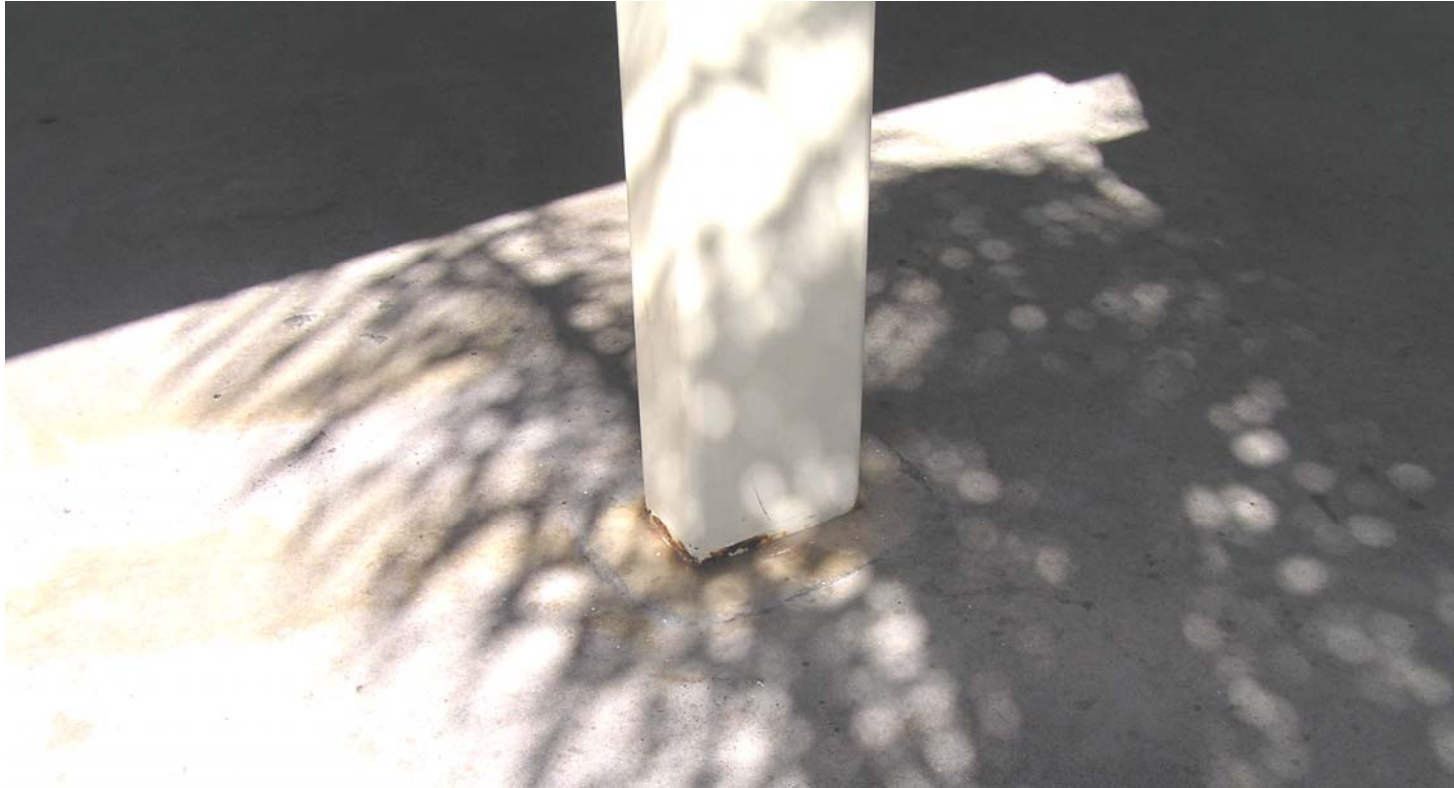
Footing of steel support showing red corrosion product

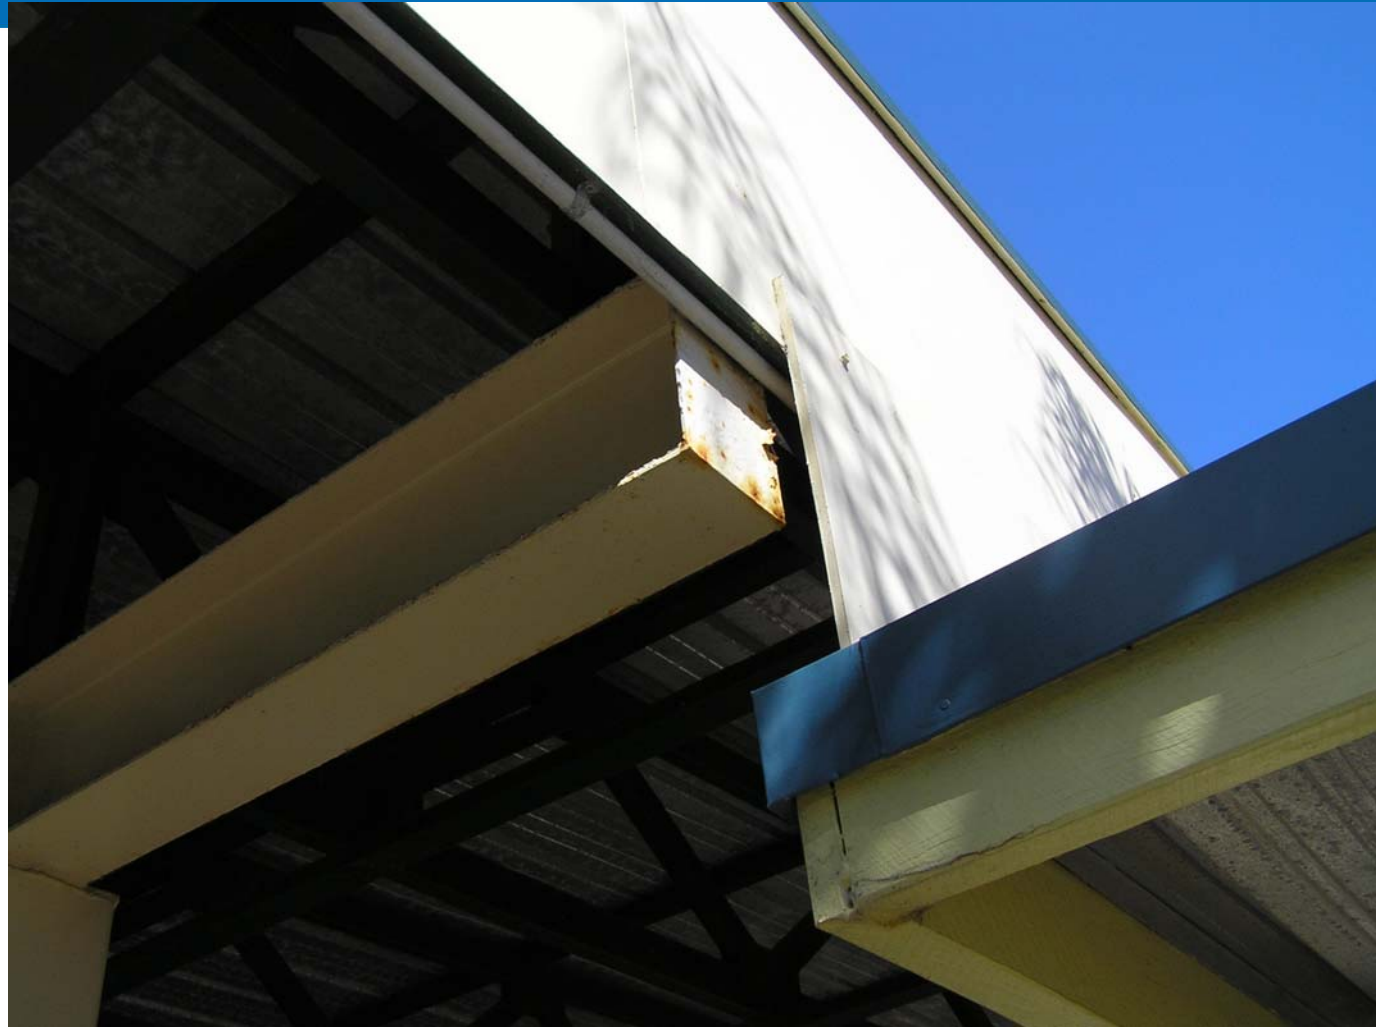
End of steel
beam showing red
rust break through.

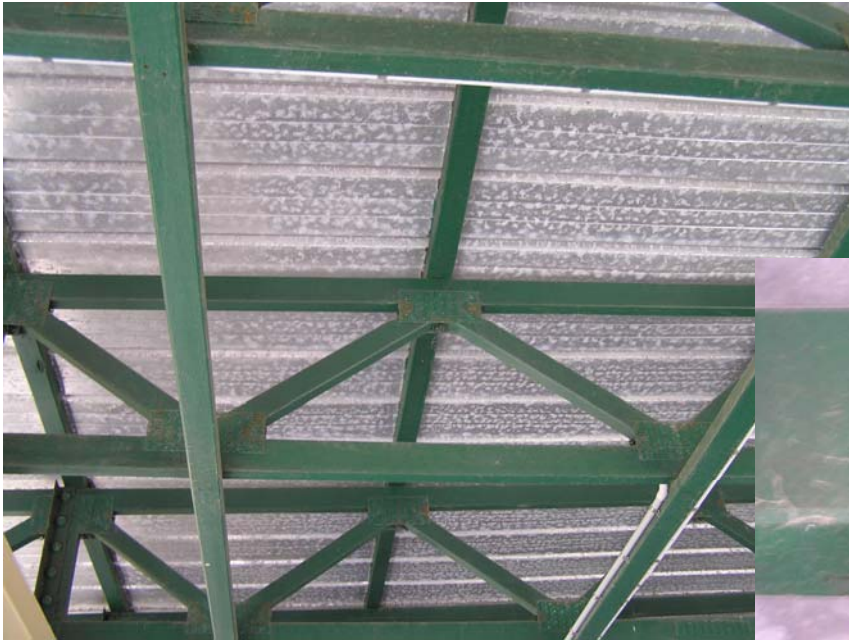
Inside covered games area showing corrosion of underside of roof sheeting and rust on painted gang nail plates

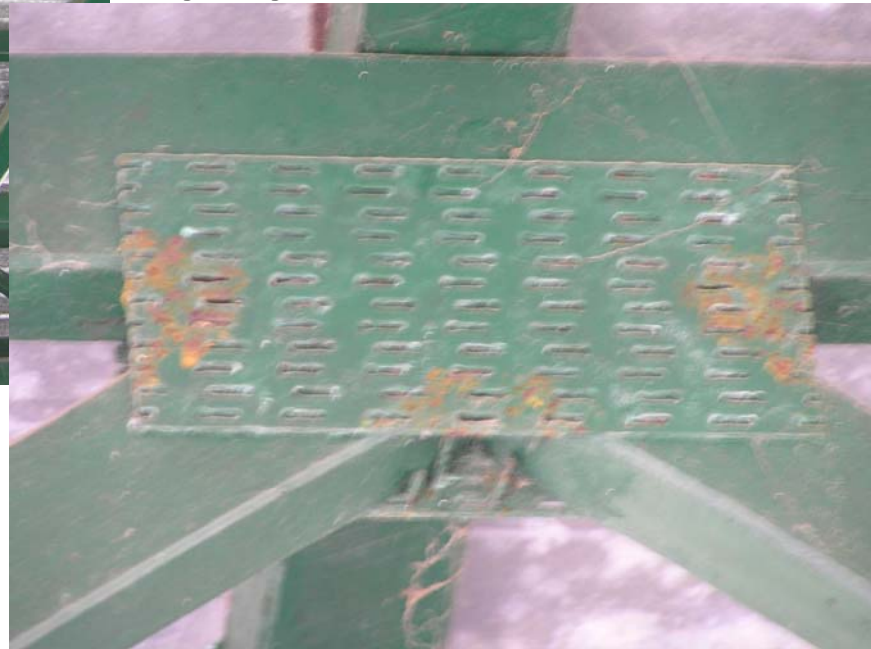
Close up of gang nail plates on inside of covered games area

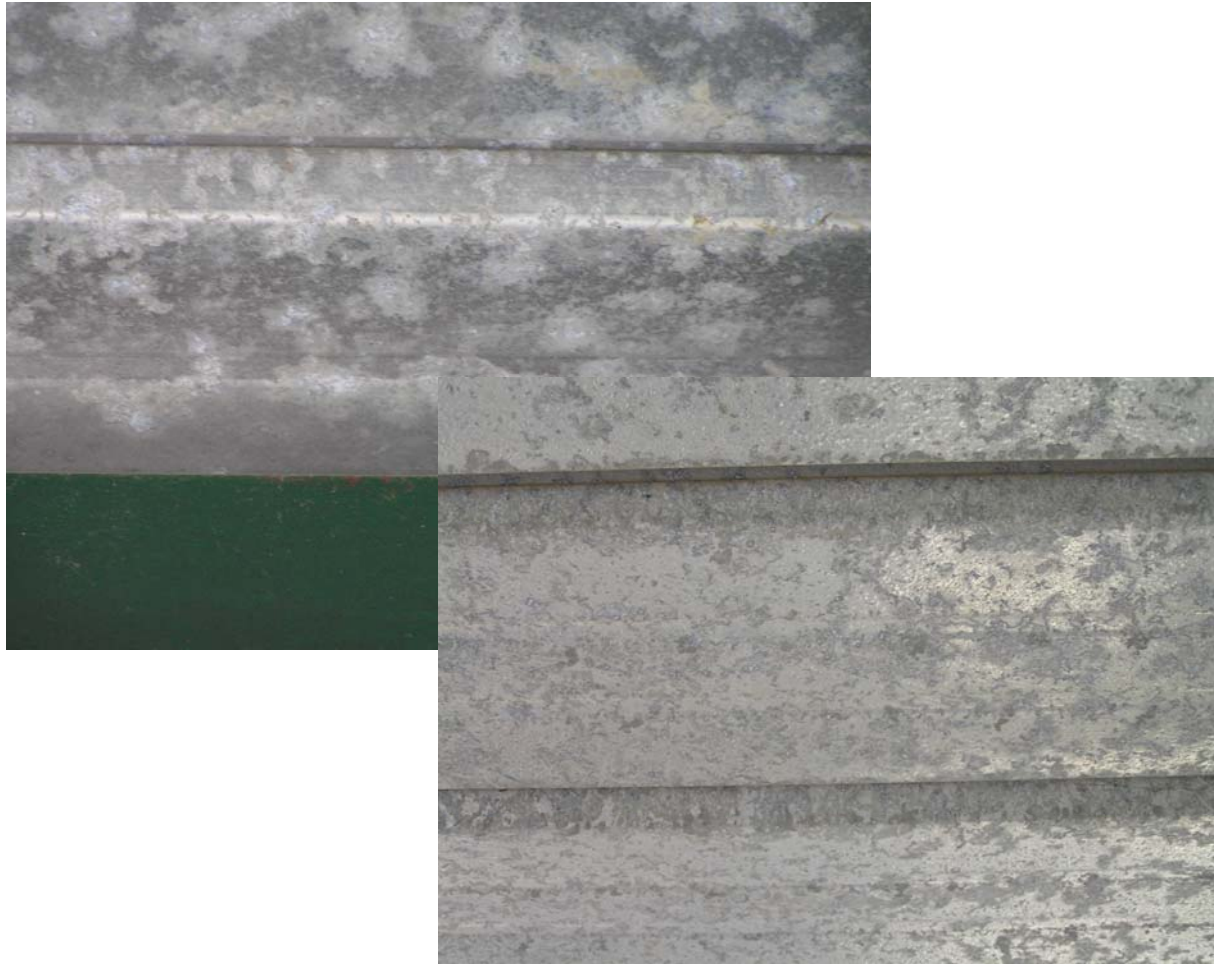
Close up of inside of roof sheeting of covered games area showing significant white corrosion product and some red rust.

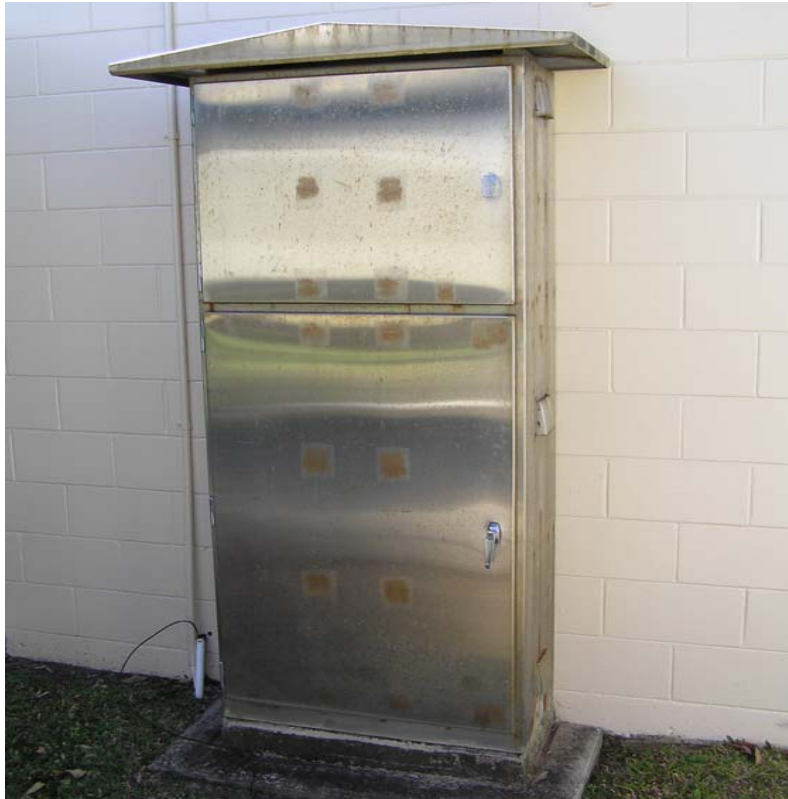
Stainless steel equipment box showing signs of rust where signs were affixed with tape

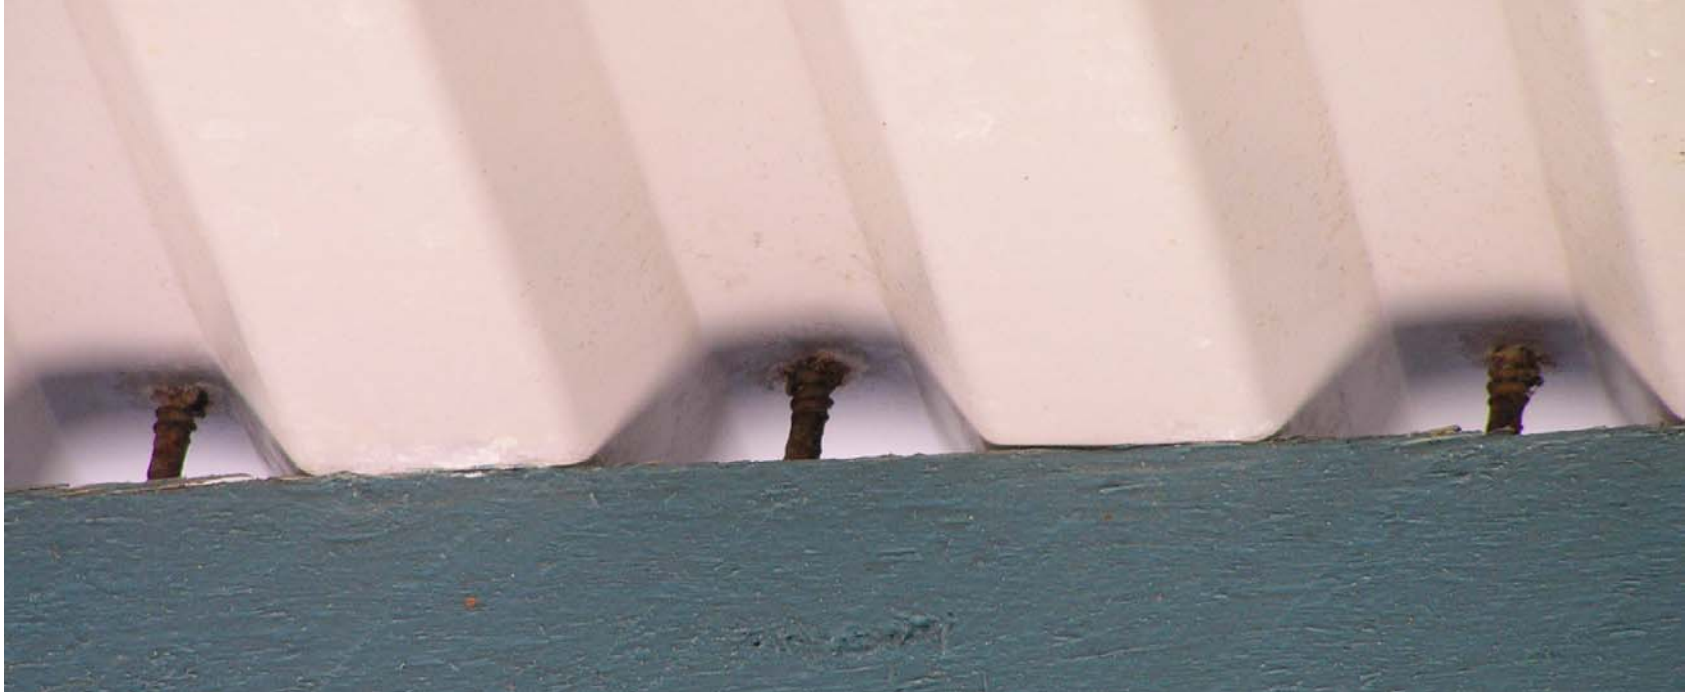
Covered walkway, fastener shanks are red rust and undercutting seen on Colorbond sheeting.

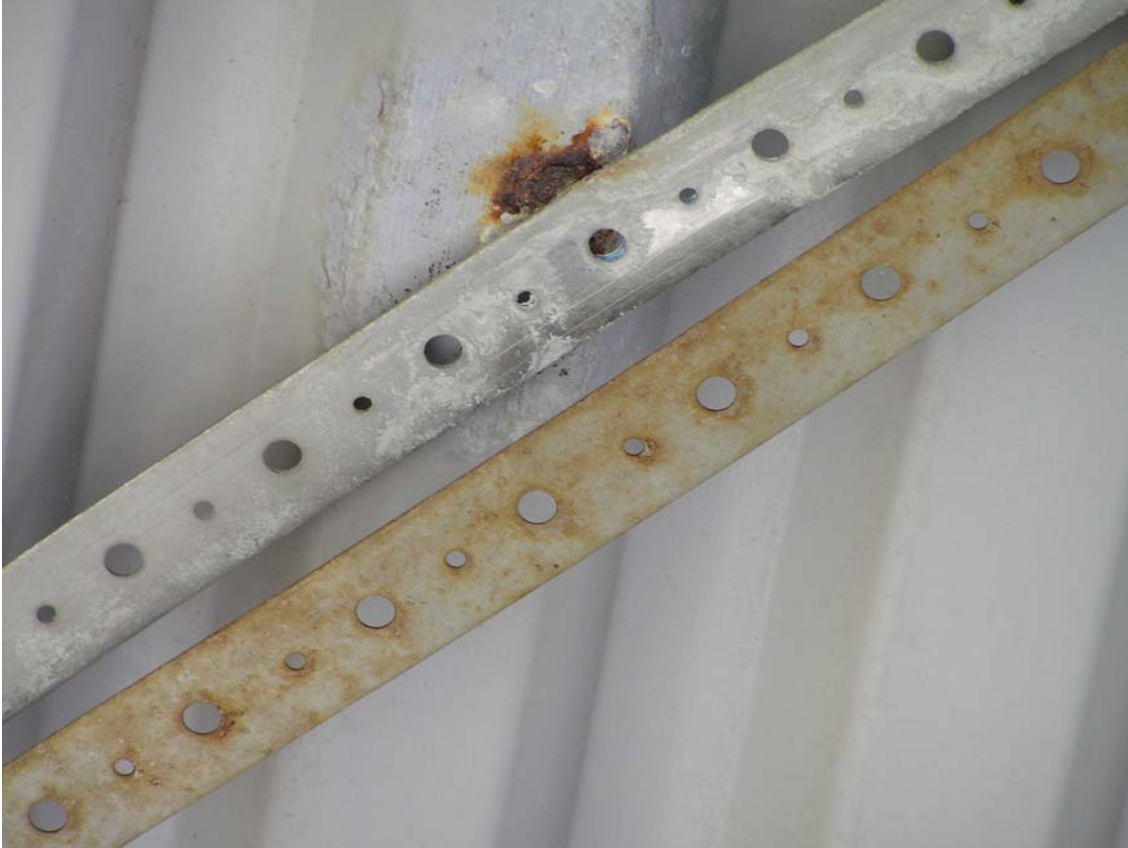
Covered set down showing red rust of stainless steel strapping not in contact with roof sheeting and red rust on roof sheeting where stainless steel strapping is in contact.

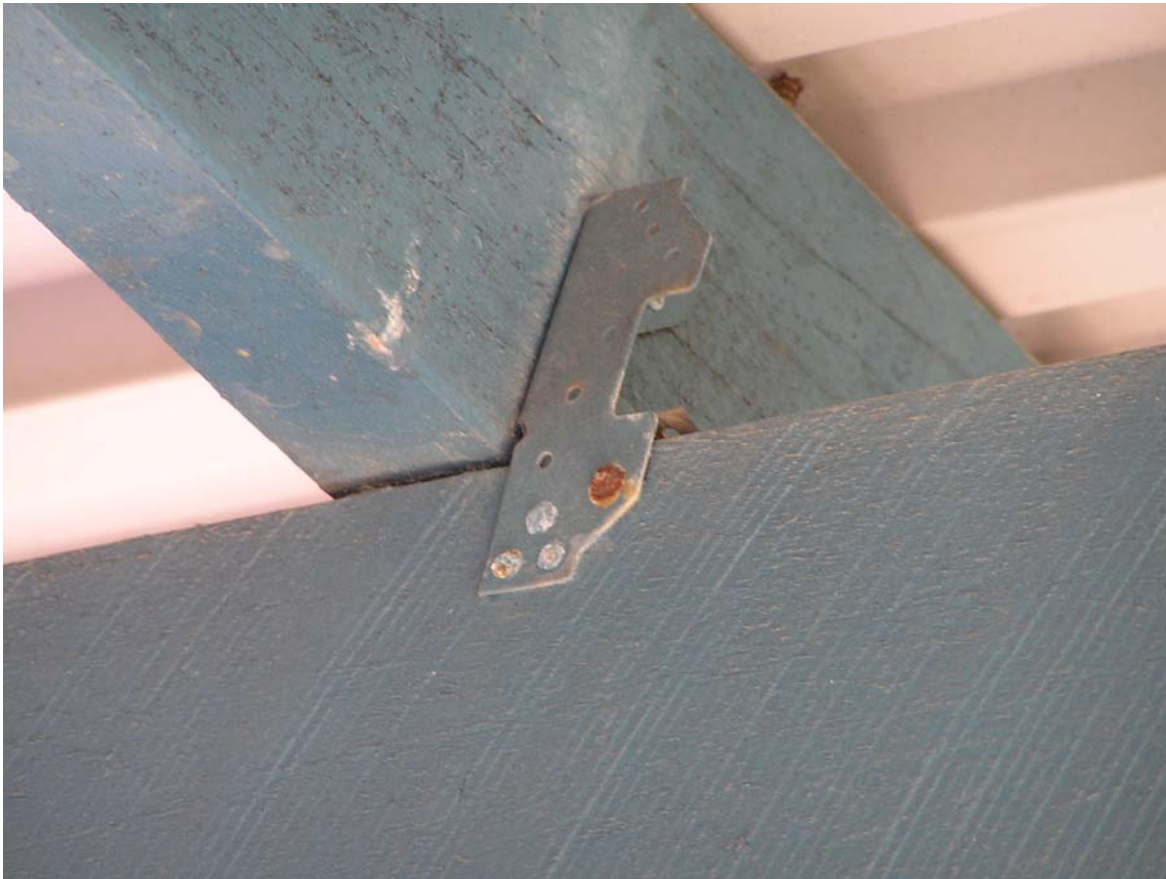
Triple grips on structure of covered set down showing signs of deterioration and roof fastener shank to red rust.

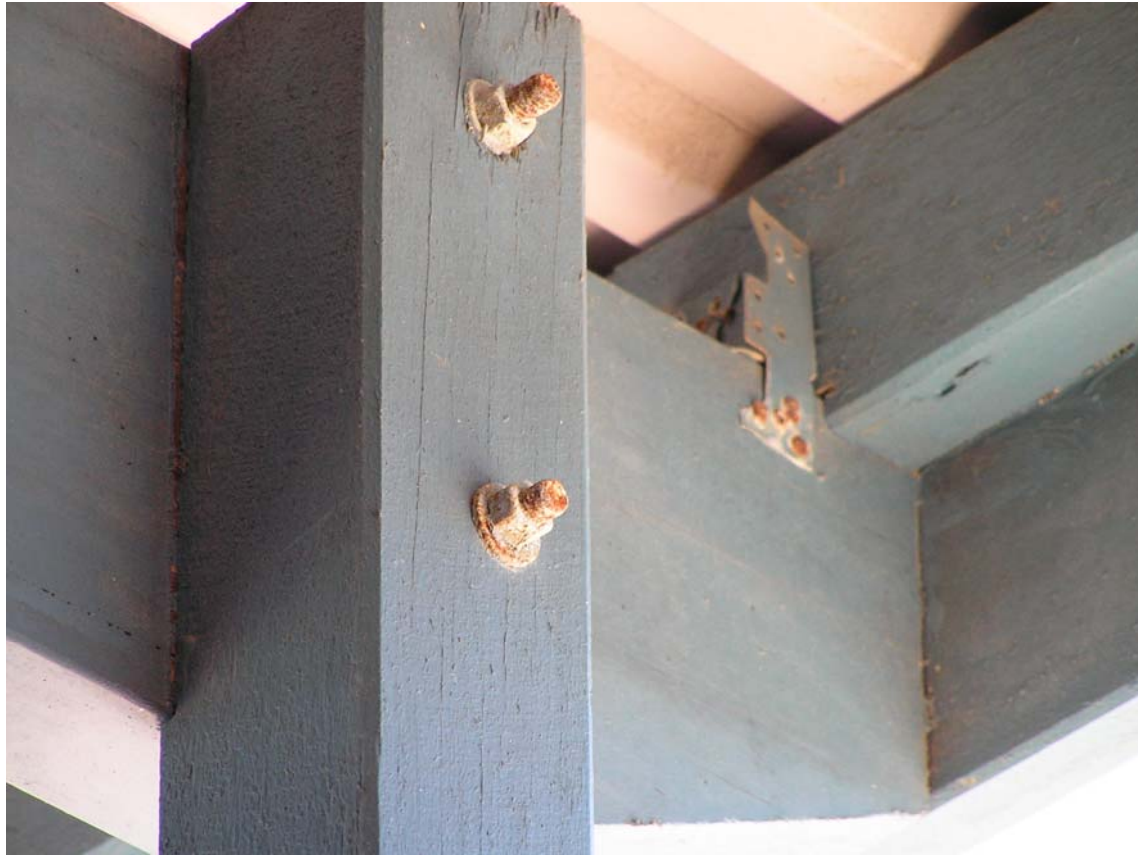
Triple grips and bolts on structure of covered set down showing signs of deterioration

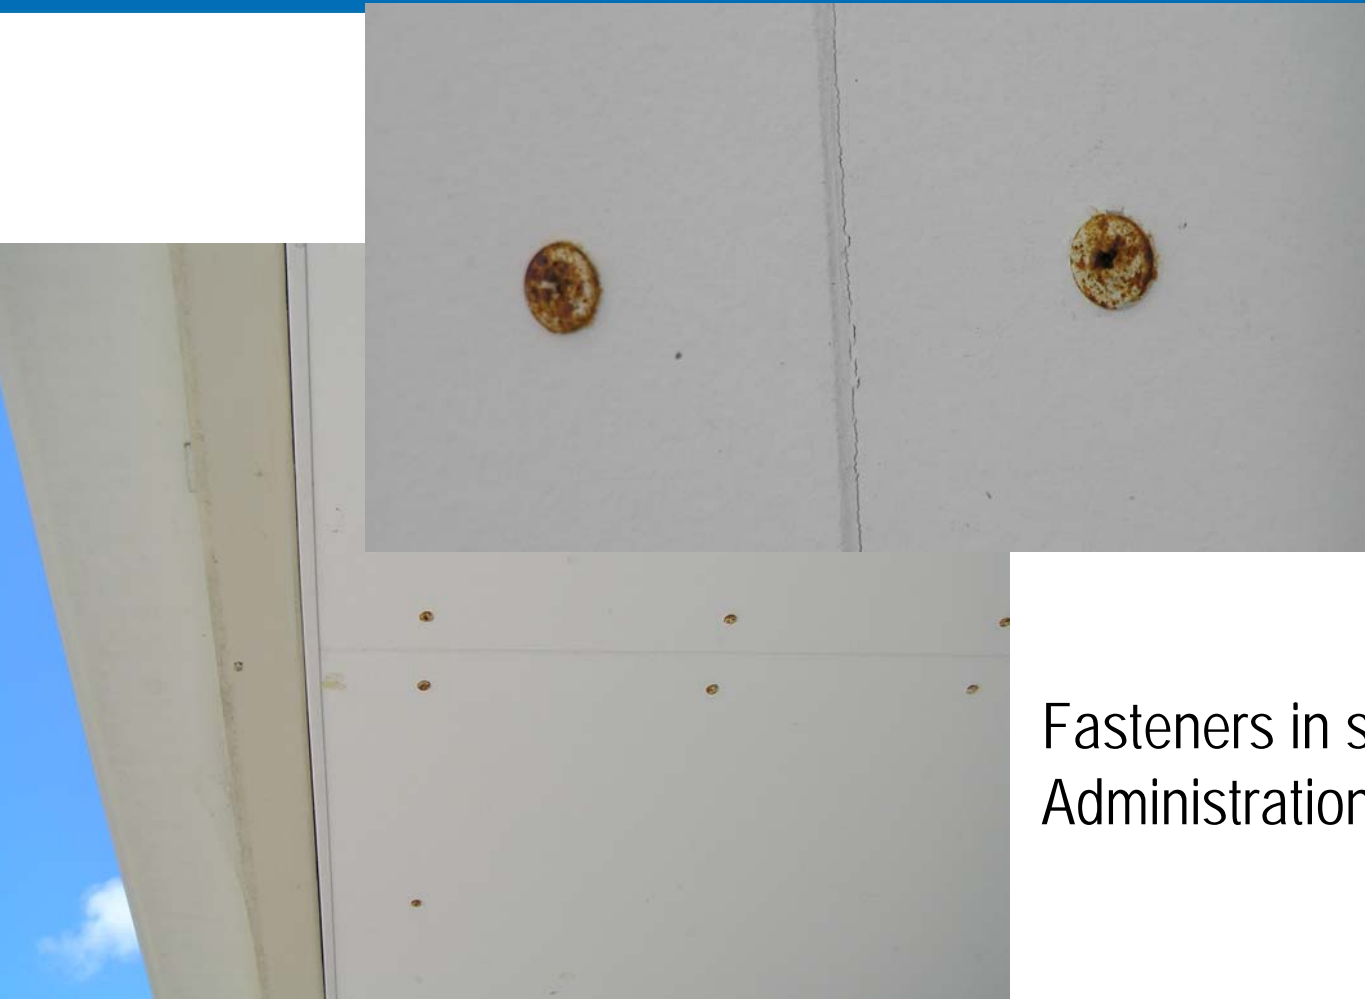
Fasteners in sheeting on porch of Administration Block.

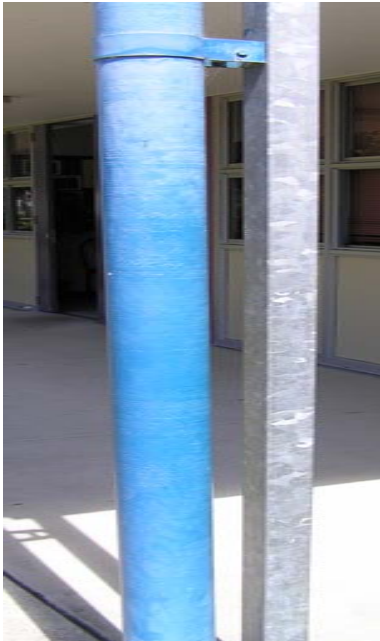
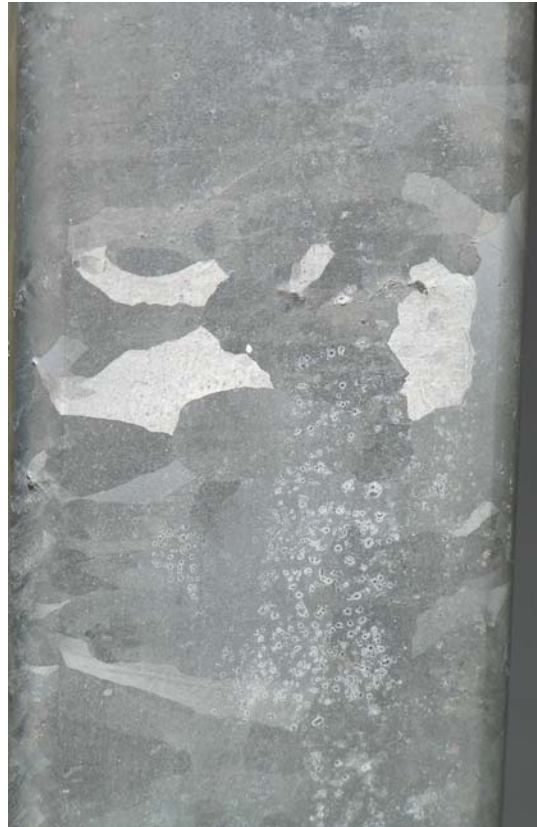
Galvanised post on Administration Block and close up showing signs of white corrosion product.

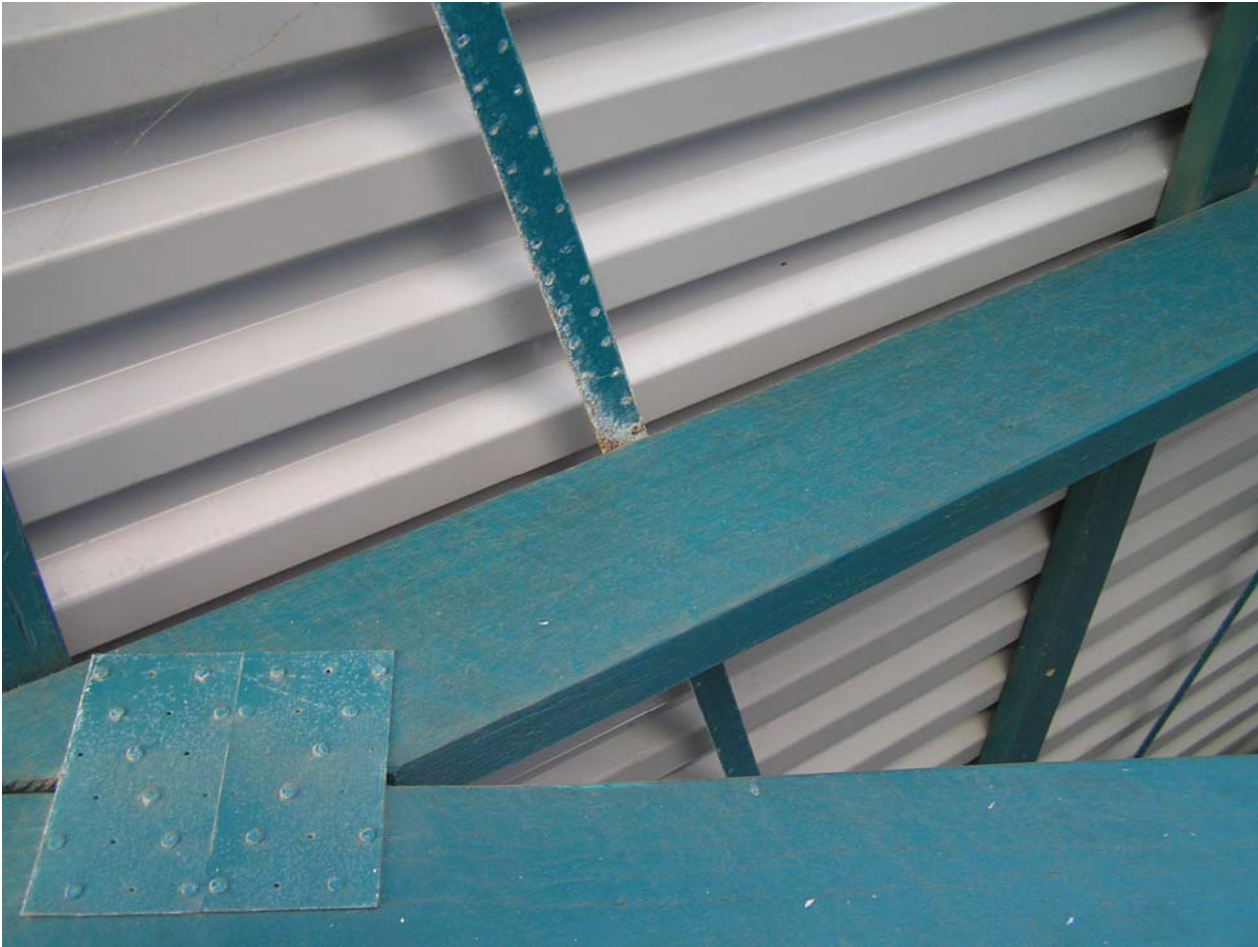
Corroded
strapping on
covered court

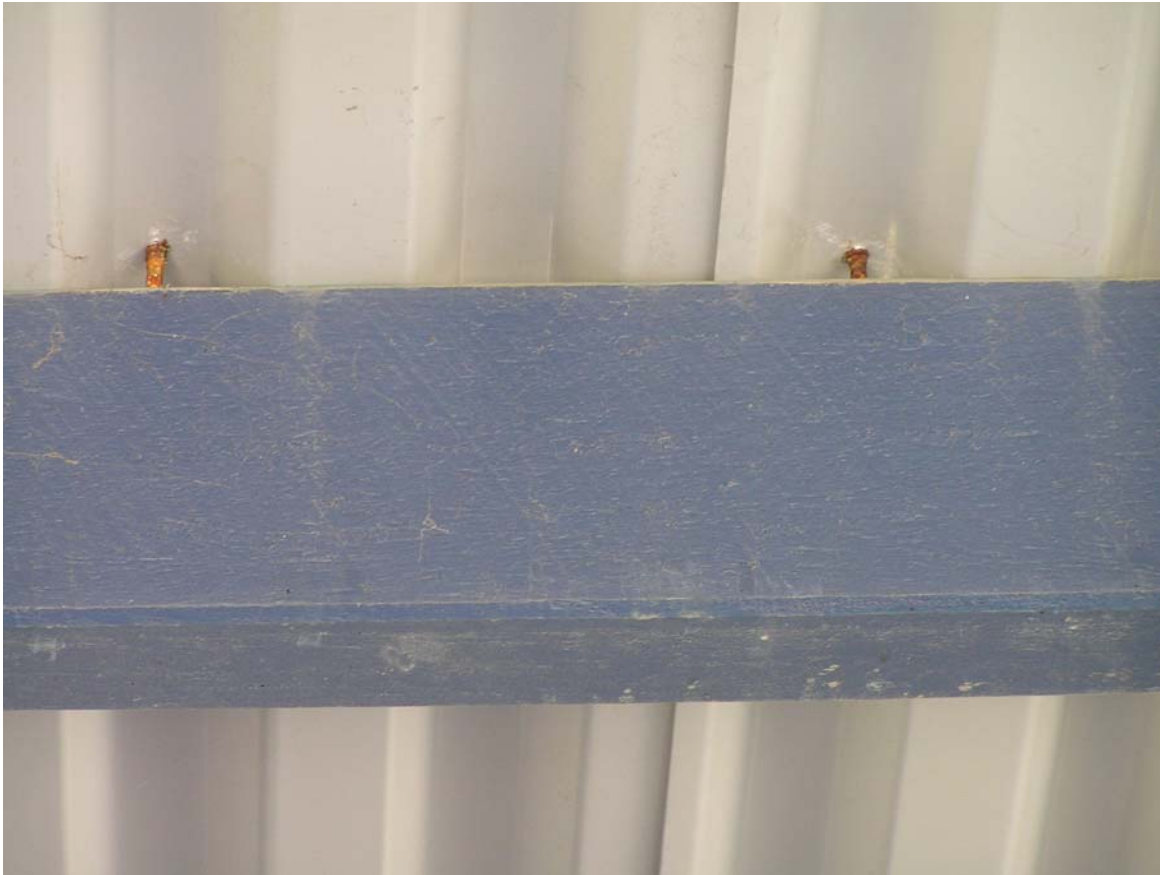
Corroded
fasteners in
covered walkway

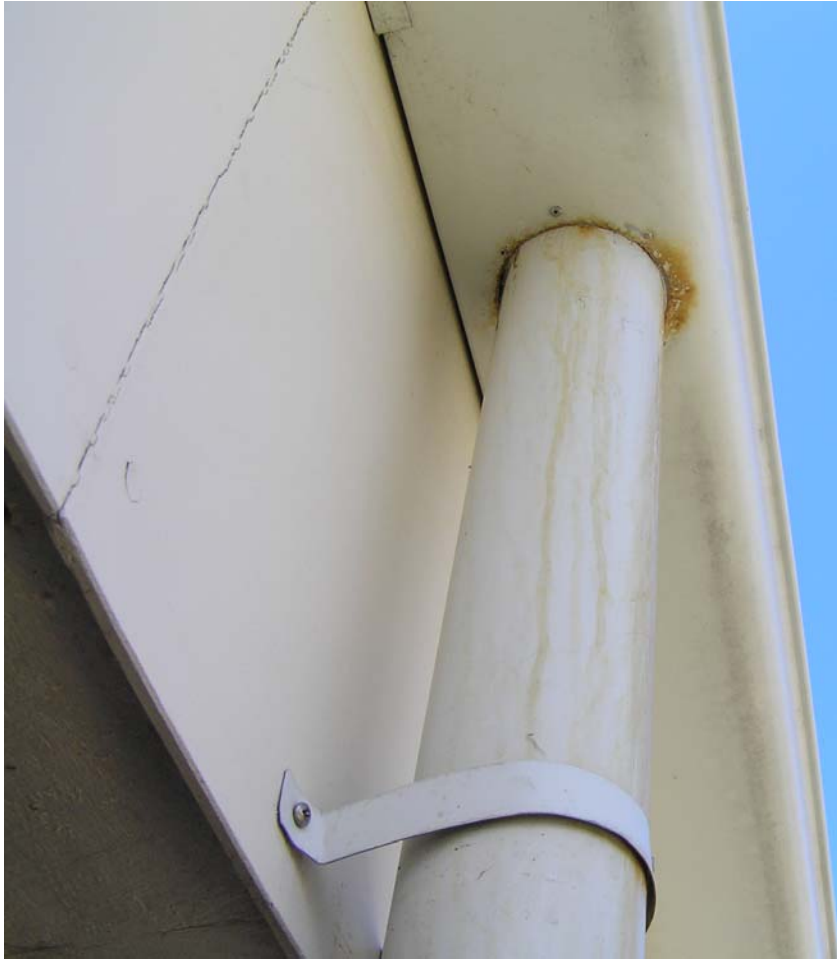
Degradation of gutter at join.
