Bringing Innovation to Facility Management

Defining Reference Service Life: An Open Innovation Approach

Trip to Sunshine Coast Queensland
September 2004

Inspection at Schools

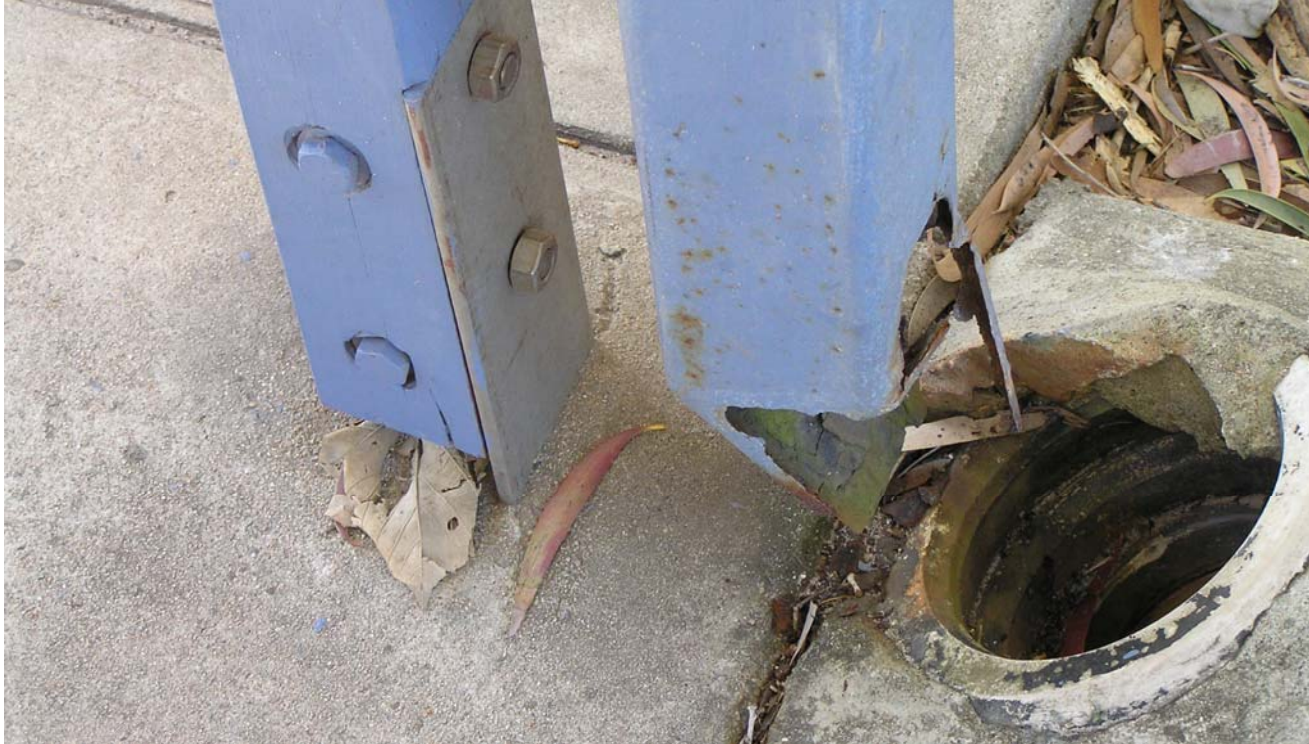
Bottom of square section, steel completely rusted away

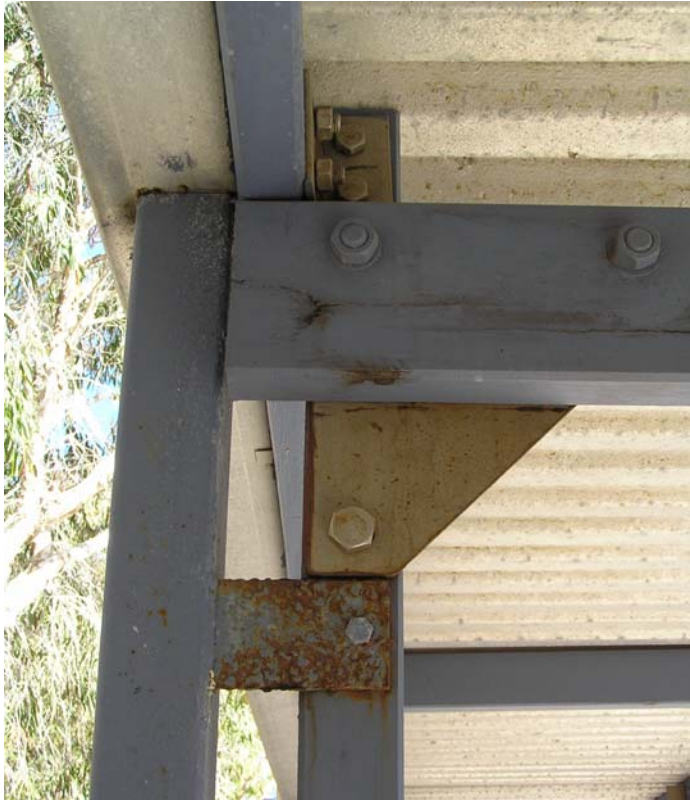
Top of downpipe also showing rusting of bracket from downpipe to support and stainless steel plates on walkway beams.

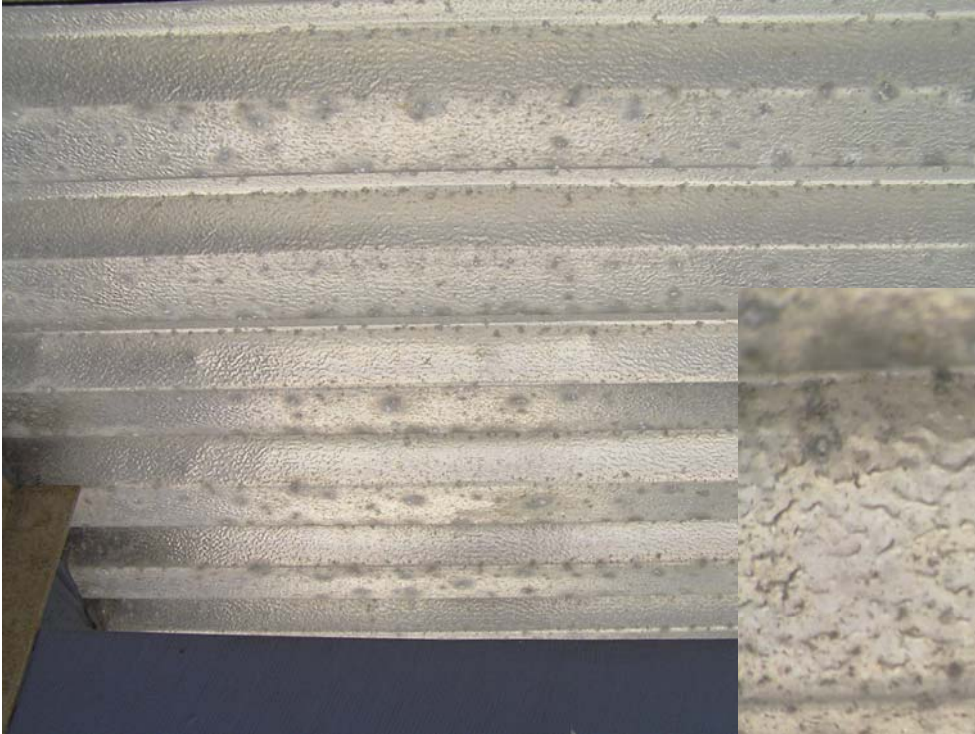
Underside of aluminium roof sheeting of covered walkway

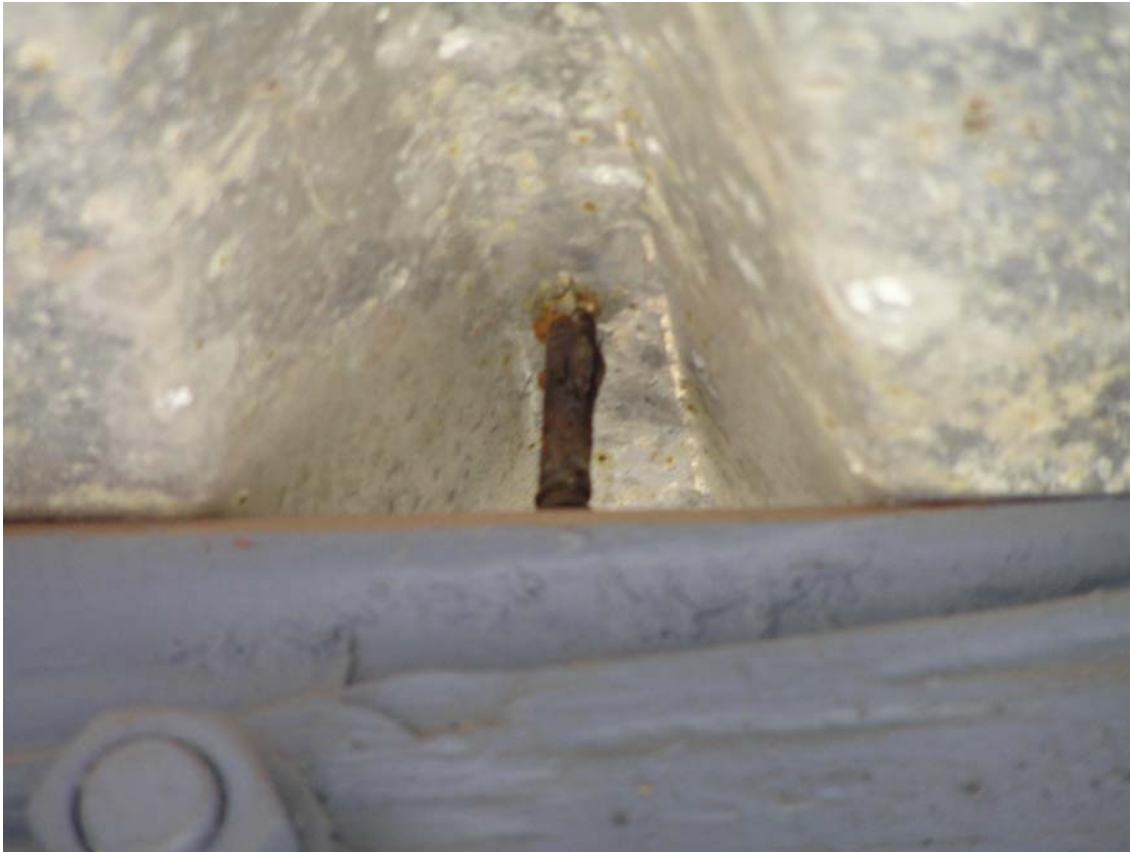
Heavily corroded fastener in sheeting of covered walkway

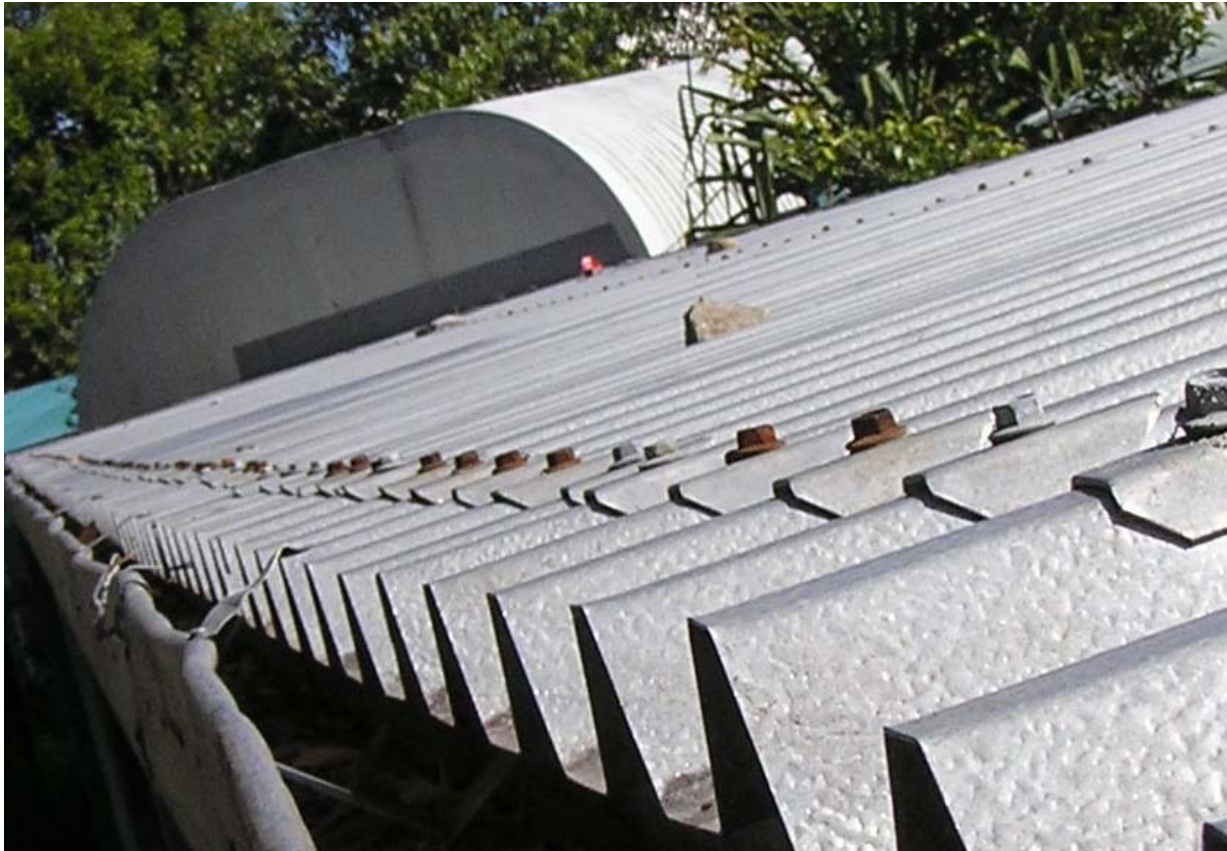
Close up of fasteners showing red rust and white corrosion product

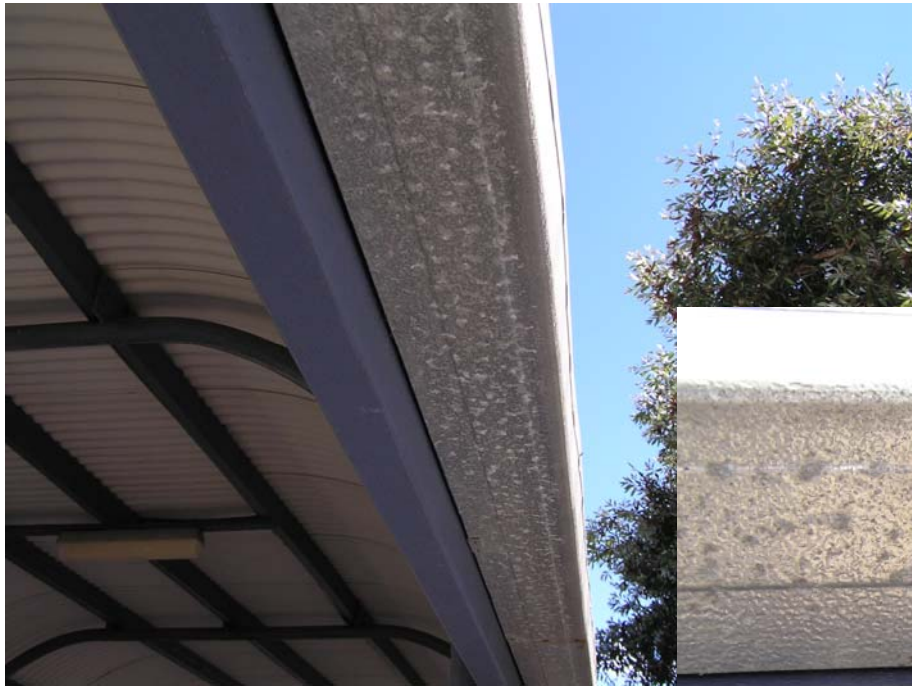
Underside of all gutters were significantly corroded

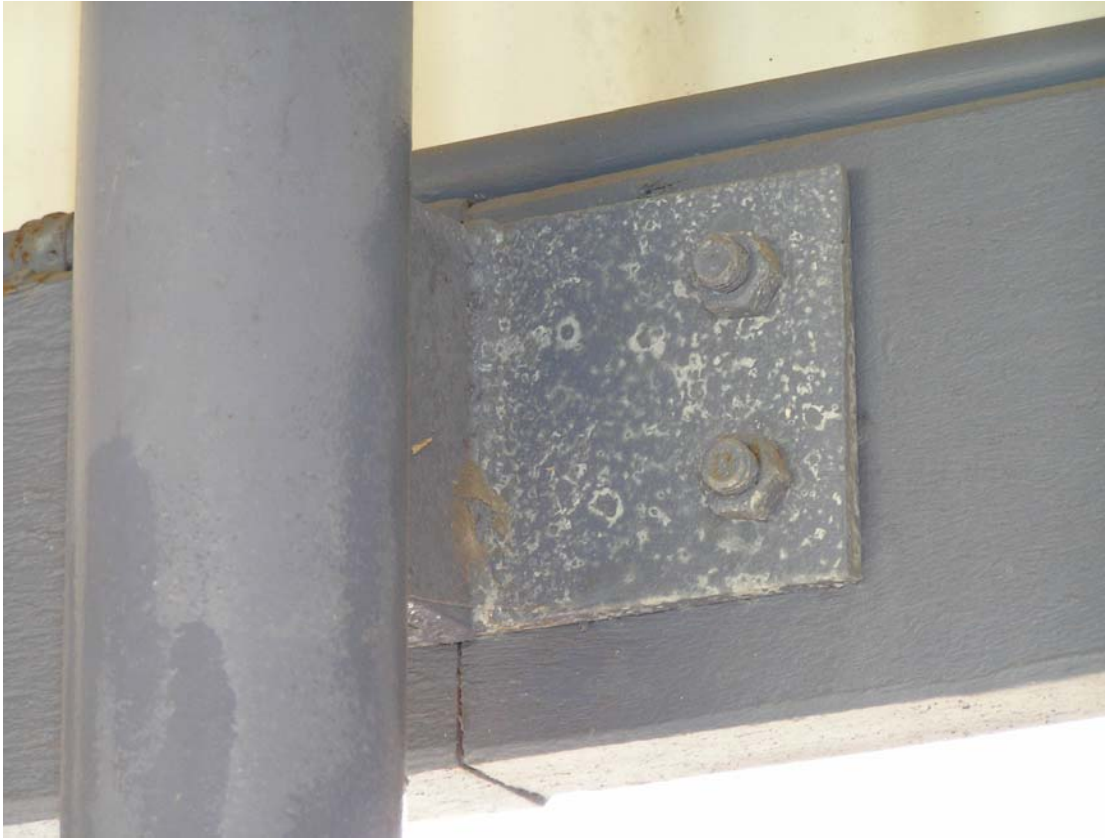
White corrosion product on painted steel brackets

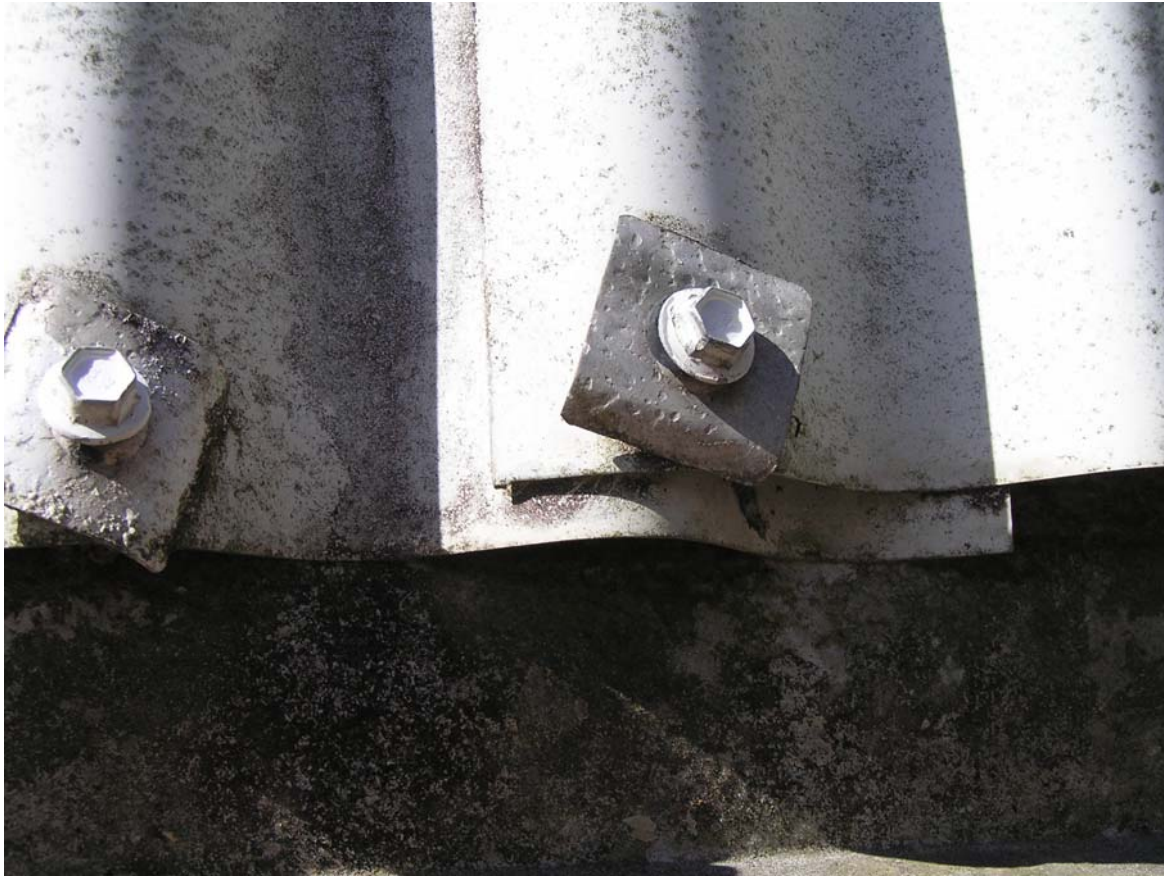
Colorbond sheeting and aluminium gutter showing significant growths.

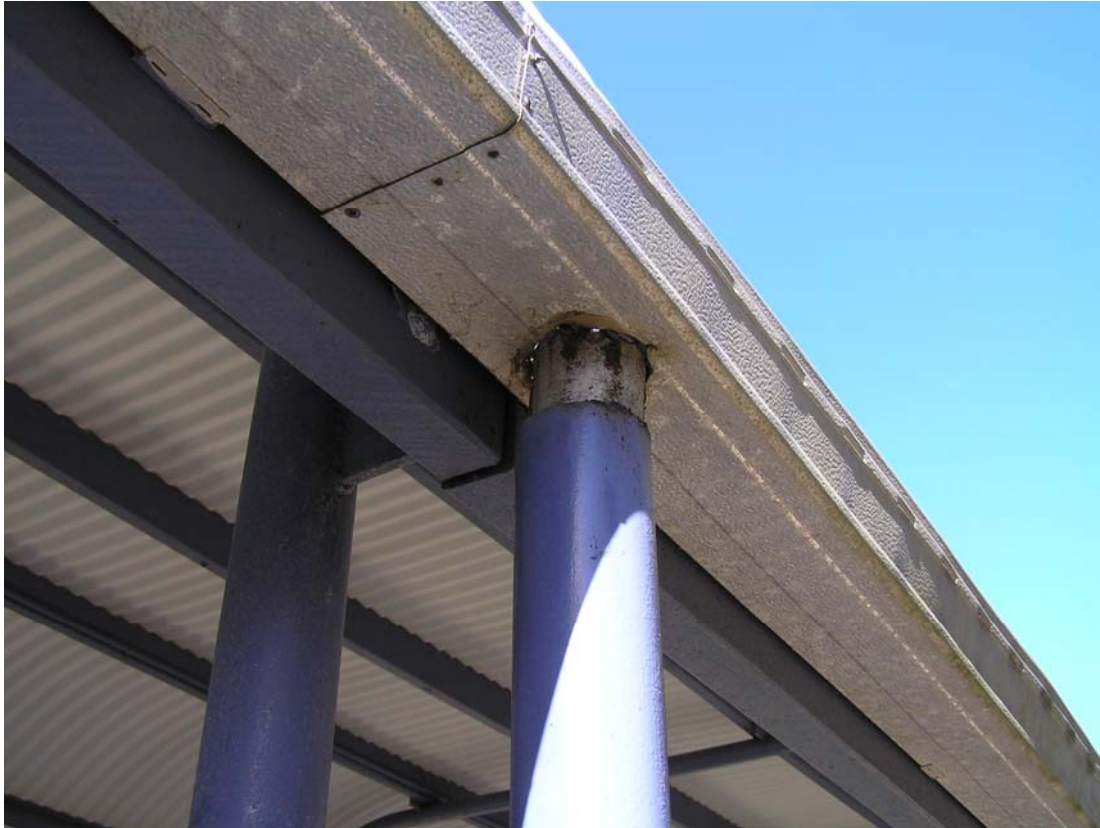
Deterioration around joint
between gutter and
downpipe

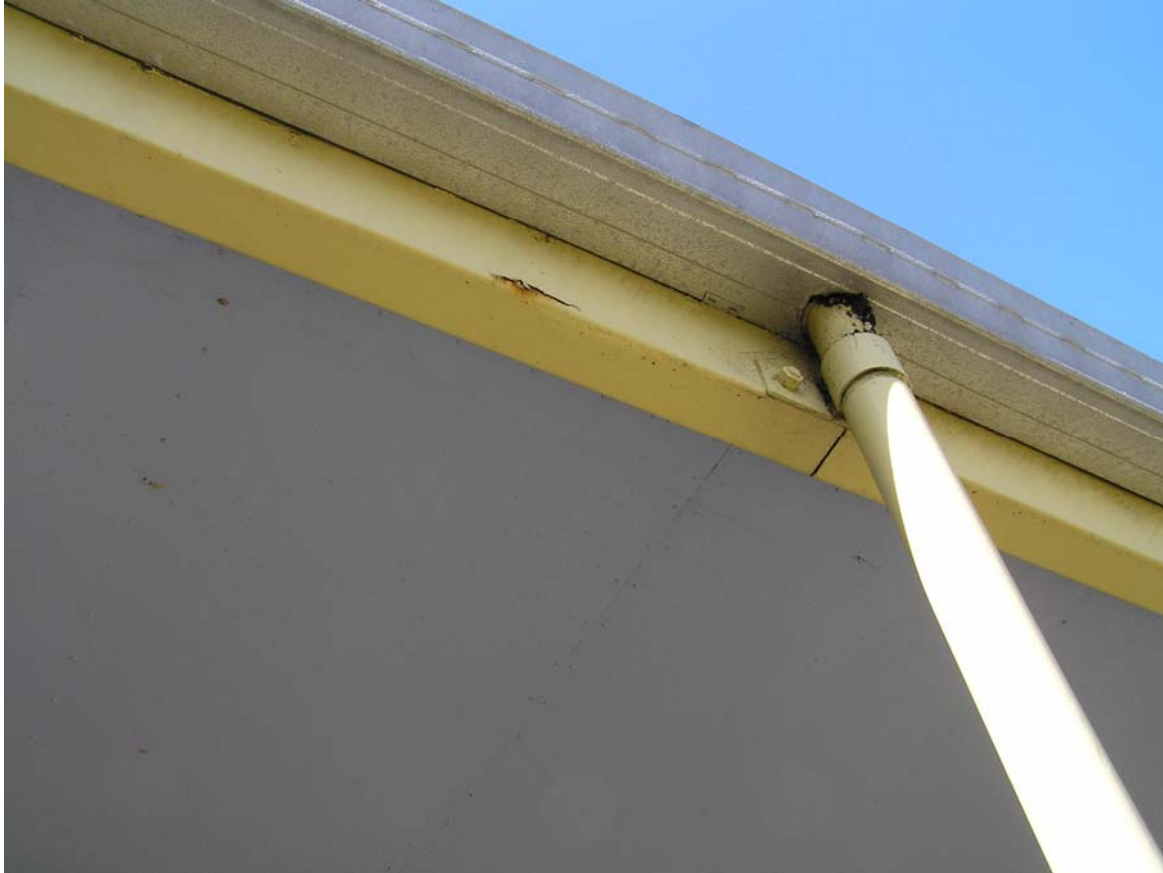
Structural downpipe showing that water has come through the joint to the gutter and red rust can be seen in U section.

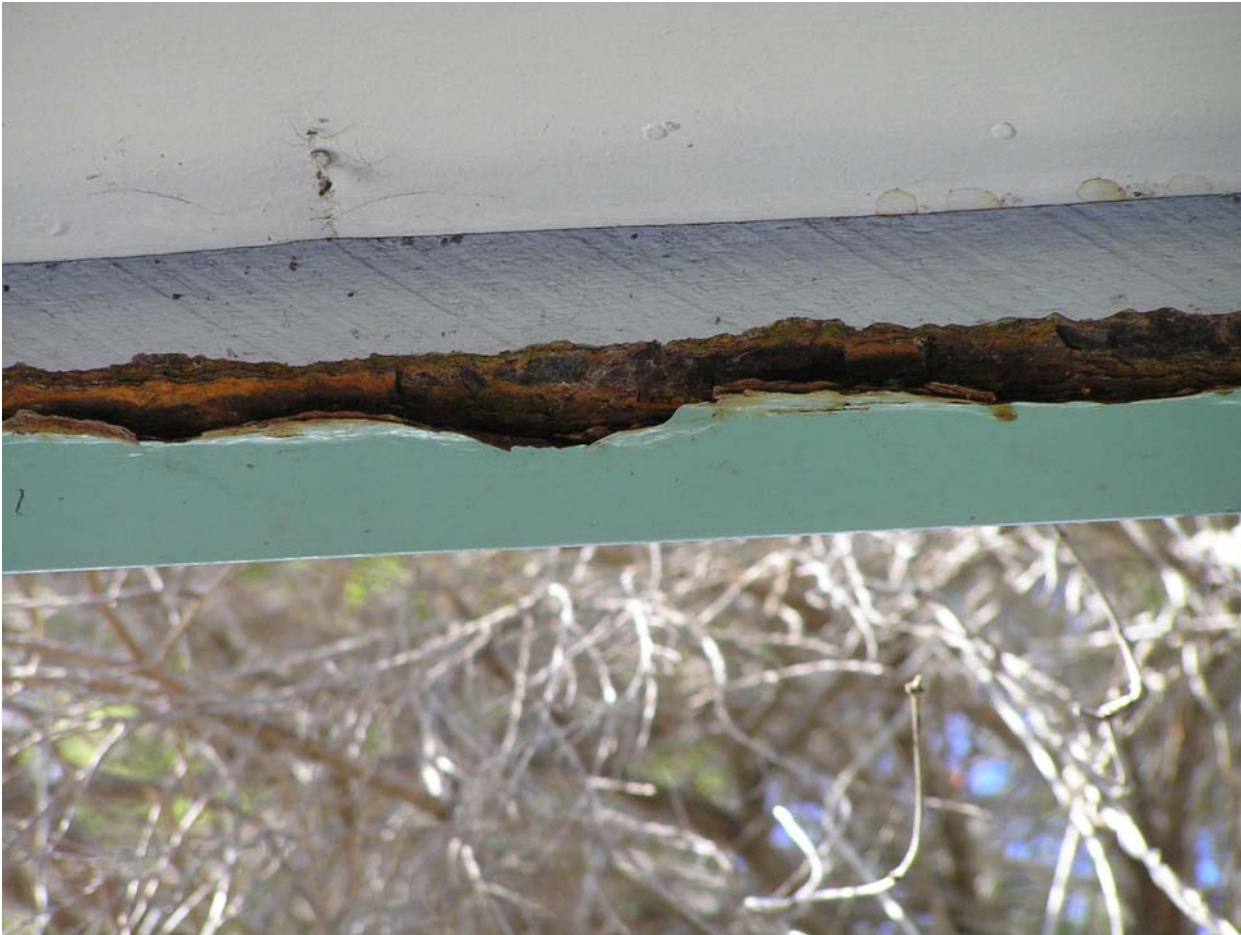
Close up of U section from under the eave , red rust can be seen and also the wood beam which is rotting

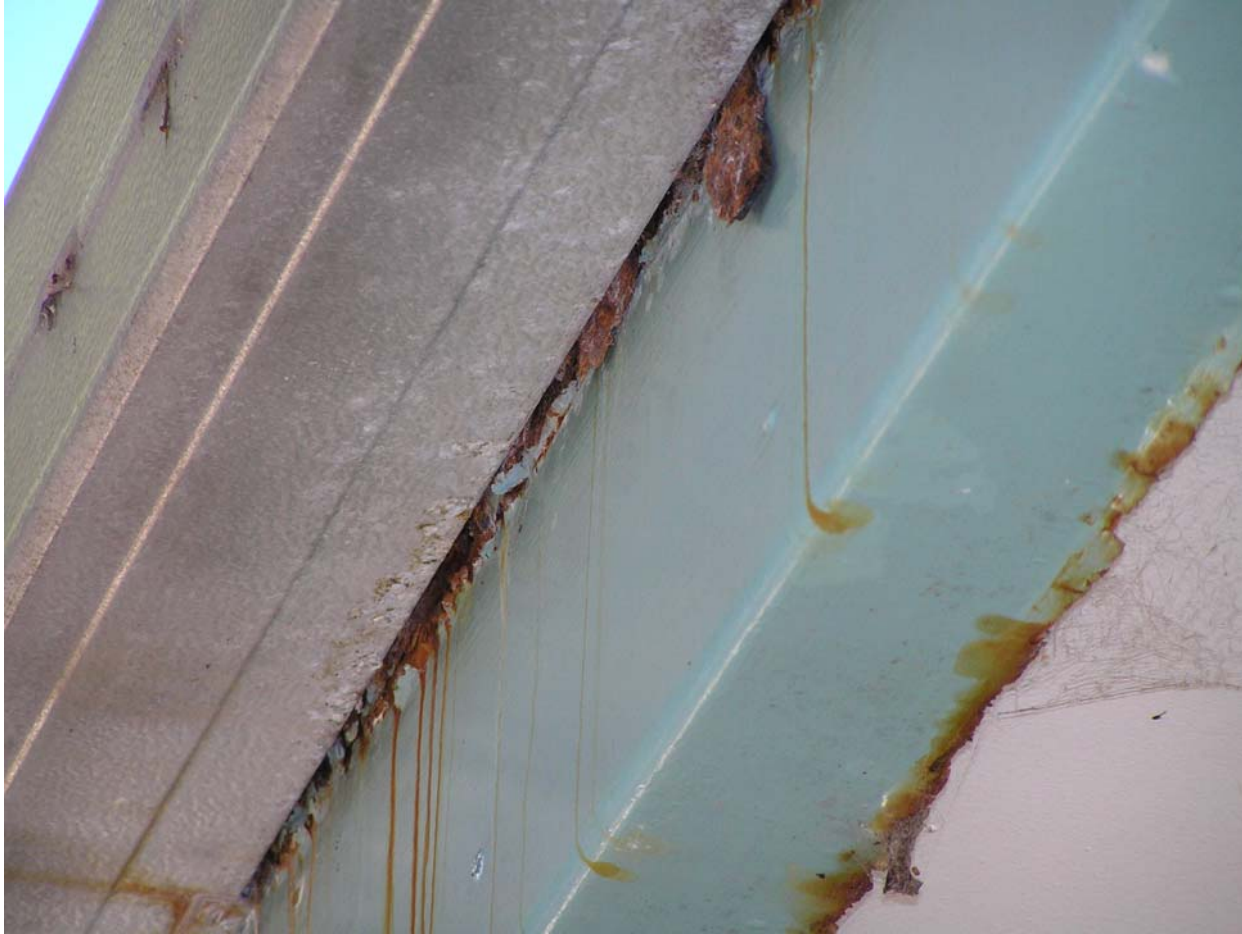
Close up of U section showing significant red rust.
