School Survey to Collect Data on Material Performance

Research Project No: 2005-003-B-08

Project: 2005-2003-B
Learning System for Life Prediction of Infrastructure

Date: June 2007

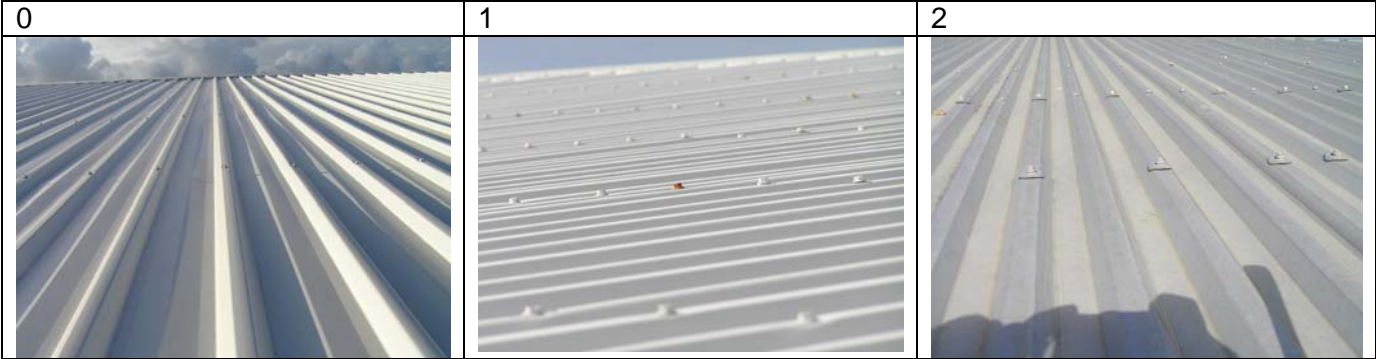
Roof rating
a) Colorbond

Figure 5: Photographs depicting the various rating categories for the different components and materials

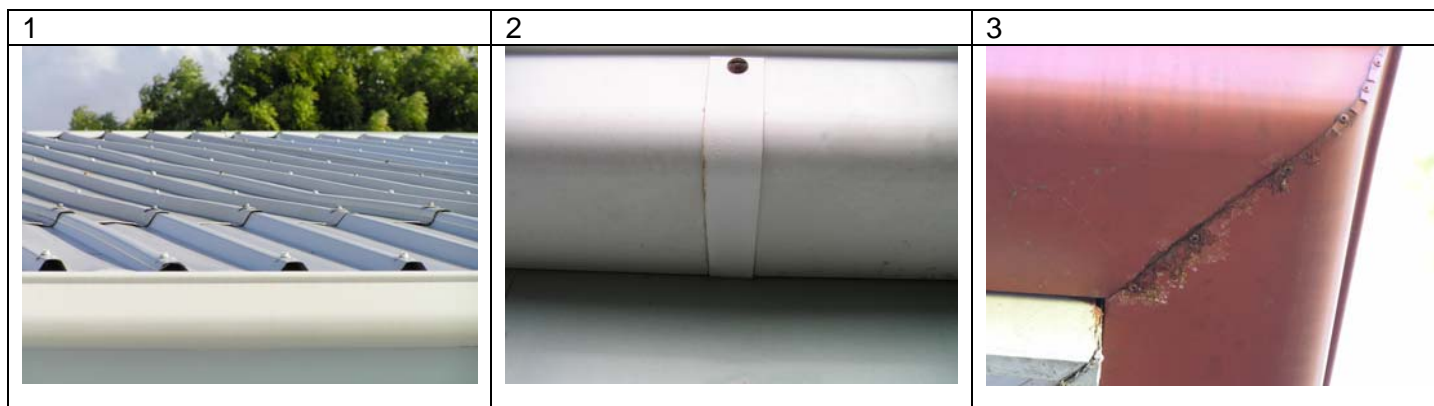
a) Colorbond

Figure 5(cont): Photographs depicting the various rating categories for the different components and materials

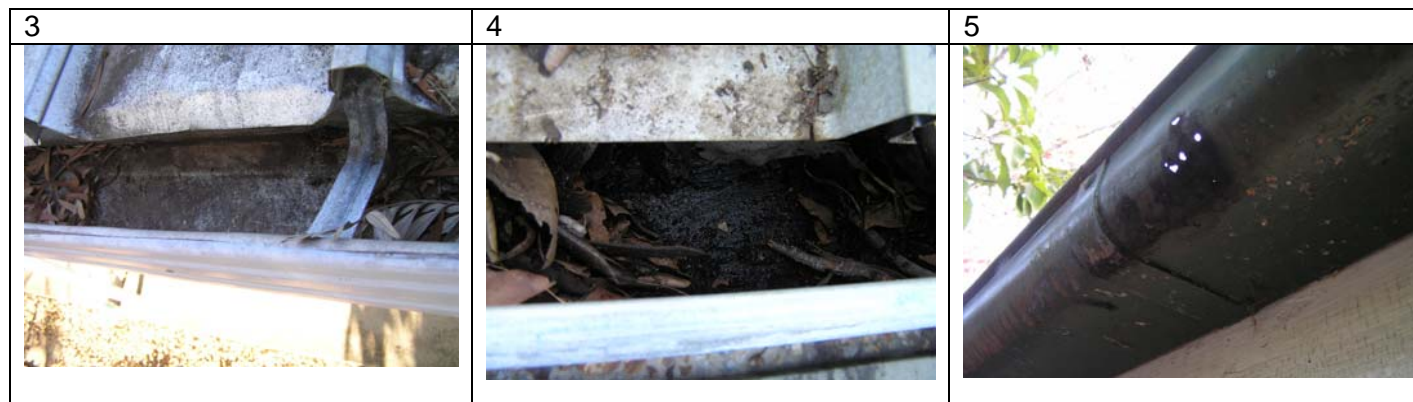
b) Zincalume (painted outside)

Figure 5(cont): Photographs depicting the various rating categories for the different components and materials

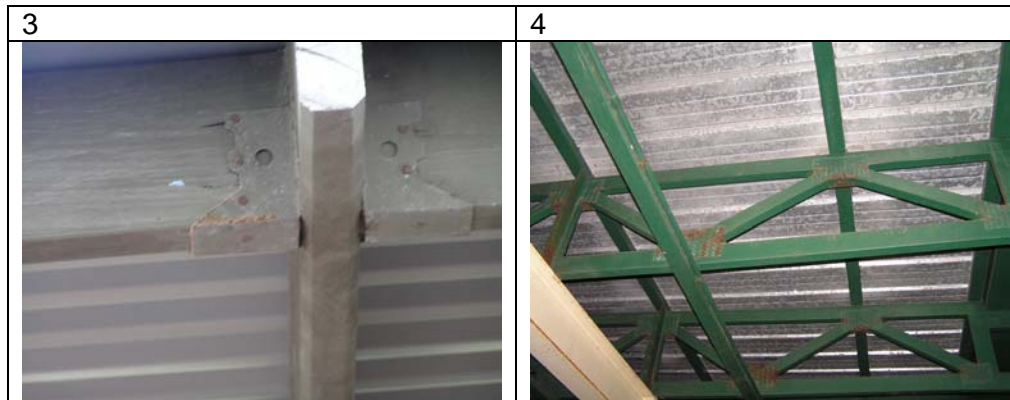
Gangnails

Figure 5(cont): Photographs depicting the various rating categories for the different components and materials

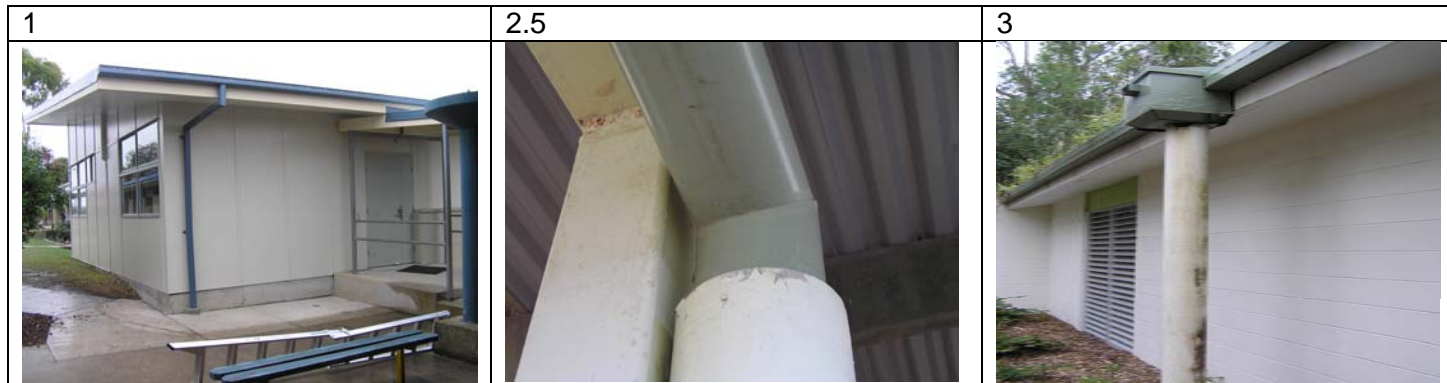
Downpipes Colorbond

Figure 5(cont): Photographs depicting the various rating categories for the different components and materials

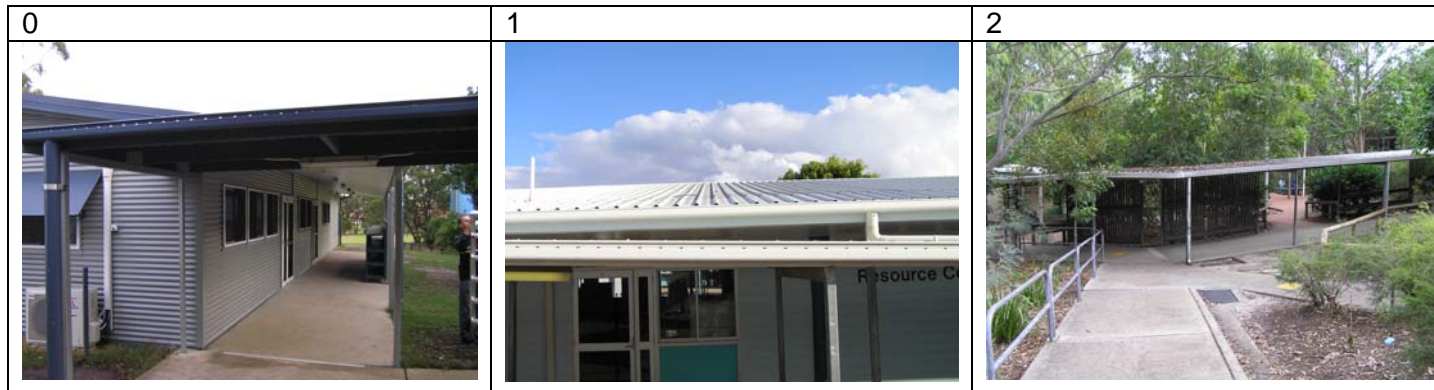
Steel supports - Galvanised

Figure 5(cont): Photographs depicting the various rating categories for the different components and materials
