Trip to Sunshine Coast Queensland, September 2004 Visit to Bridge and Foreshore

Report No 2002-059-B No 8

Project Name Case Based Reasoning in Construction and Infrastructure Projects

Date: January 2005

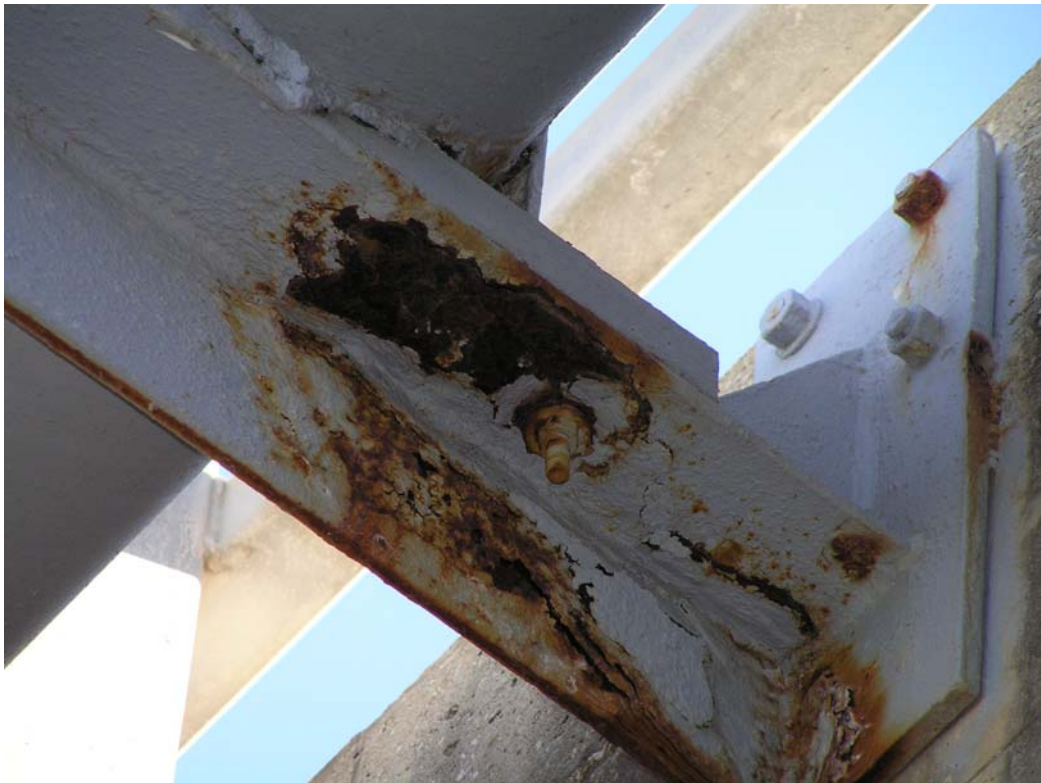
The following figures show the bridge and associated metal components. The metallic guard rails and supports are made from a number of different materials. The main guard rails and the crash barriers are galvanised and the pipe and supports are painted steel. The galvanised rails show white corrosion products on the surface with some spots of red rust. The pipe and supports show significant paint deterioration and red rust.

Figure 12. Pipeline support viewed from below showing red rust

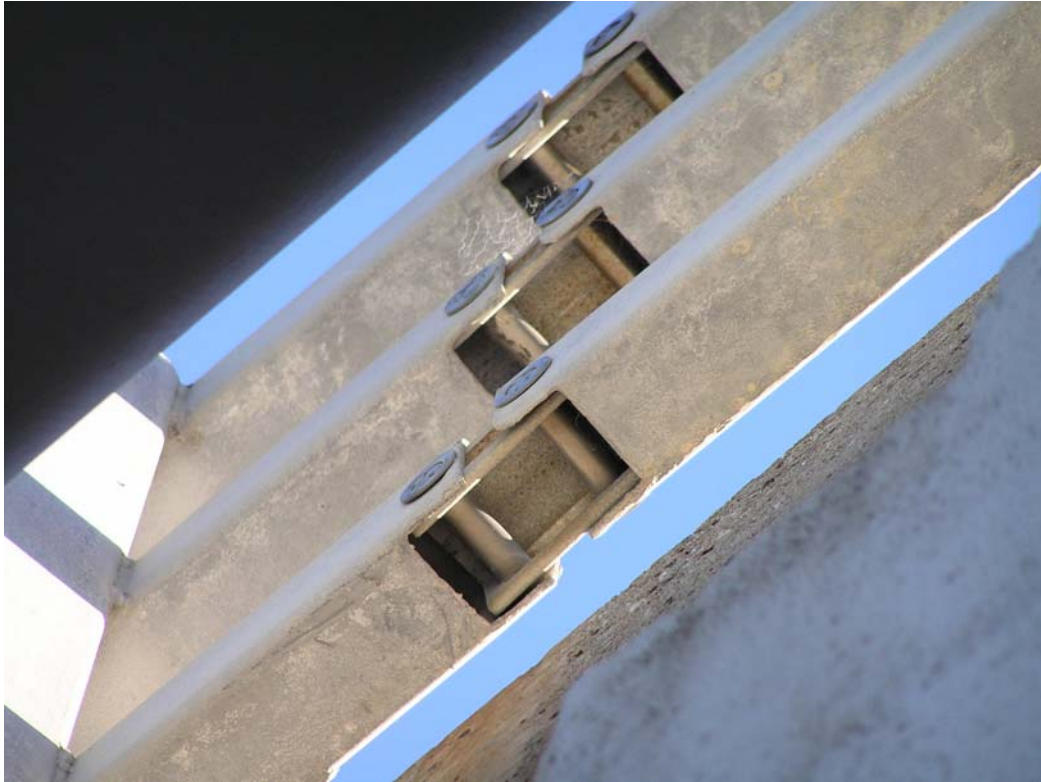
Figure 13. Underside of guard rails showing some signs of white corrosion product

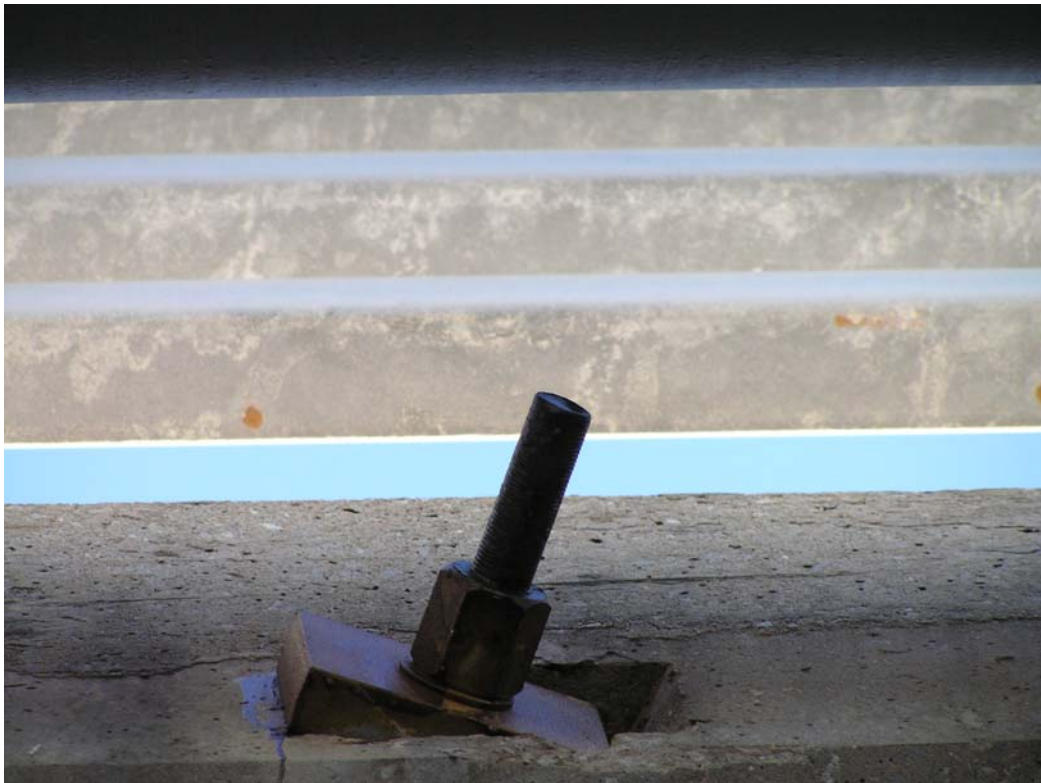
Figure 16. Guard rails seen from below showing white corrosion product and possible red rust

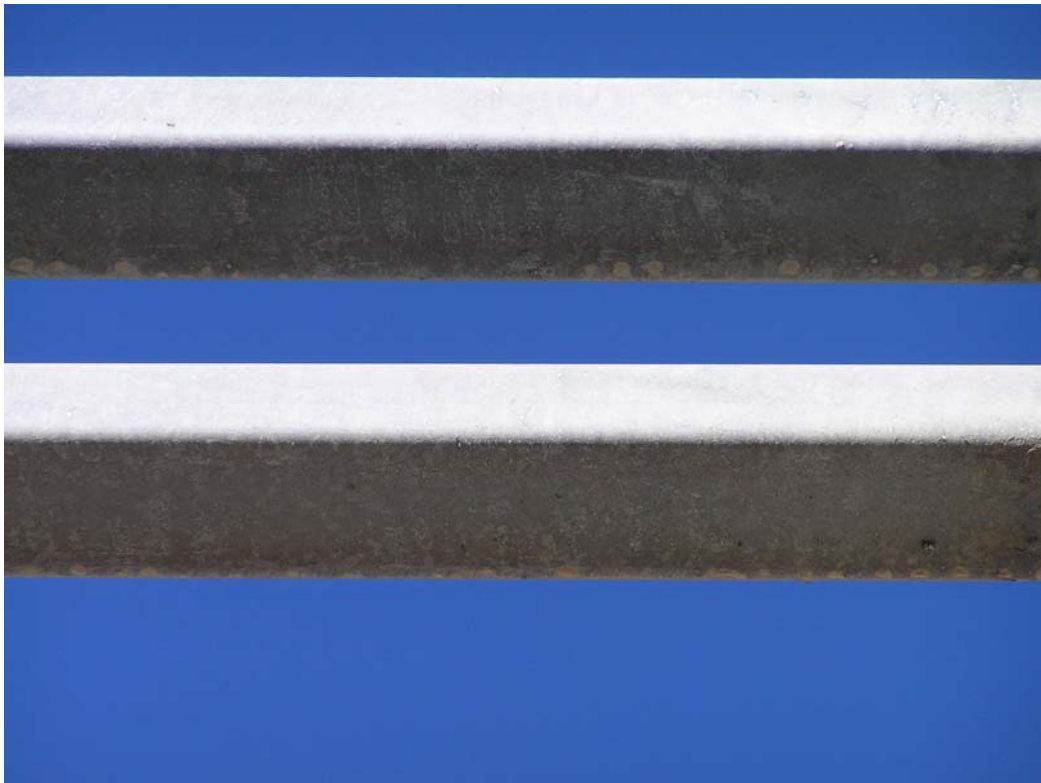
Figure 18. Guard rails on western side of the bridge showing white corrosion products

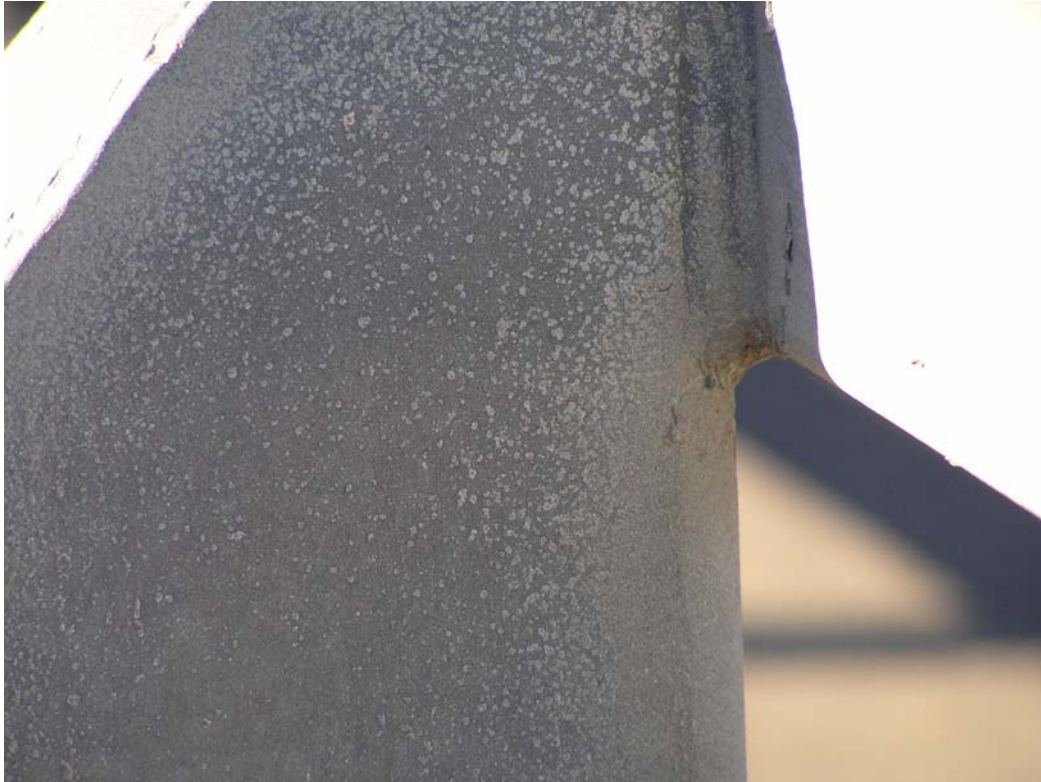
Figure 21. Close up of corrosion on guard rail

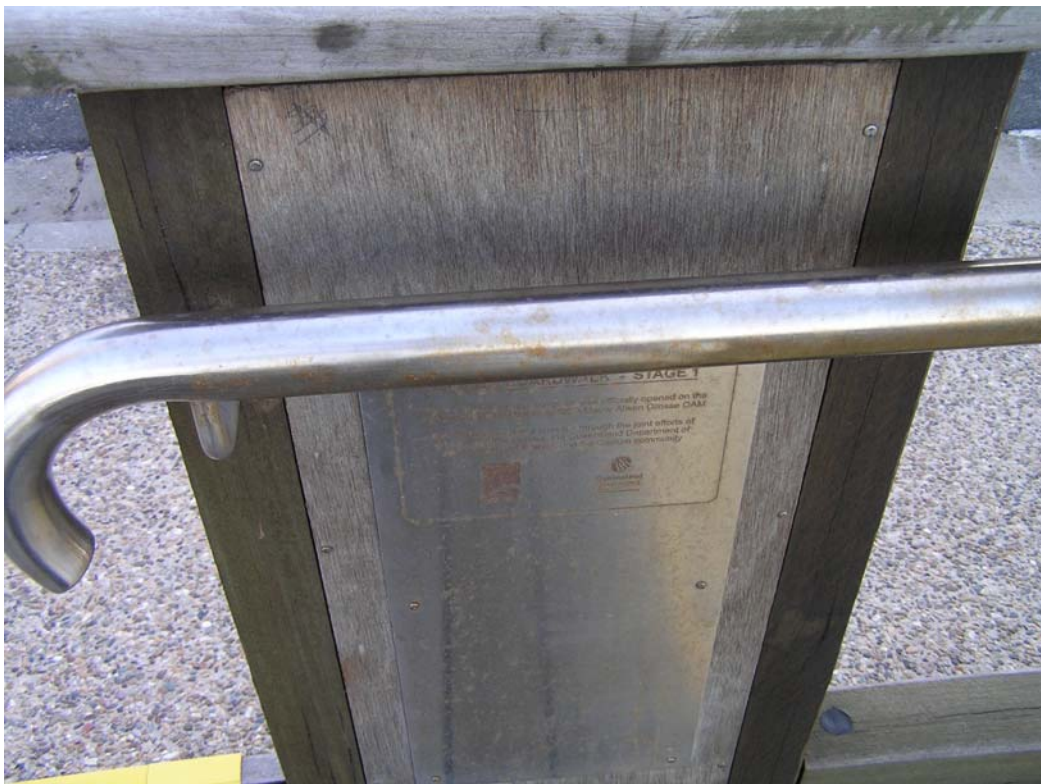
Figure 26, Figure 27 and Figure 28 show the hand rails and plaque on the boardwalk. The stainless steel handrails and the plaque show excessive "tea staining" which would have been avoided if the level of polishing had been correctly specified.

Figure 26. Handrail and plaque on foreshore boardwalk

"Tea staining" of stainless steels occurs in marine environments and is caused by a number of factors. The simplest way to stop "tea staining" seems to be to specify a

very smooth finish, the smoother the better. Electro polishing would be a method to specify to get a smooth finish and minimise the “tea staining”.

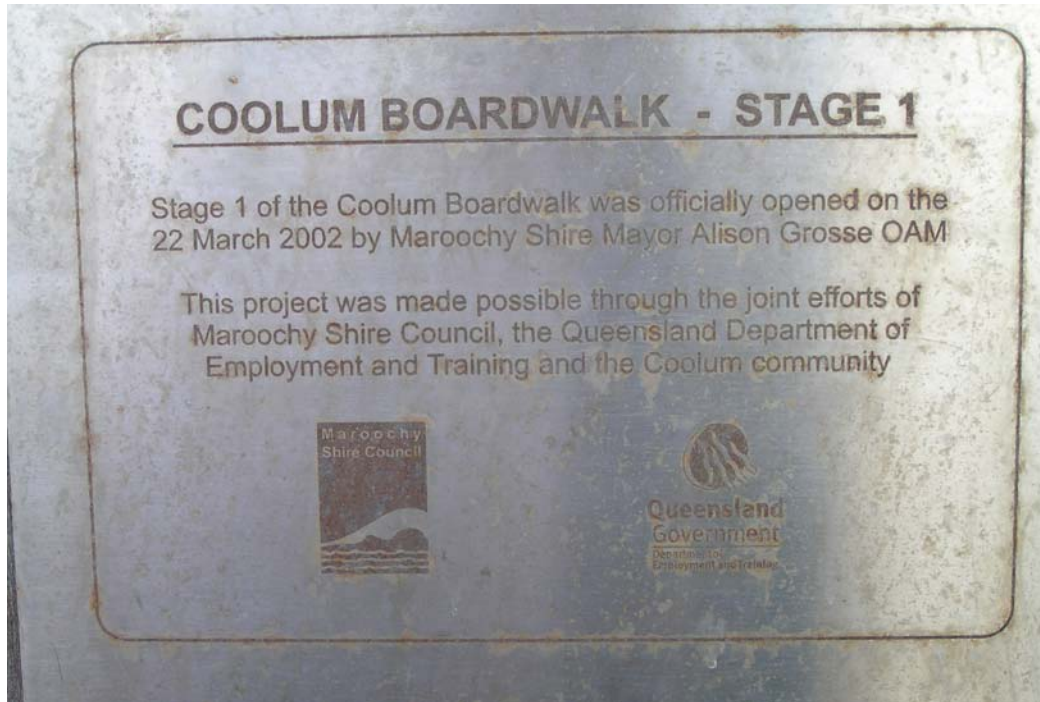
Figure 27. Close up of plaque showing significant "tea staining" of the stainless steel

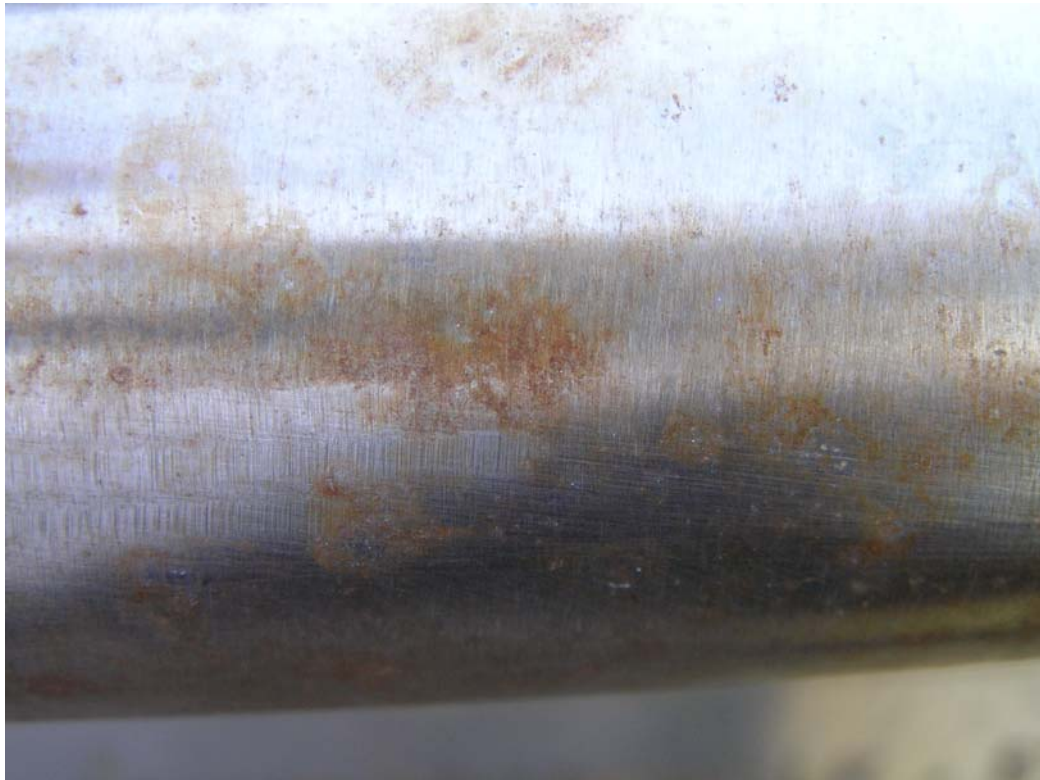
Figure 28. "Tea staining" on hand rail

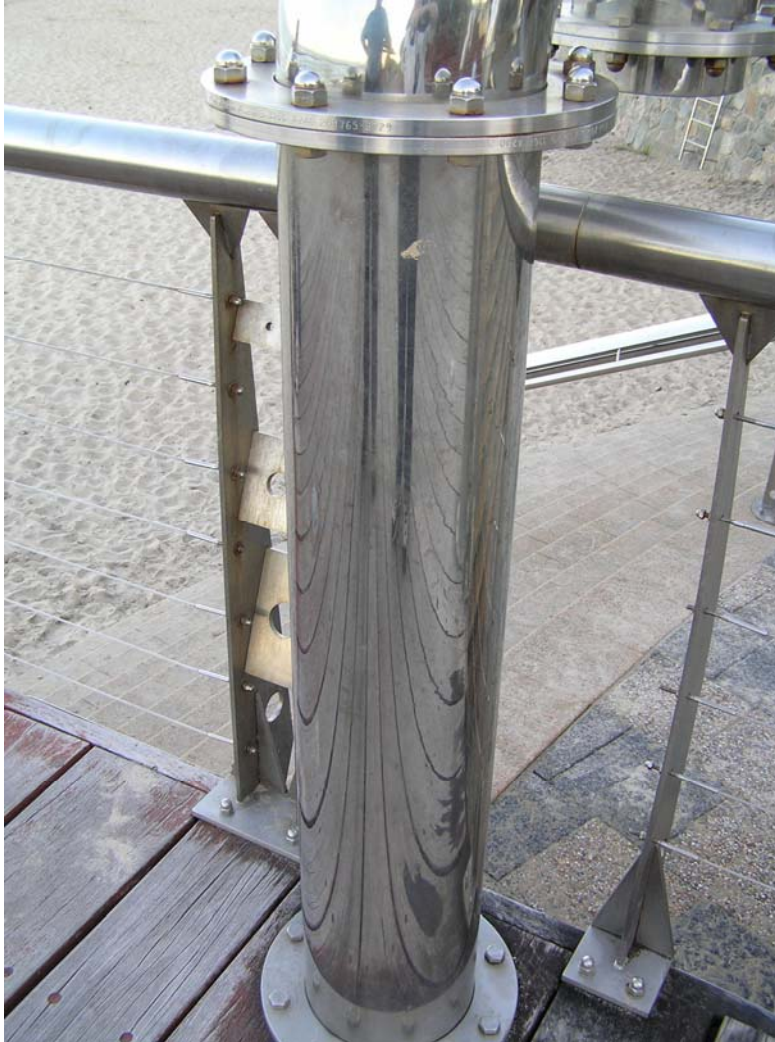
Figure 29 shows some street furniture in the same location that looks to have been correctly specified. It is in good condition while other items are showing staining. Figure 30 shows a bolt on this object that is showing some staining. It is unclear what is causing this staining.

Figure 29. Stainless steel street furniture in good condition

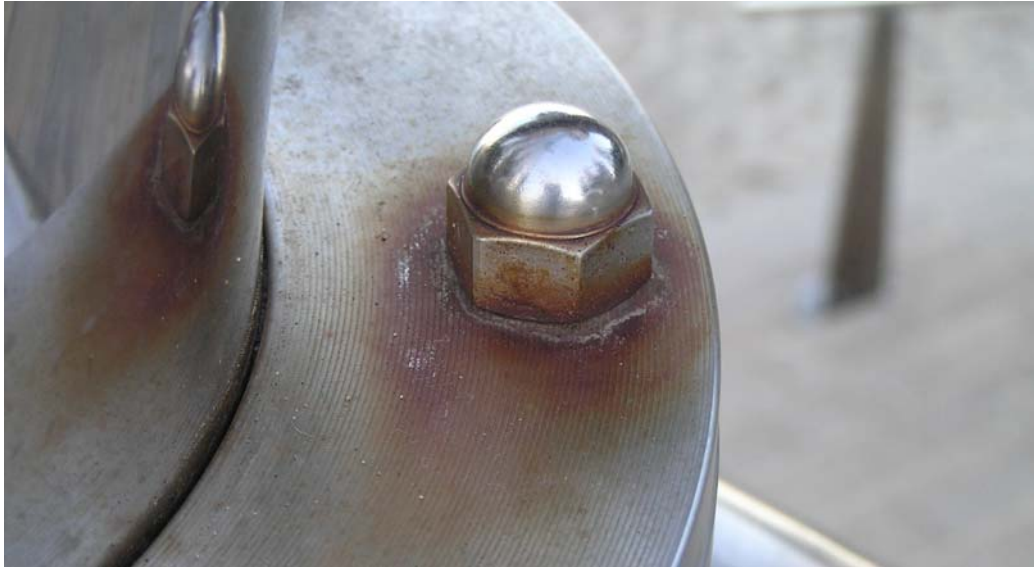
Figure 30. Red rust staining from bolt

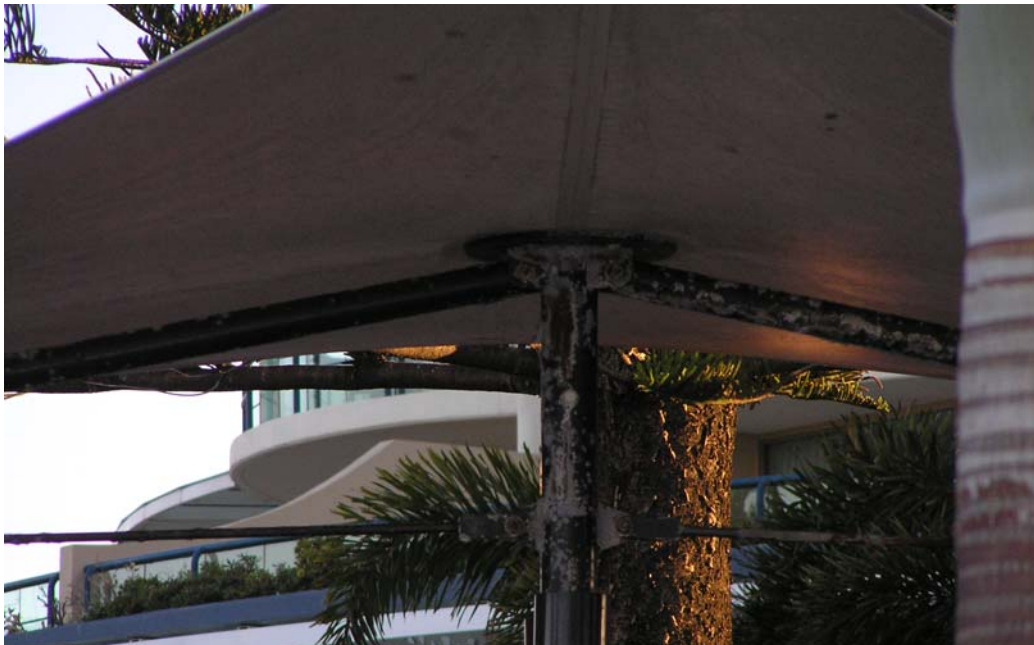
Figure 31 shows a canvas shelter support which is showing very severe degradation. Figure 32 shows a close up of the support which is of a painted galvanised steel construction. There is a lot of white corrosion product and red rust present.

Figure 31. Canvas shelter with painted galvanised steel supports

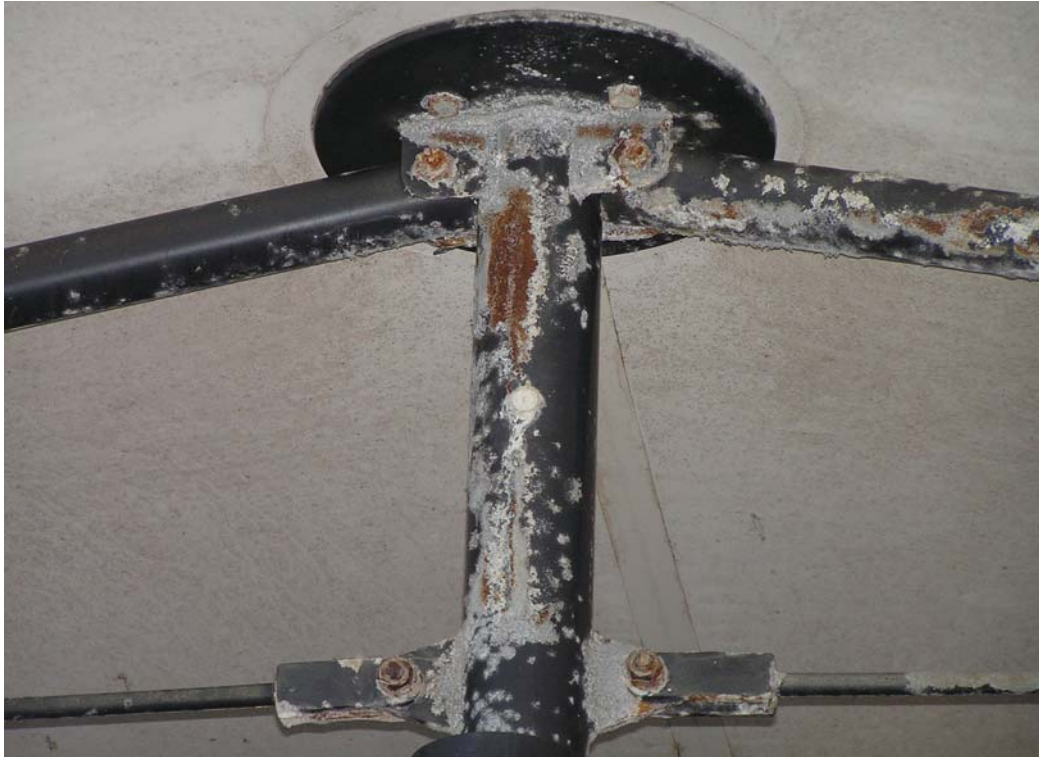
Figure 32. Close-up of shelter support showing red rust, white corrosion product and paint deterioration.

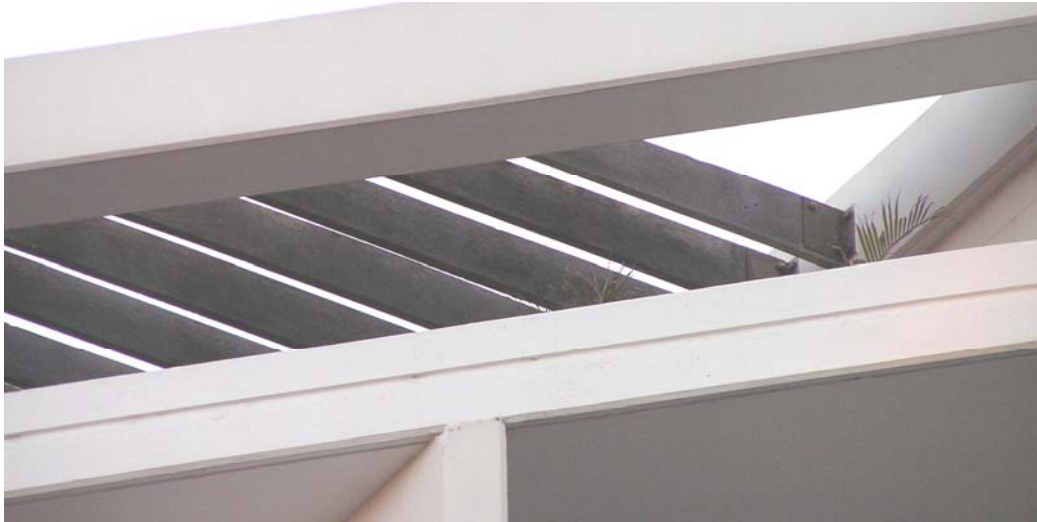
These galvanised purlins are showing a lot of white corrosion product and would seem to be the wrong choice for this structure.

Figure 34. Galvanised Purlins on top floor of building showing white corrosion product
