Trip to Sunshine Coast Queensland, September 2004 Visit to Schools

Report No 2002-059-B No 7

Research Program: B Program Name Environmental Sustainability Research Project No.: 2002-059-B Project Name Case Based Reasoning in Construction and Infrastructure Projects

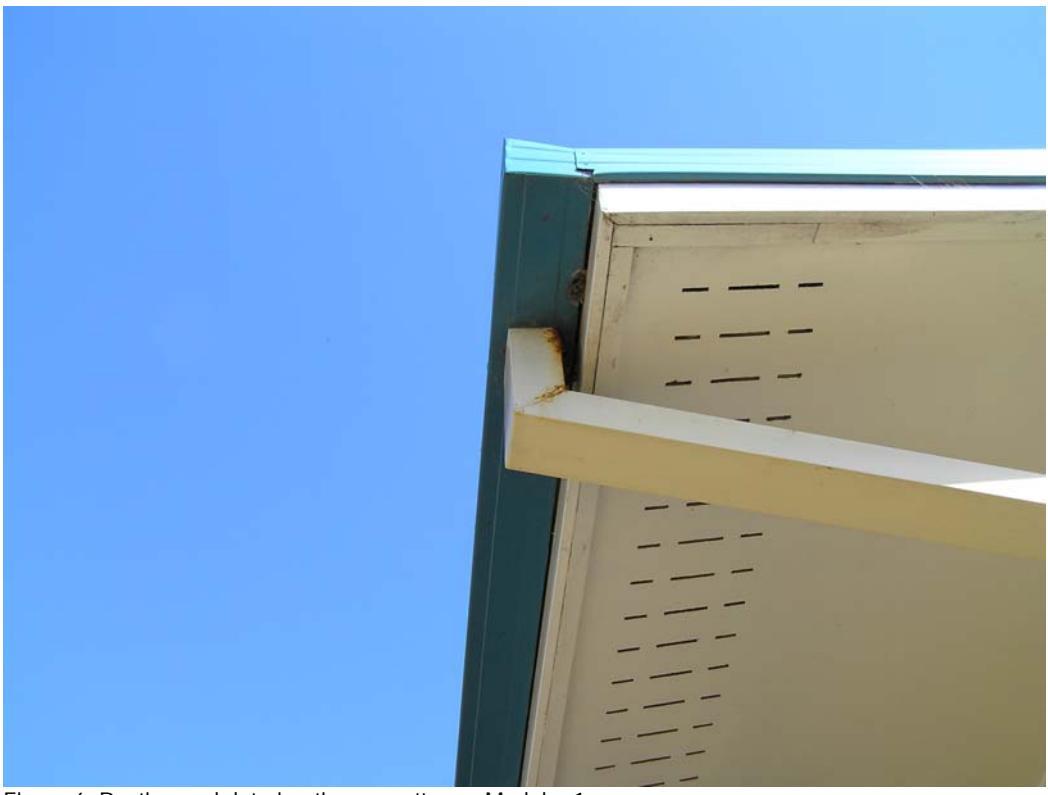
Figure 6 Rusting and deterioration on gutter on Modular 1

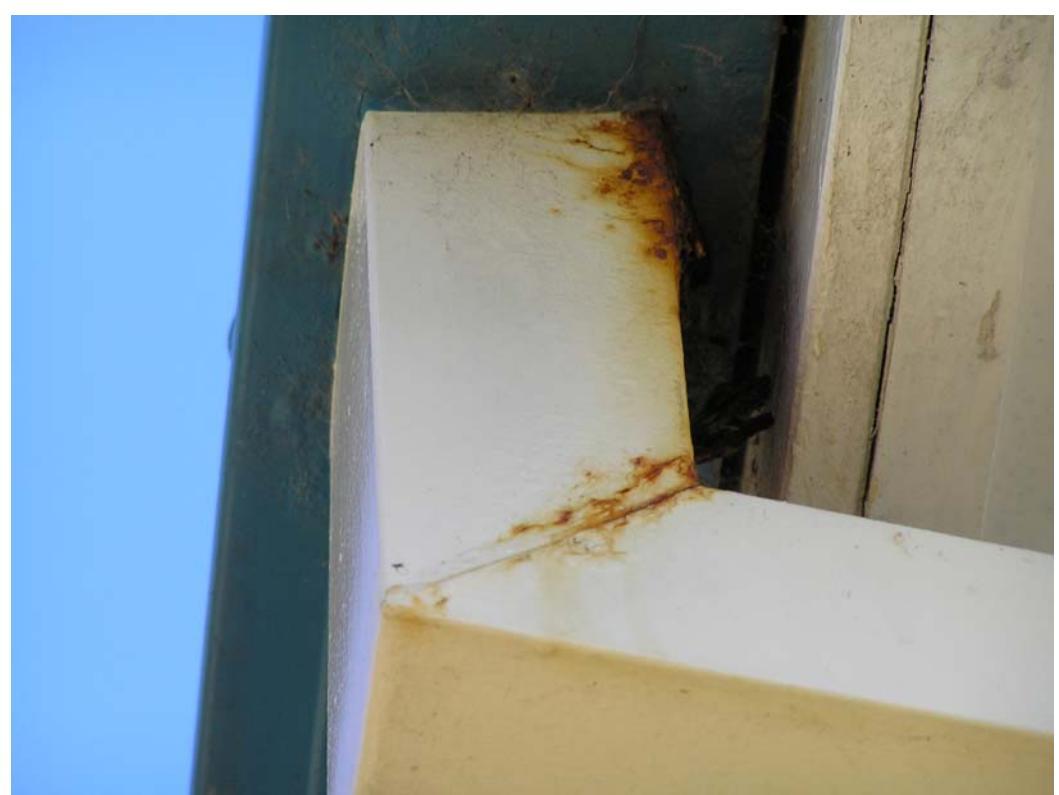
Figure 7 Close up of rusting and deterioration on gutter on Modular 1 showing that problems are associated with the joints.

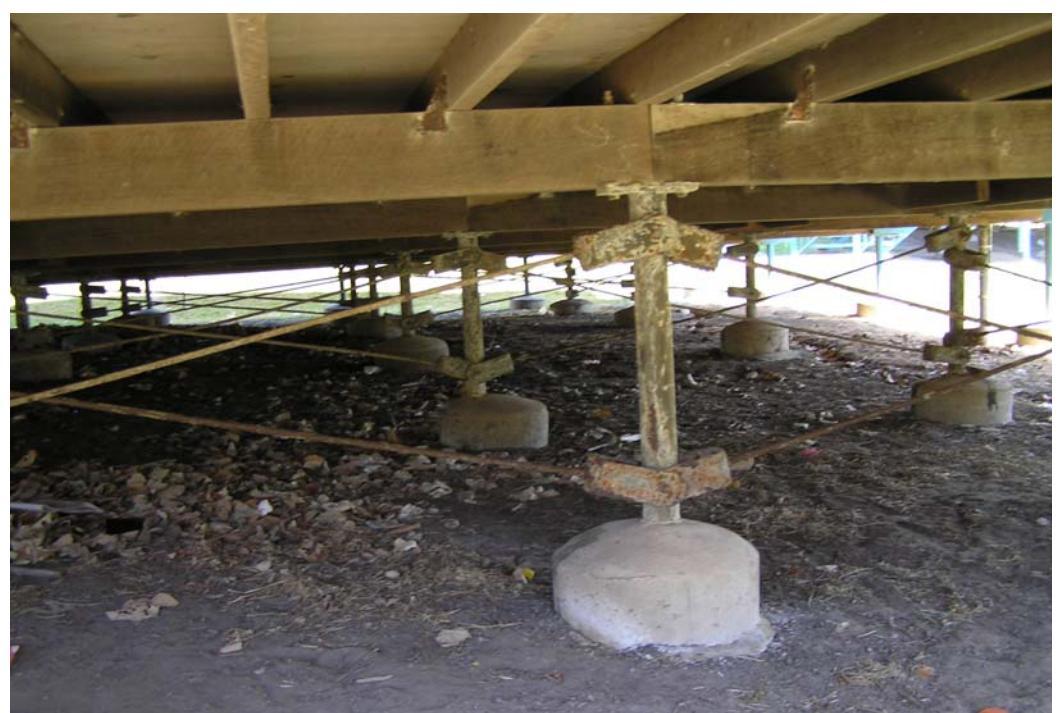
Figure 8 Sub-floor of Modular 1 showing significant deterioration of sub floor metallic components.

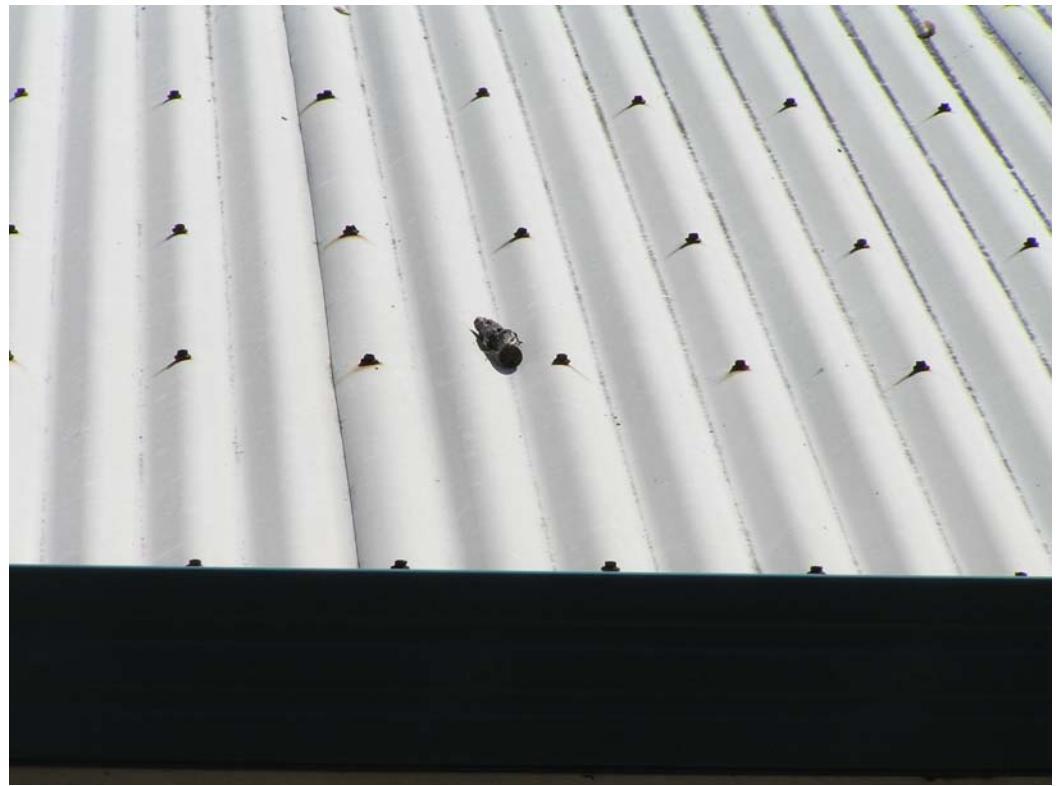
Figure 12 Fasteners on roof of Modular 1 showing rust staining on to sheeting.

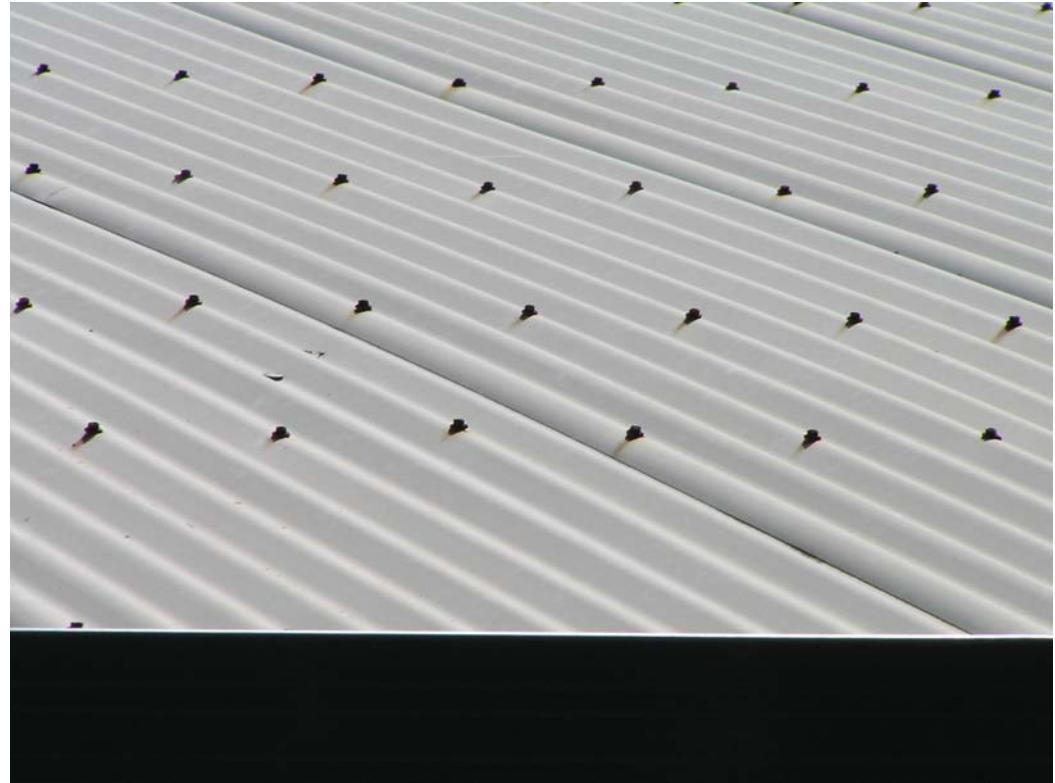
Figure 13 Fasteners on roof of Modular 1 showing rust staining on to sheeting.

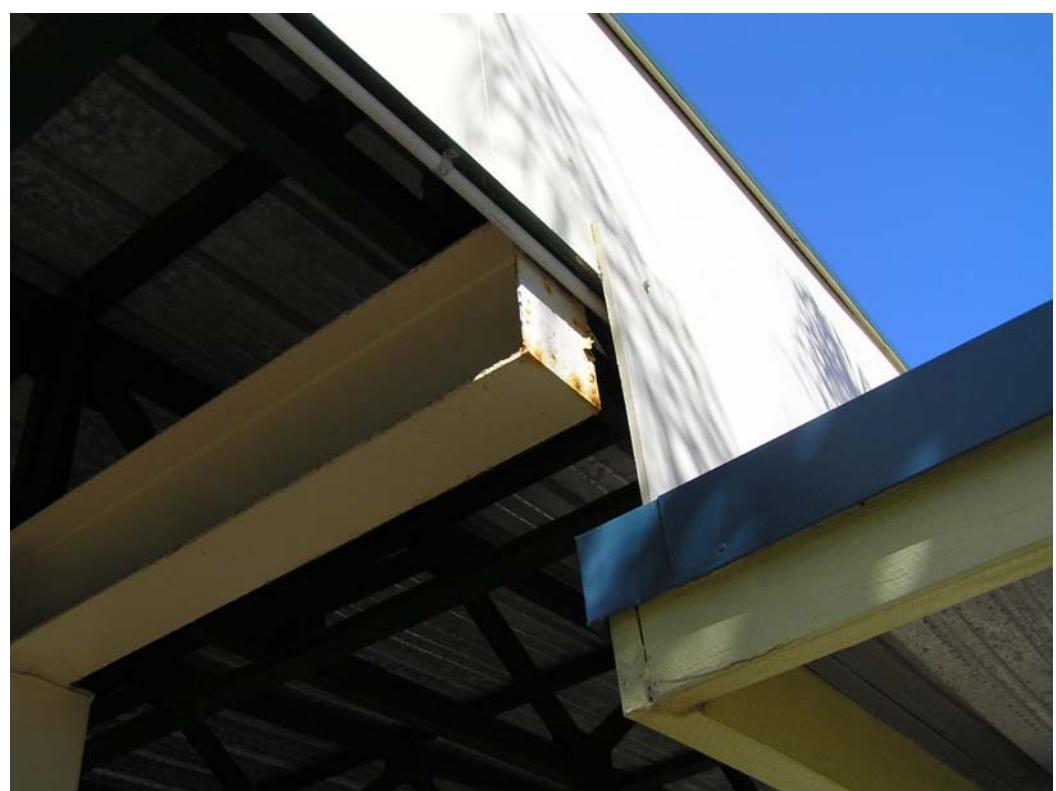
Figure 16 End of steel beam showing red rust break through.

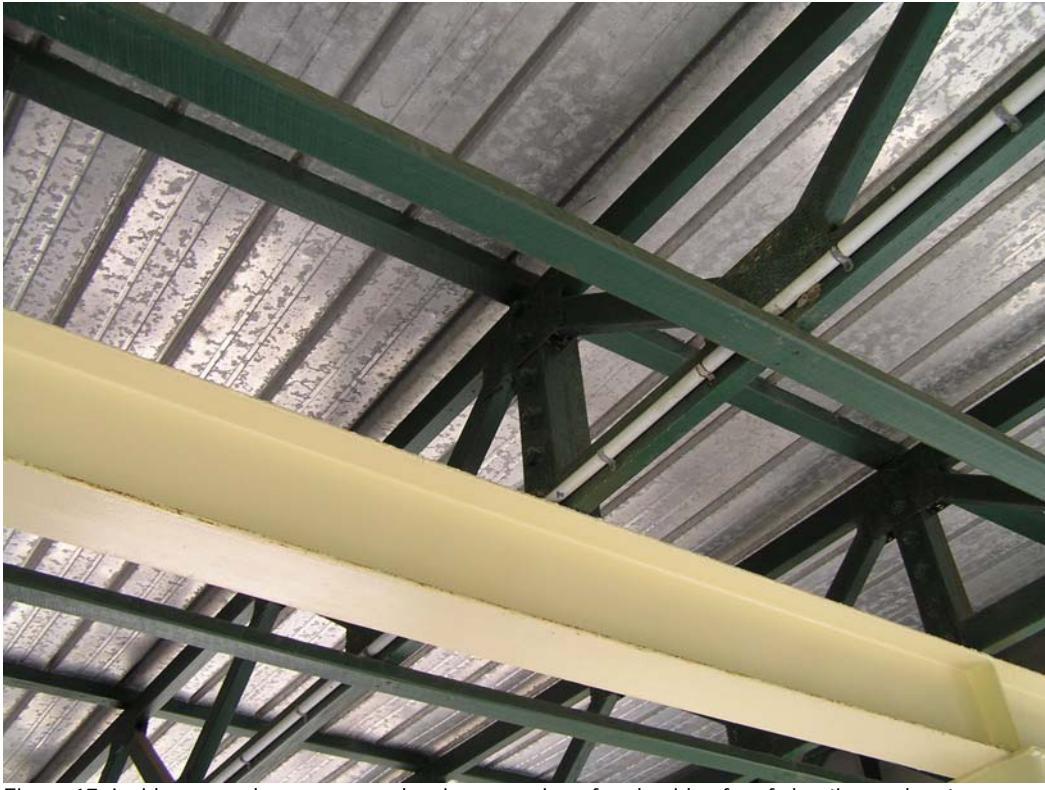
Figure 17 Inside covered games area showing corrosion of underside of roof sheeting and rust on edges of beams.

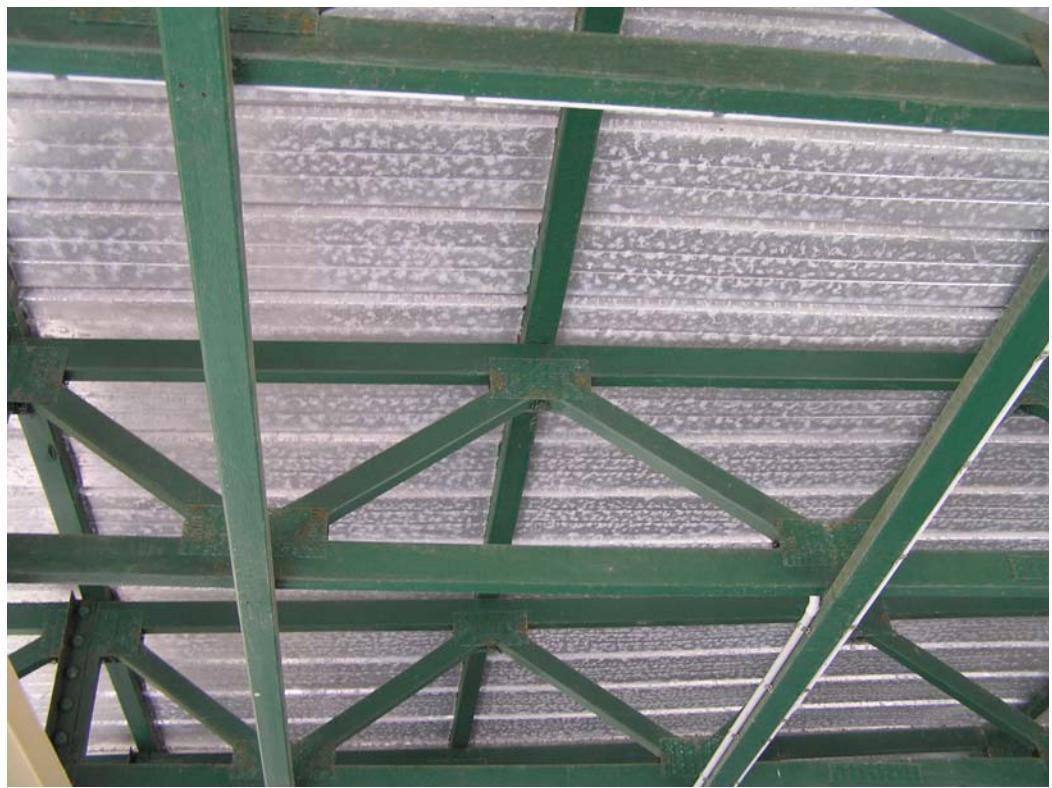
Figure 18 Inside covered games area showing corrosion of underside of roof sheeting and rust on painted gang nail plates.

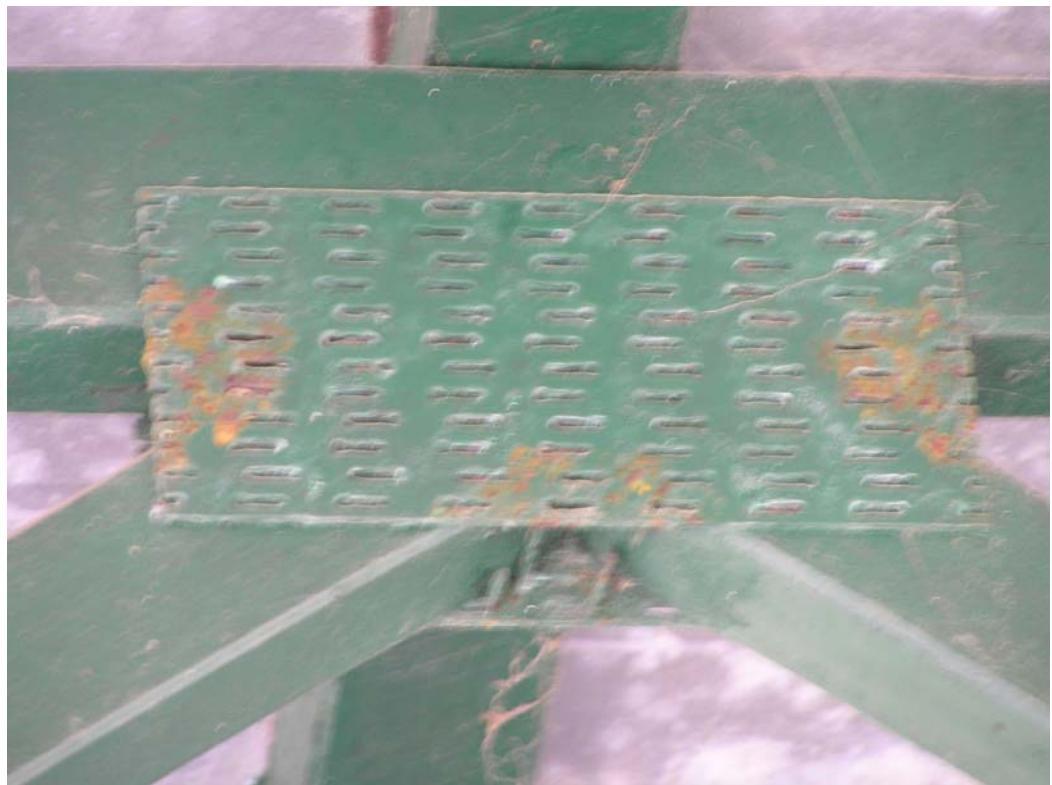
Figure 19 Close up of gang nail plates on inside of covered games area.

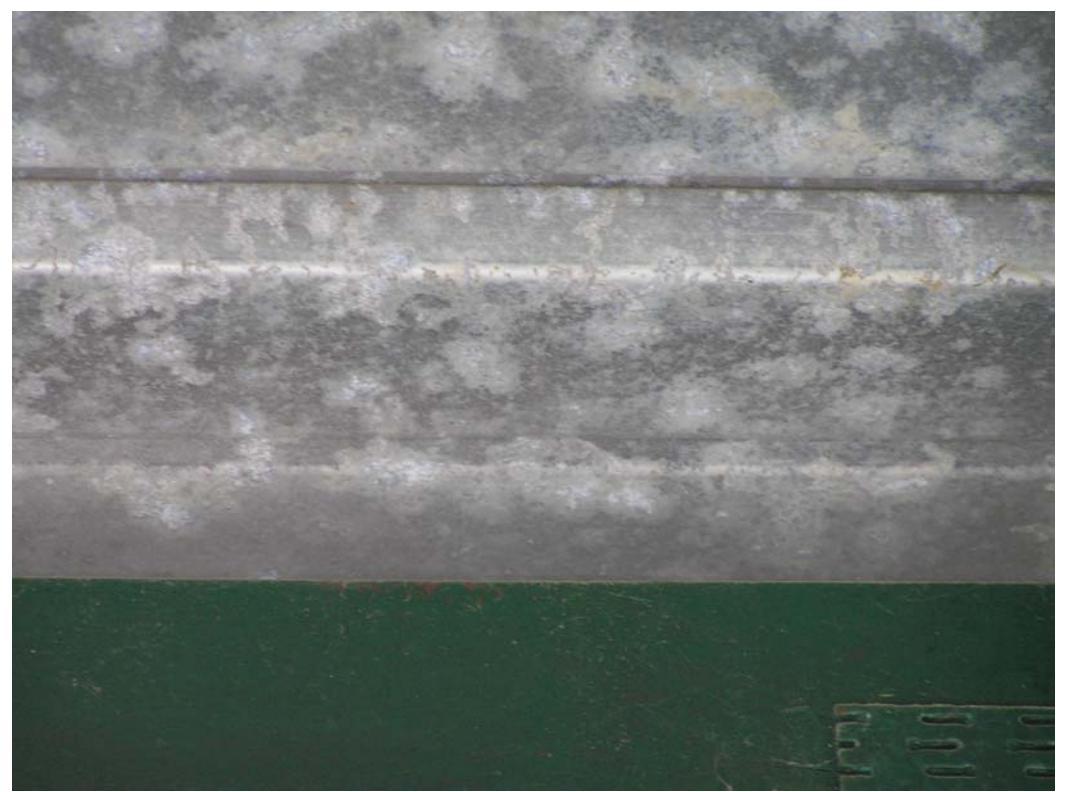
Figure 20 Close up of inside of roof sheeting of covered games area showing significant white corrosion product and some red rust.

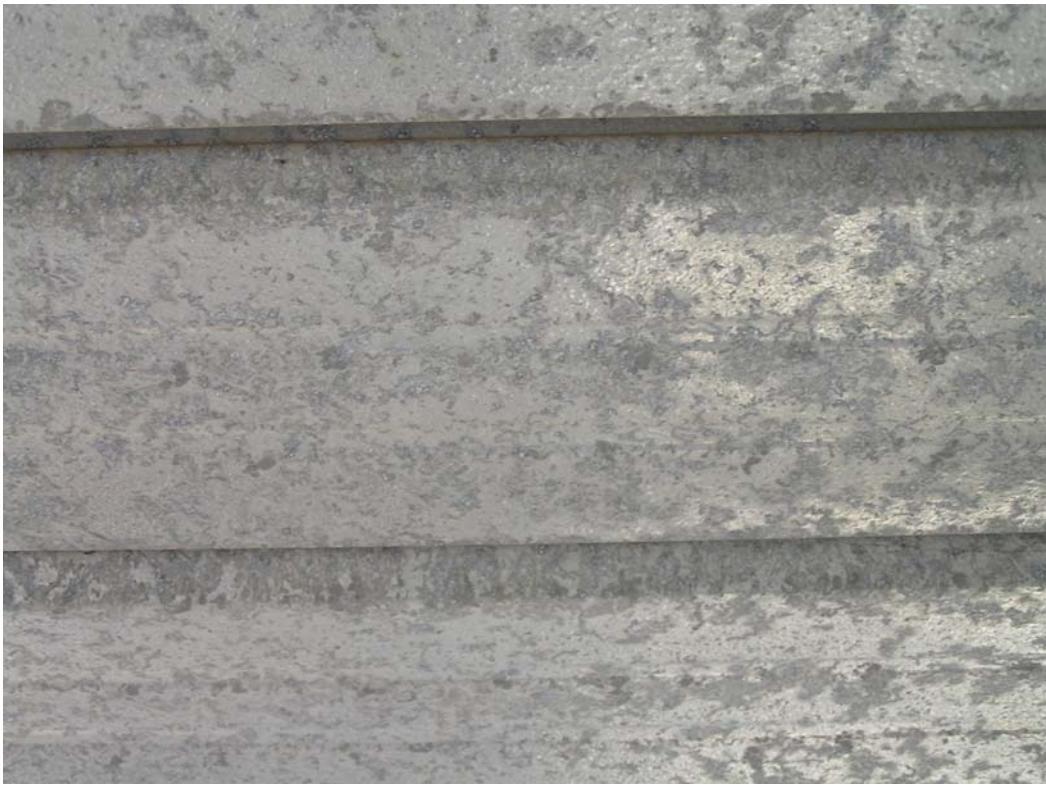
Figure 21 Close up of inside of roof sheeting of covered games area showing significant white corrosion product.

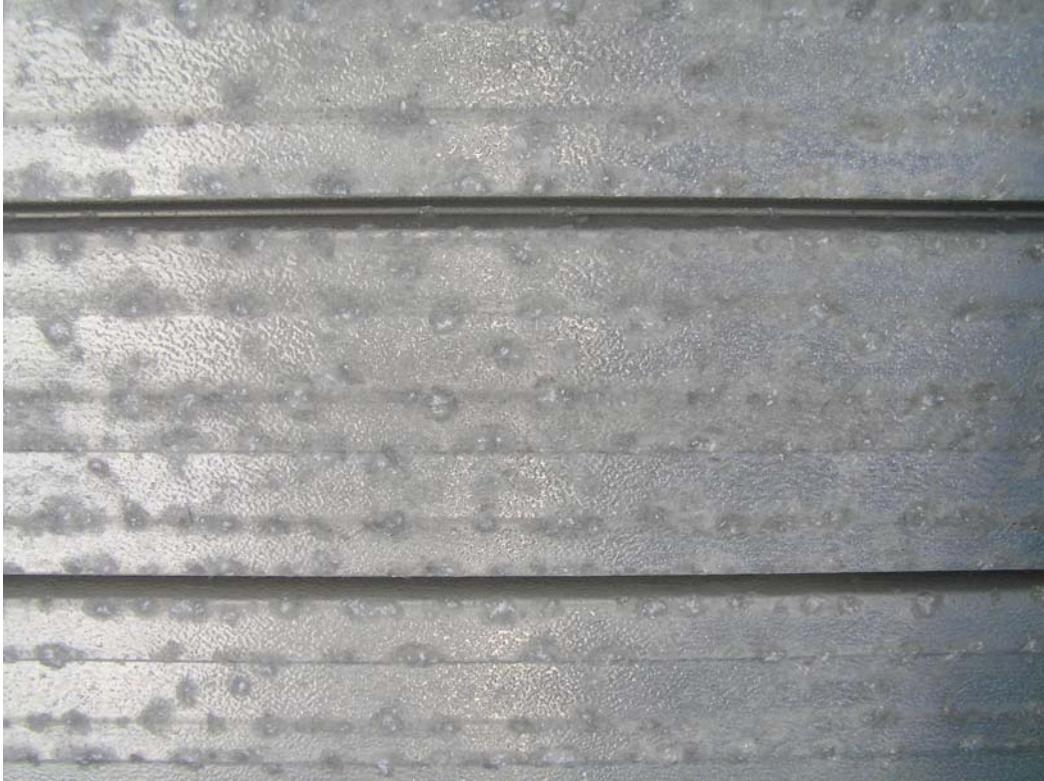
Figure 24 Close up of covered walkway showing significant white corrosion product, possibly aluminium construction.

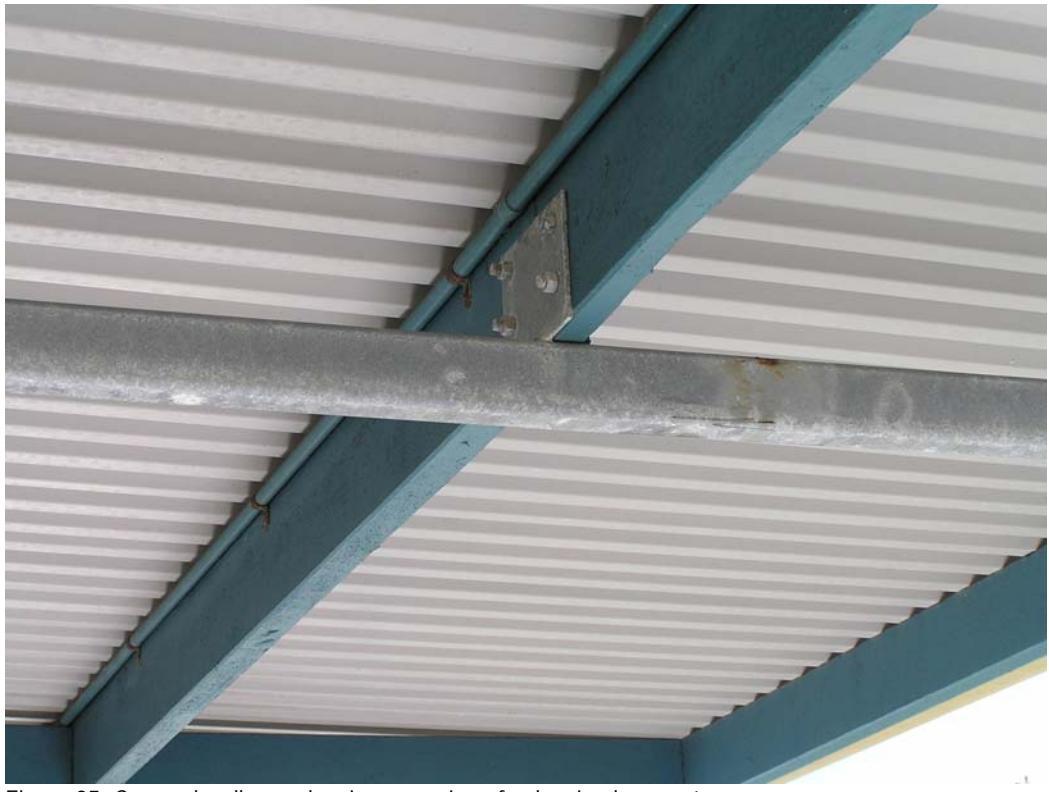
Figure 25 Covered walkway showing corrosion of galvanised support.

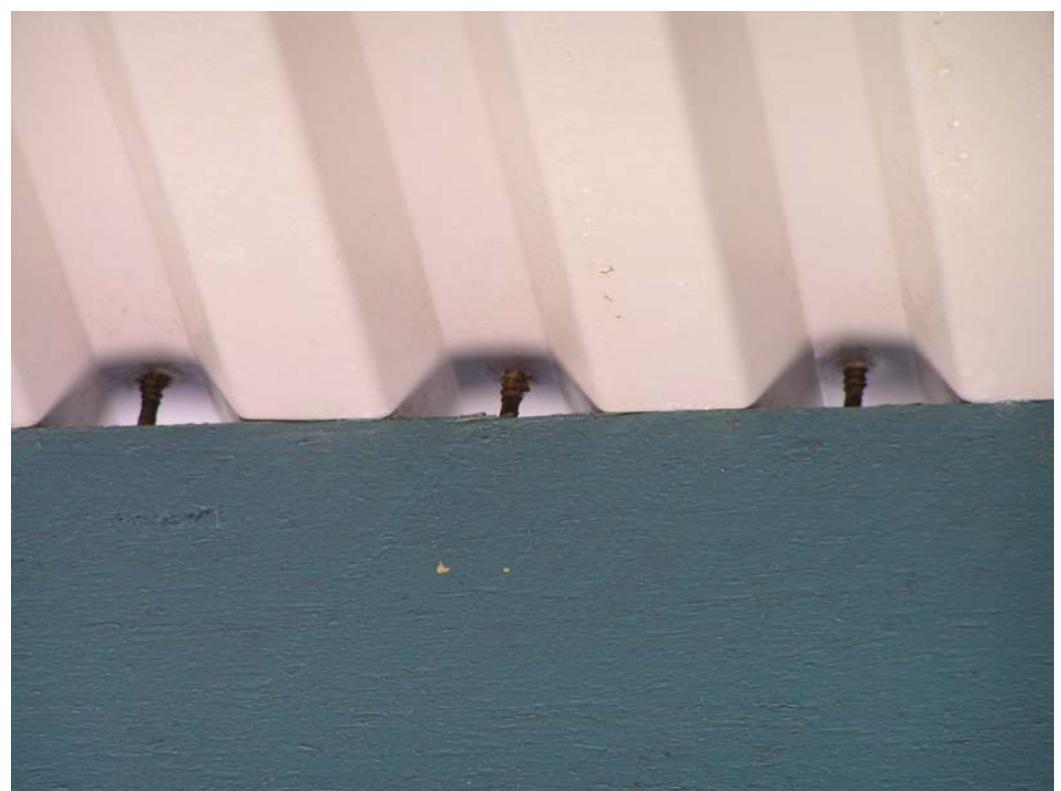
Figure 26 Covered walkway, fastener shanks are red rust and undercutting seen on Colorbond sheeting.

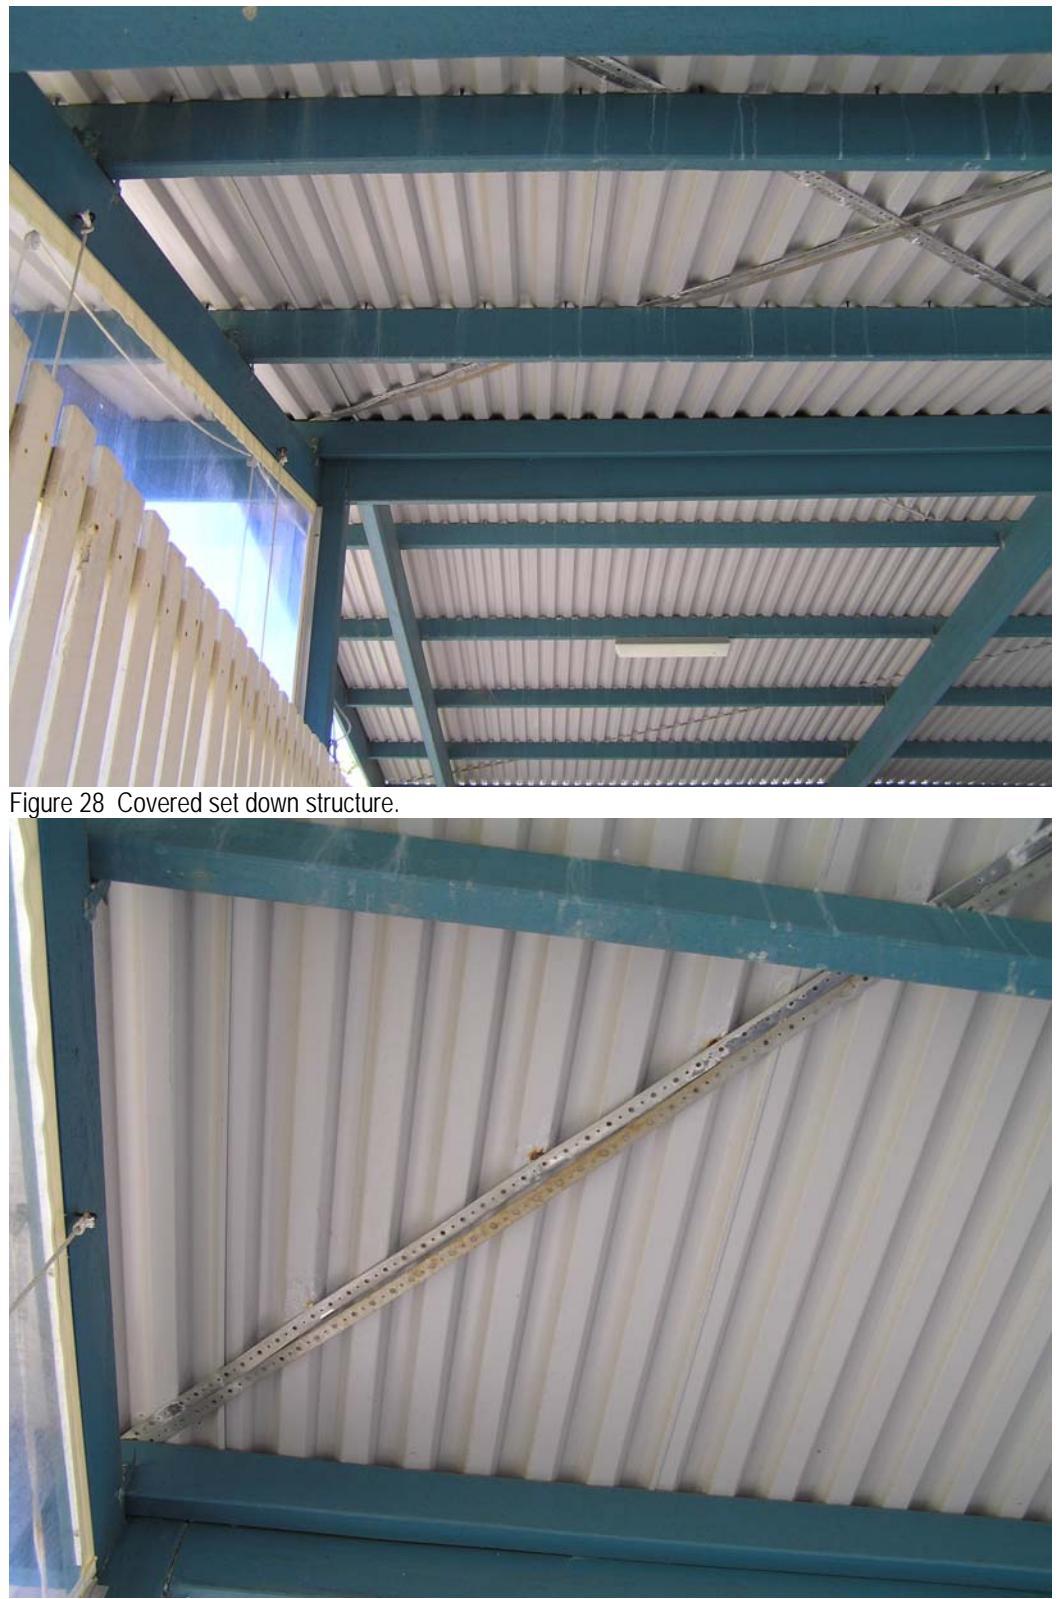
The following figures show an attempt at building with more corrosion resistant components but actually causing additional problems. Stainless steel strapping was used in the construction of the Covered set down but it is in contact with the Colorbond roof sheeting. The strap that is not in contact is corroding and the strap in contact with the Colorbond is causing the Colorbond to corrode. The Colorbond is showing significant red rust and will in the near future if it hasn't already, corrode through. This could have been avoided by making sure the strapping did not touch the Colorbond sheeting.

Figure 29 Covered set down showing red rust of stainless steel strapping not in contact with roof sheeting and red rust on roof sheeting where stainless steel strapping is in contact.

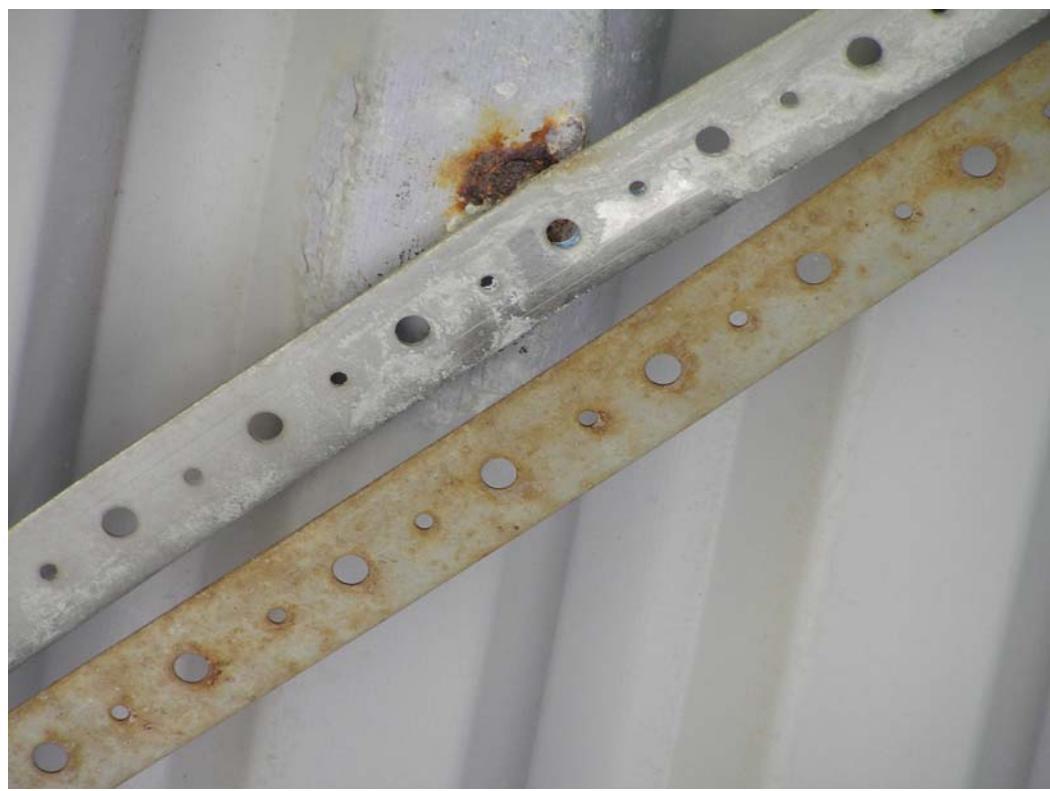
Figure 30 Close up showing red rust of stainless steel strapping not in contact with roof sheeting and red rust on roof sheeting where stainless steel strapping is in contact.

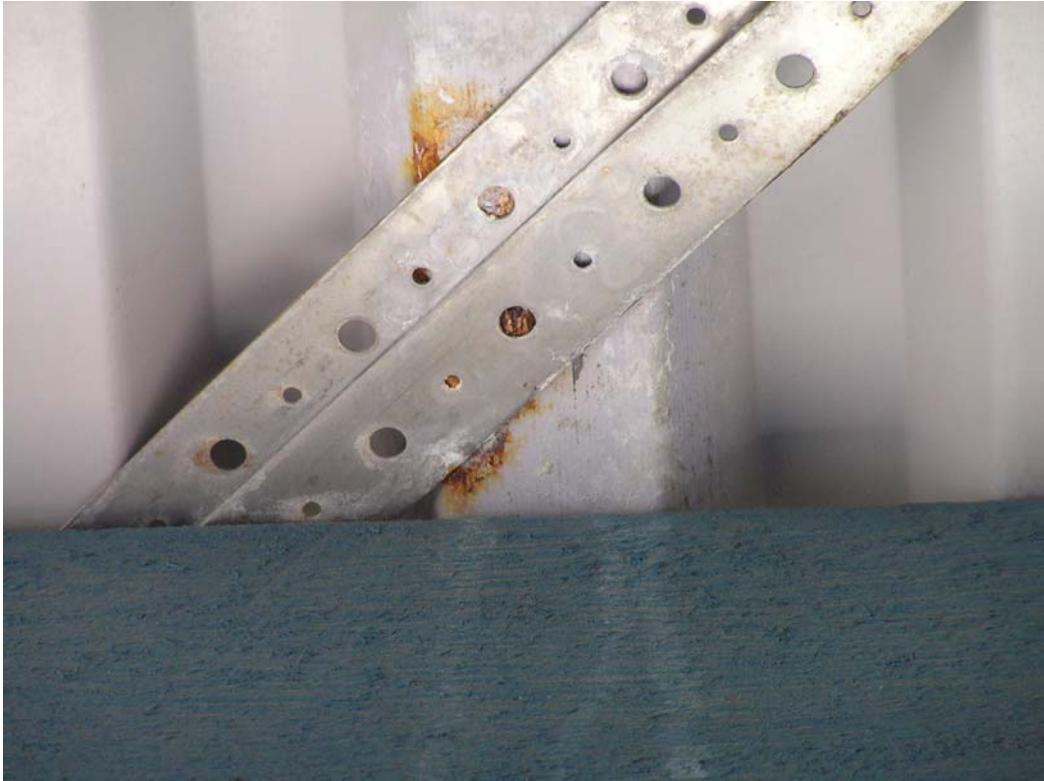
Figure 32 Close up showing red rust on roof sheeting where stainless steel strapping is in contact.

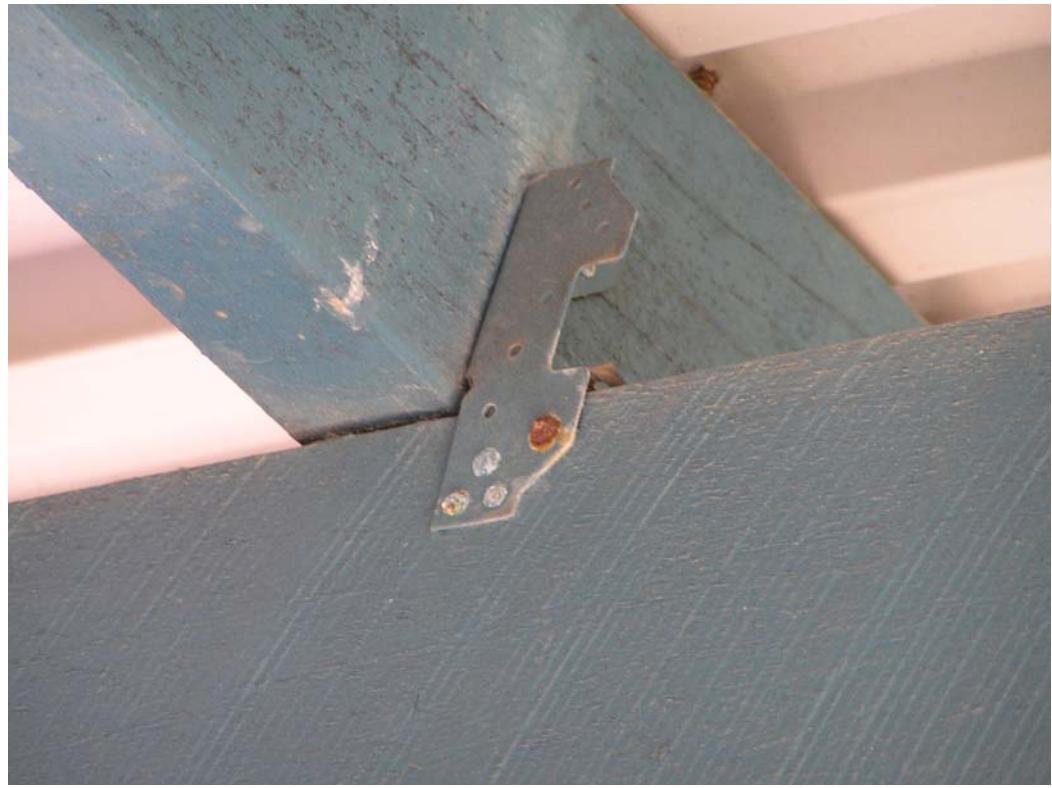
Figure 33 Triple grips on structure of covered set down showing signs of deterioration and roof fastener shank to red rust.

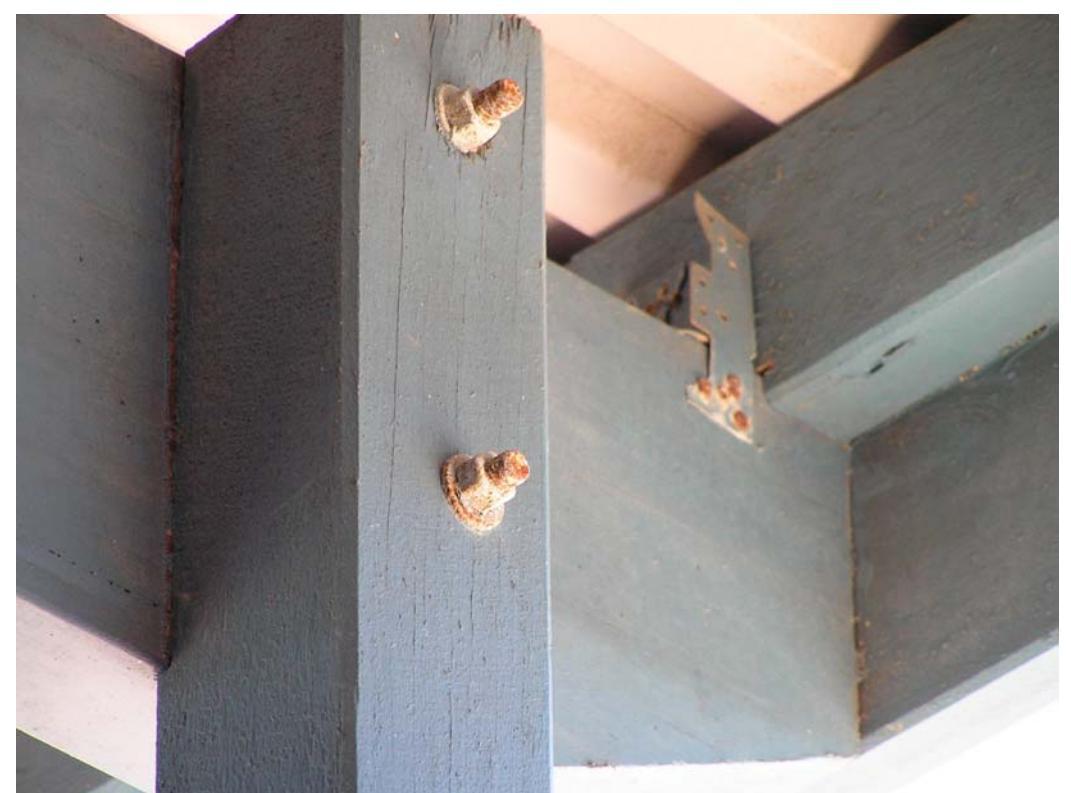
Figure 34 Triple grips and bolts on structure of covered set down showing signs of deterioration.

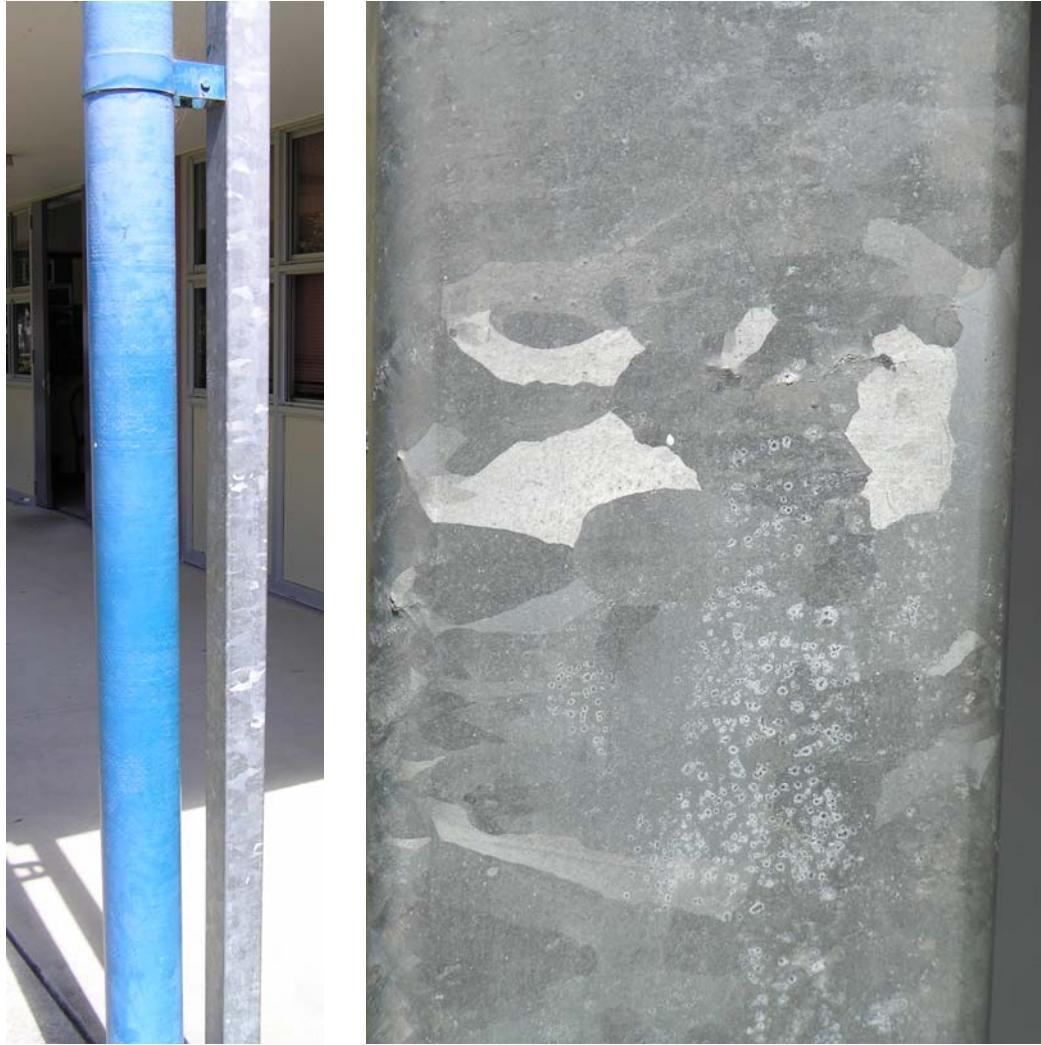
Figure 39 Galvanised post on Administration Block and close up showing signs of white corrosion product.

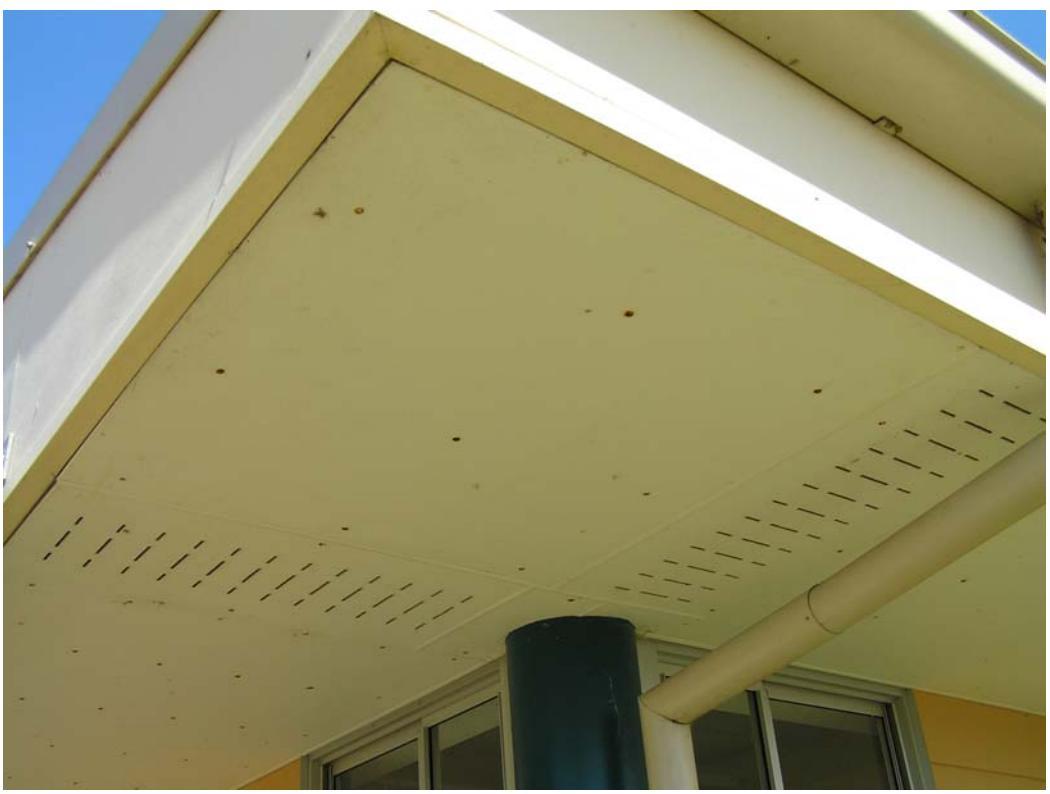
Figure 41 Rust on fasteners on Block N.

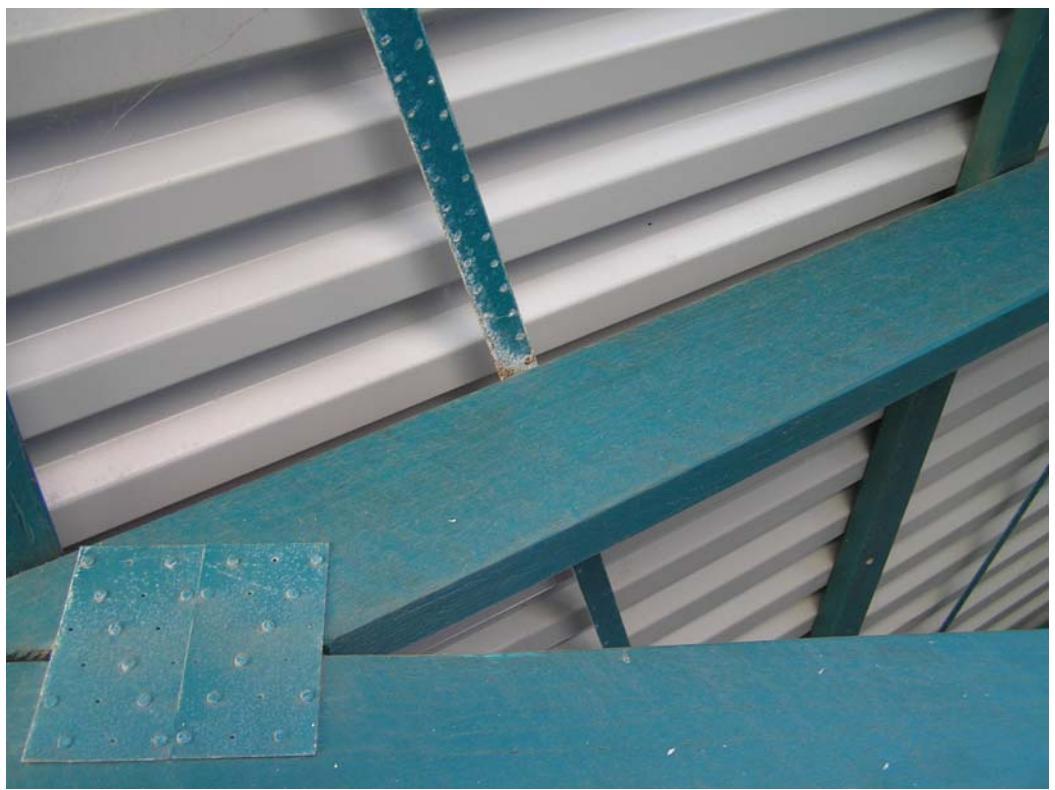
Figure 43 Corroded strapping on covered court.

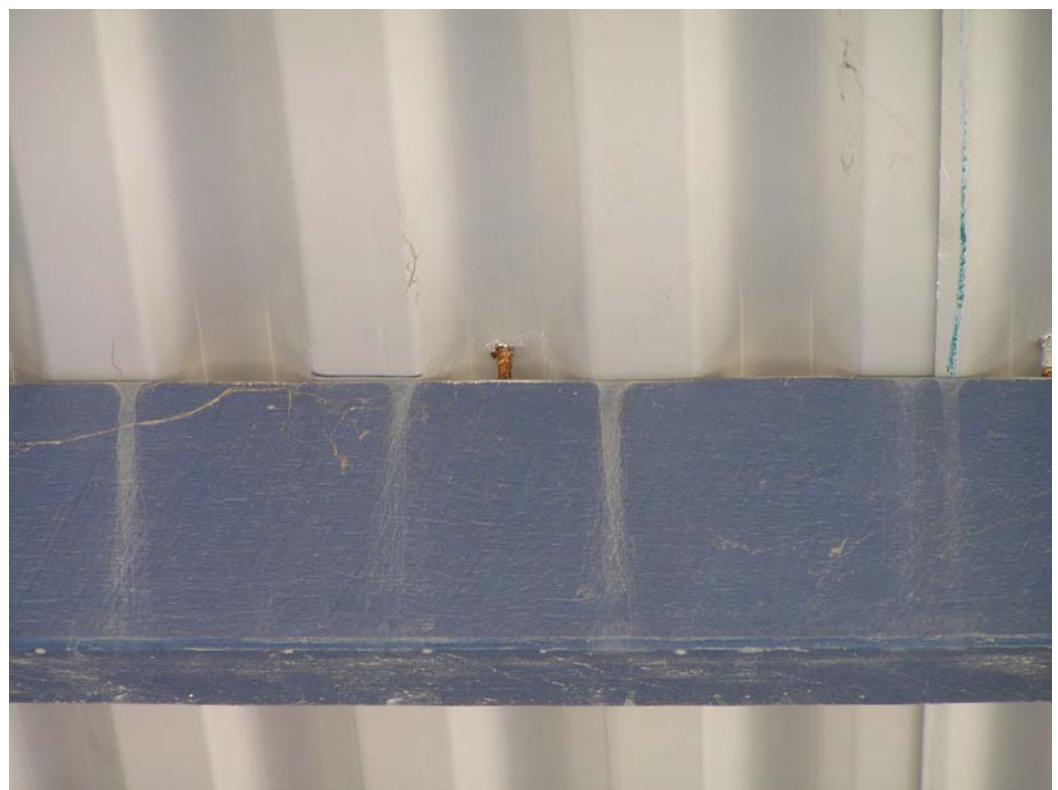
Figure 44 Corroded fasteners in covered walkway.

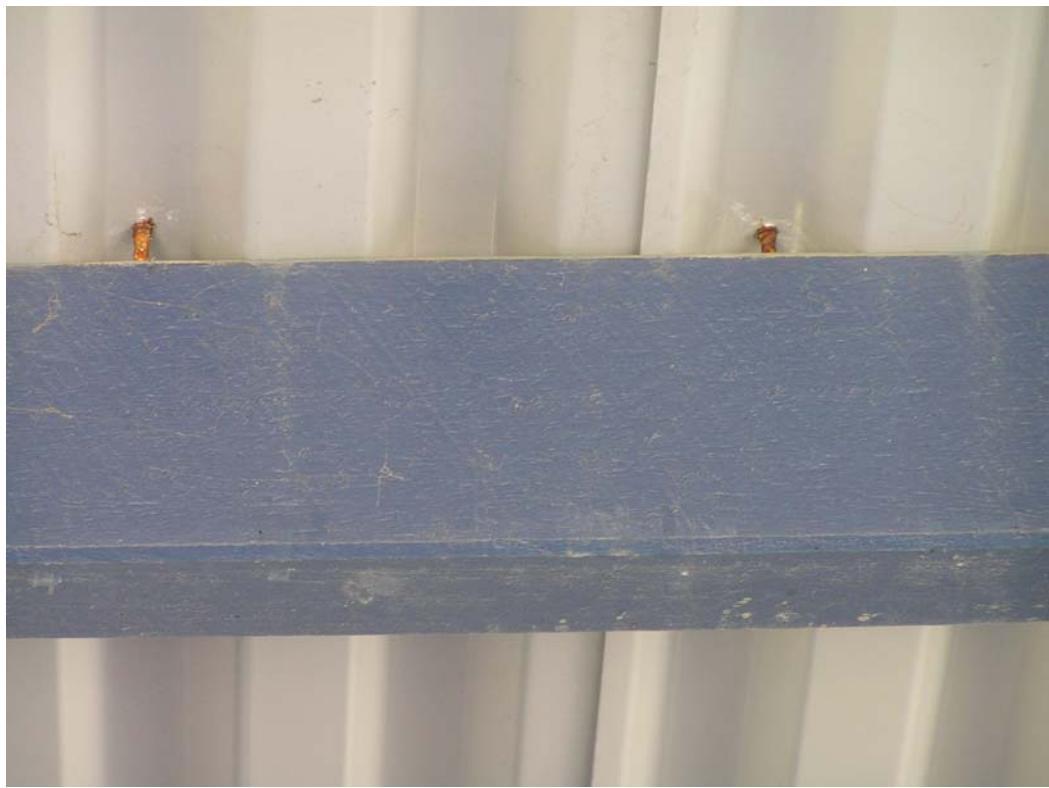
Figure 45 Corroded fasteners in covered walkway.

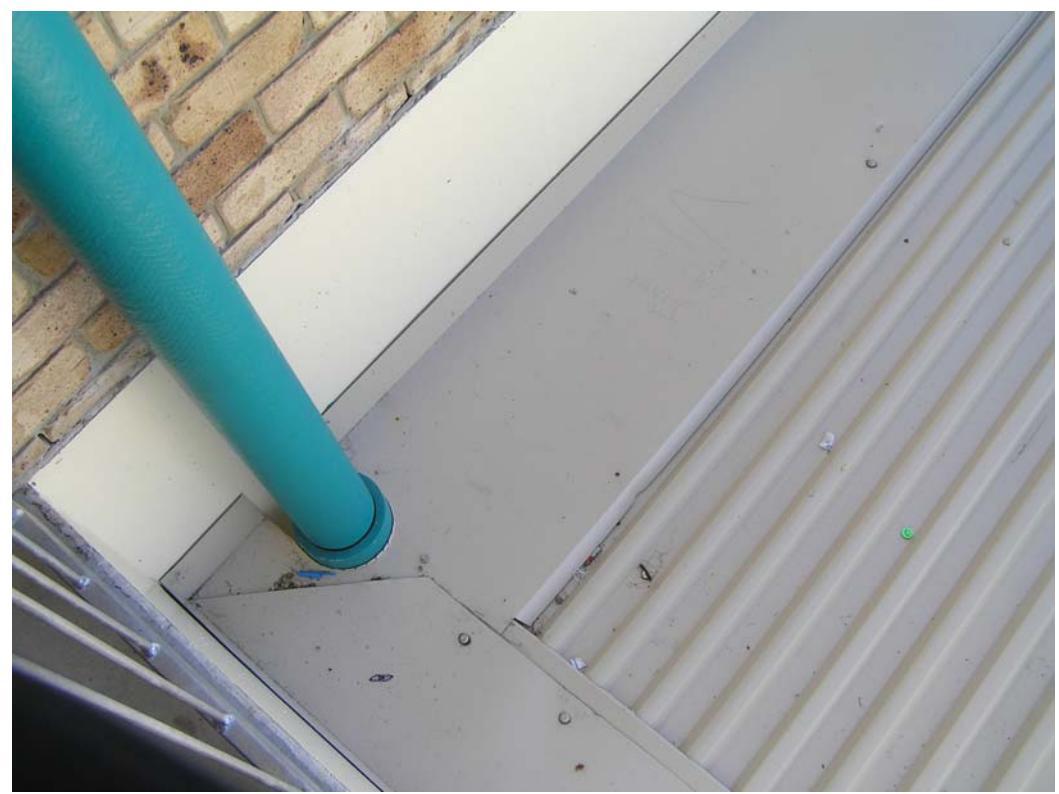
Figure 50 Roof of covered walkway from block G showing rust stains from discarded swarf.
