Trip to Sunshine Coast Queensland, September 2004 Visit to Schools

Report No 2002-059-B No 7

Research Program: B Program Name Environmental Sustainability Research Project No.: 2002-059-B Project Name Case Based Reasoning in Construction and Infrastructure Projects

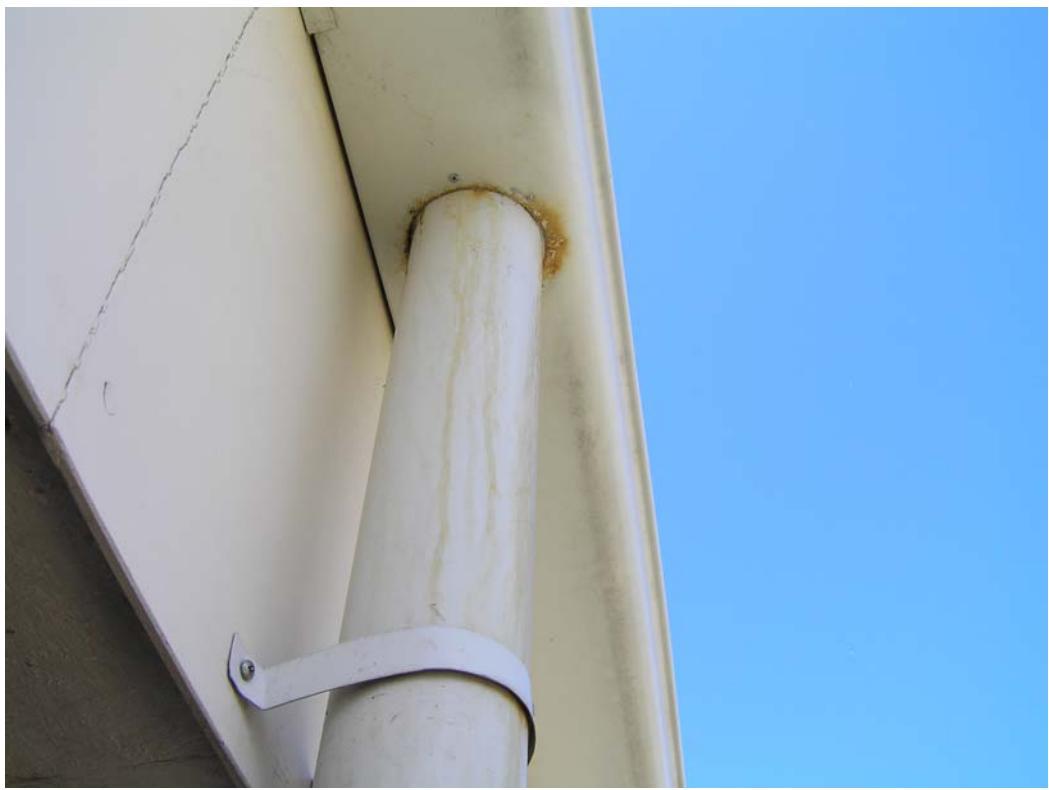
Figure 52 Degradation of gutter at join.

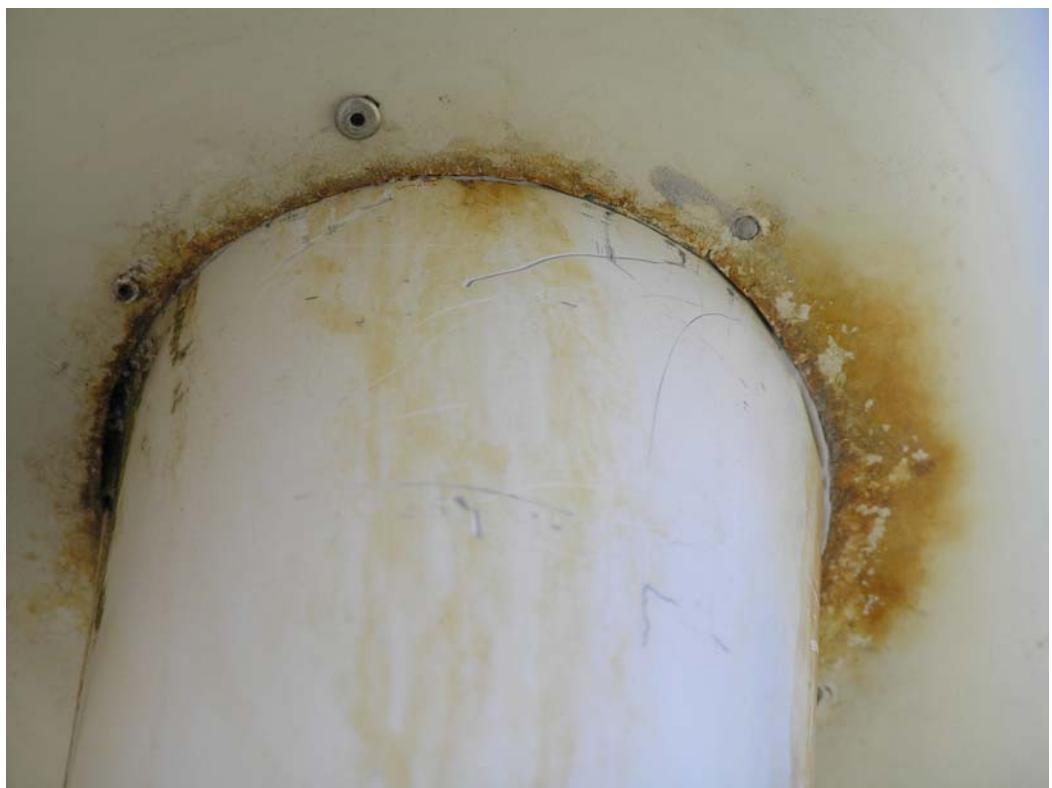
Figure 53 Close up of degradation of gutter at join, note pop rivets corroded away.

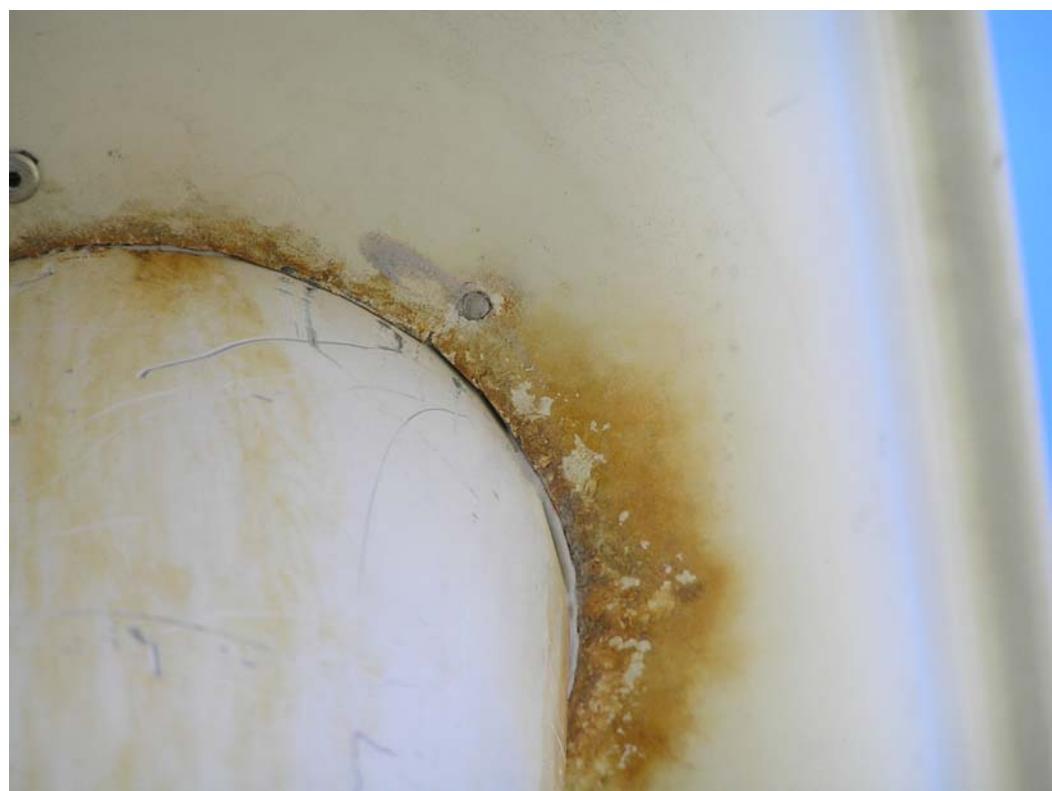
Figure 54 Close up of degradation of gutter at join, note pop rivets corroded away.

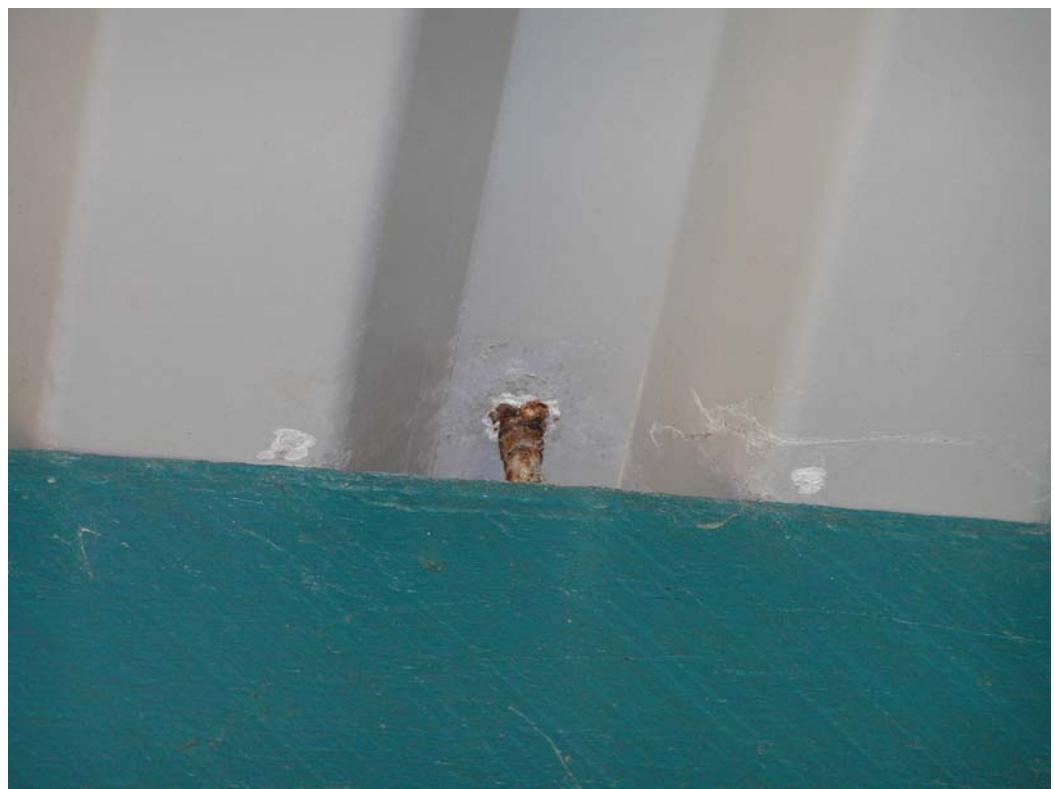
Figure 55 Corroded fastener under covered area, sheeting also showing undercutting.

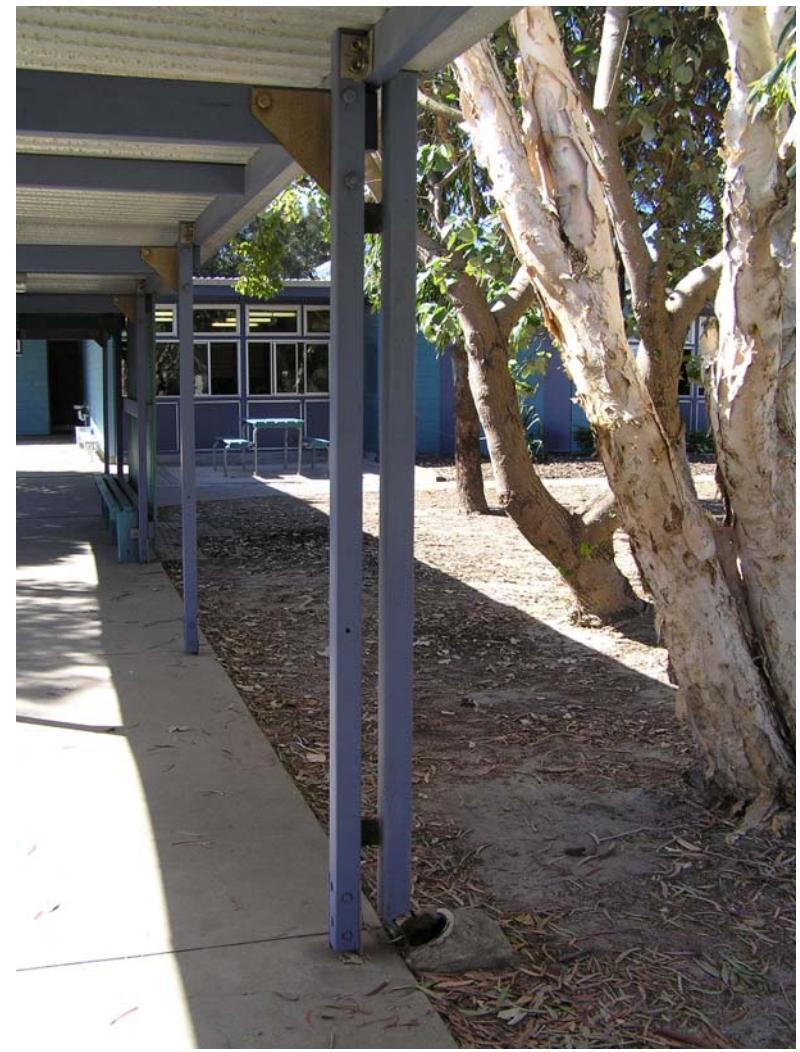
On some covered walkways square section steel was used as downpipes. It is assumed the steel was used as standard downpipes would be destroyed by the students. It can be seen in the following figures that the painted steel is corroding from the inside out.

Figure 64 Covered walkway showing timber support and steel down pipe.

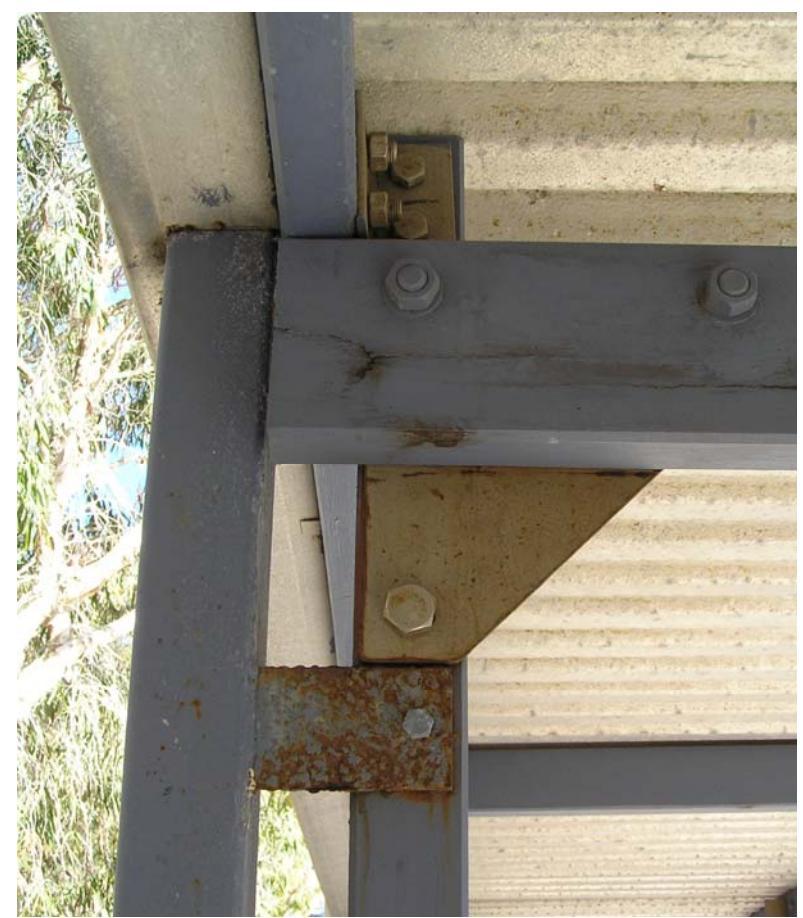
Figure 66 Top of downpipe also showing rusting of bracket from downpipe to support and stainless steel plates on walkway beams.

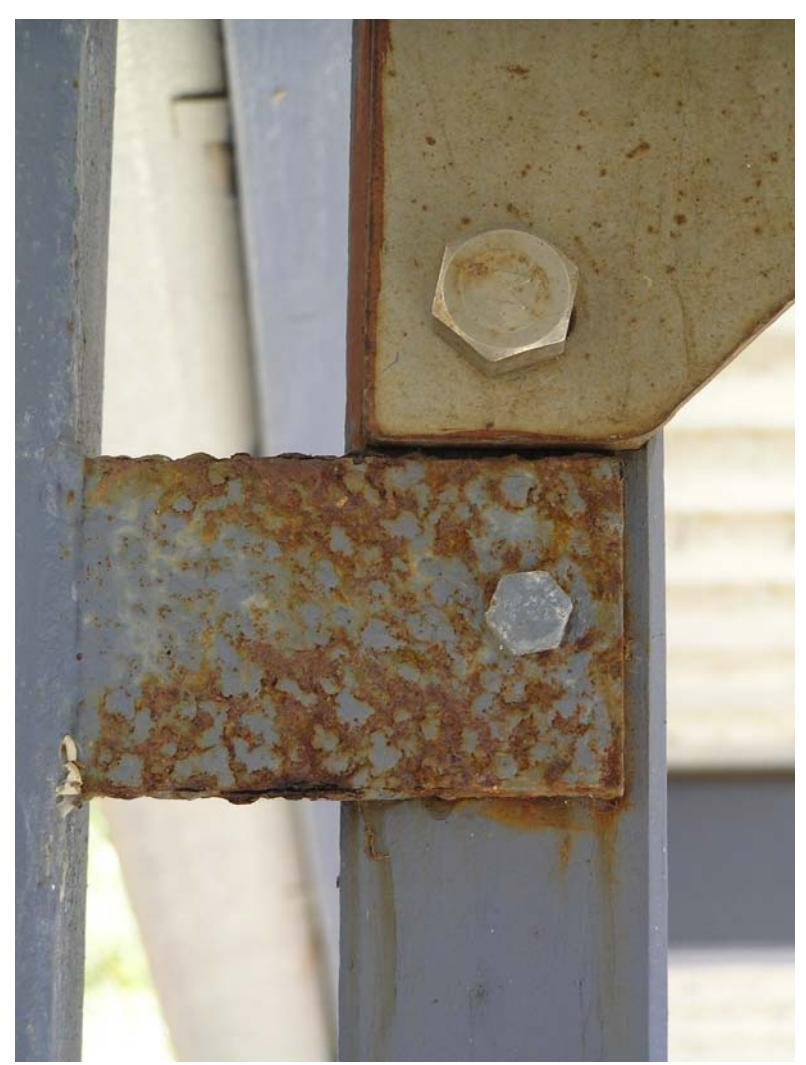
Figure 67 Close up of downpipe bracket and stainless steel connector plate.

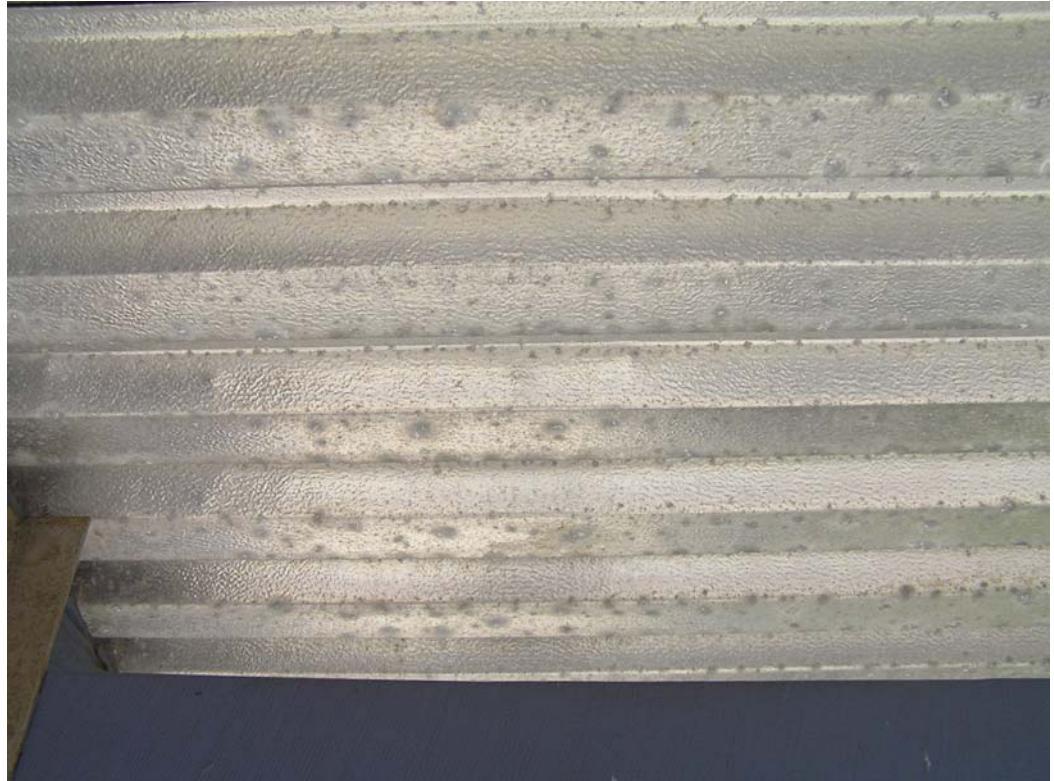
The aluminium sheeting used on the walkways looked ok on the exposed outer surface but underneath there was significant corrosion. It looked like galvanised fasteners were used to fasten the sheeting and these where corroded on the heads, some to 100% red rust. The shanks of all the fasteners where heavily corroded.

Figure 68 Underside of aluminium roof sheeting of covered walkway.

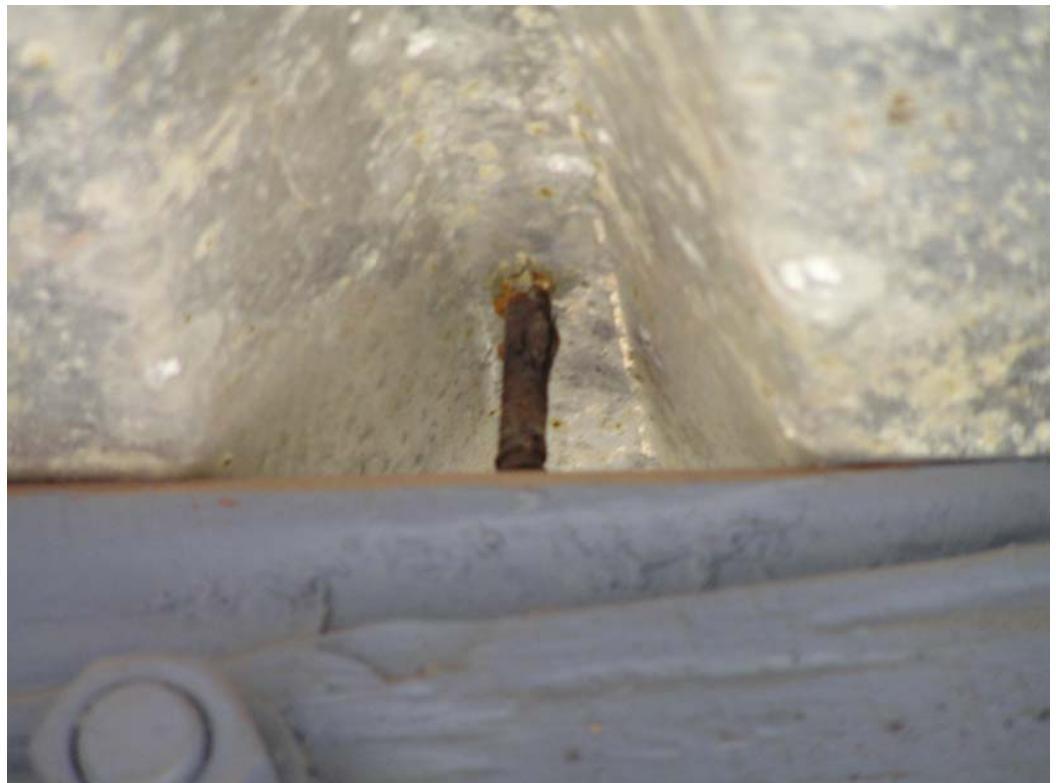
Figure 70 Heavily corroded fastener in sheeting of covered walkway.

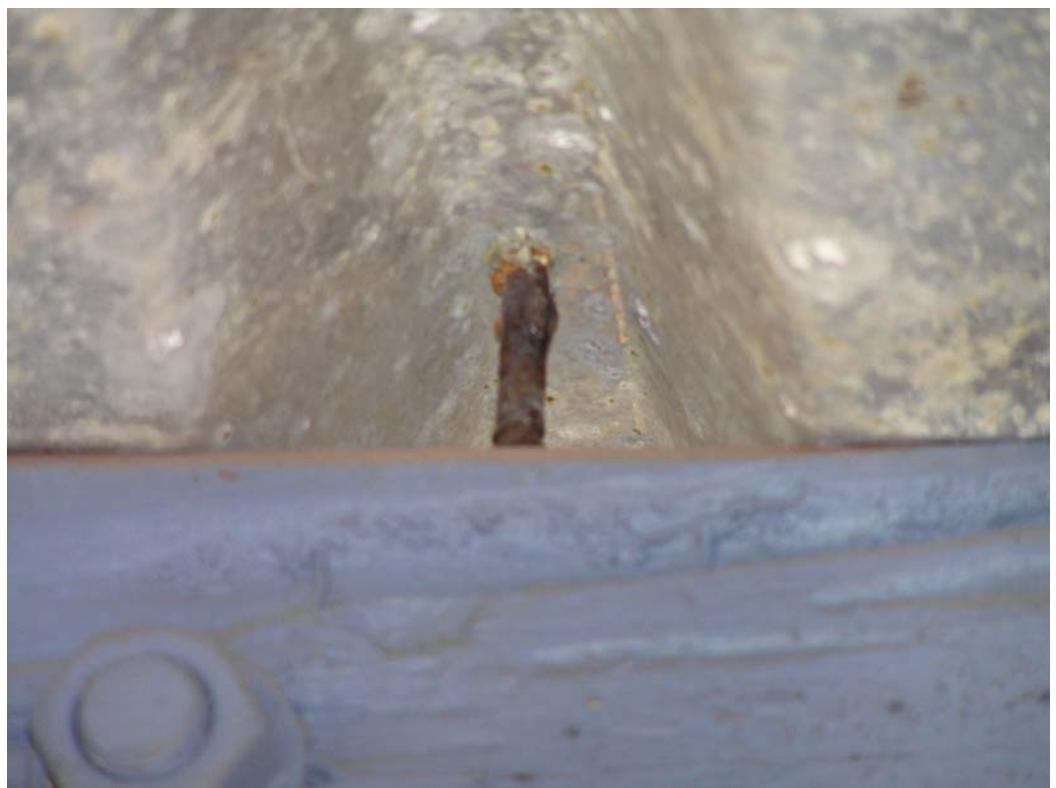
Figure 71 Heavily corroded fastener in sheeting of covered walkway.

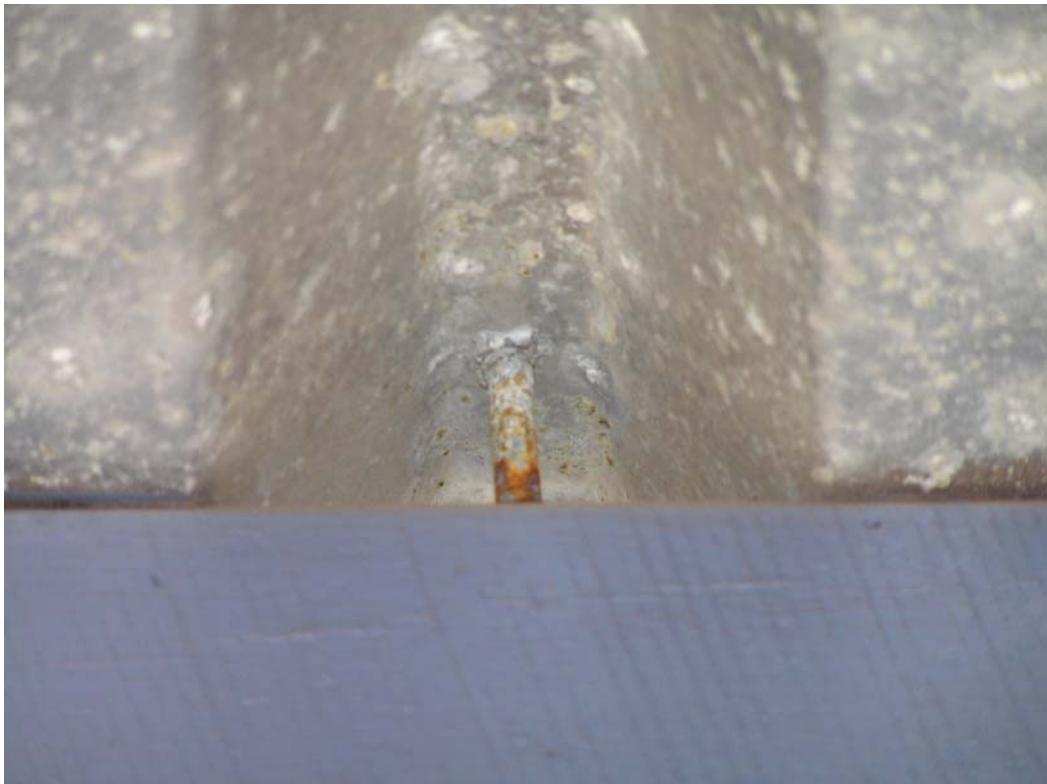
Figure 72 Heavily corroded fastener in sheeting of covered walkway.

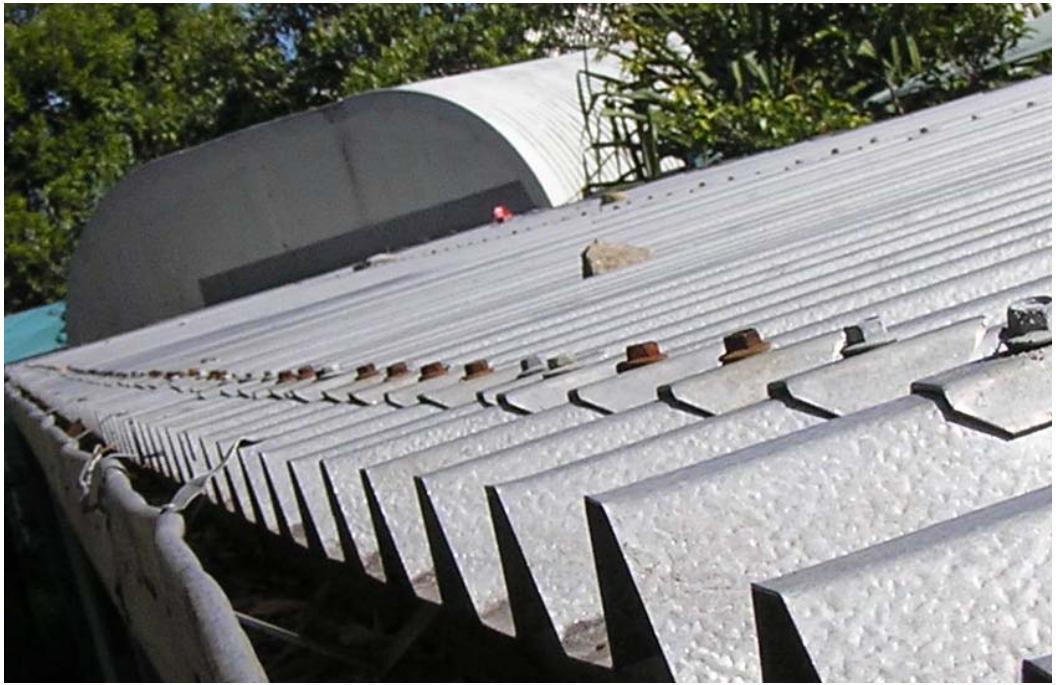
Figure 78 Close up of fasteners showing red rust and white corrosion product.

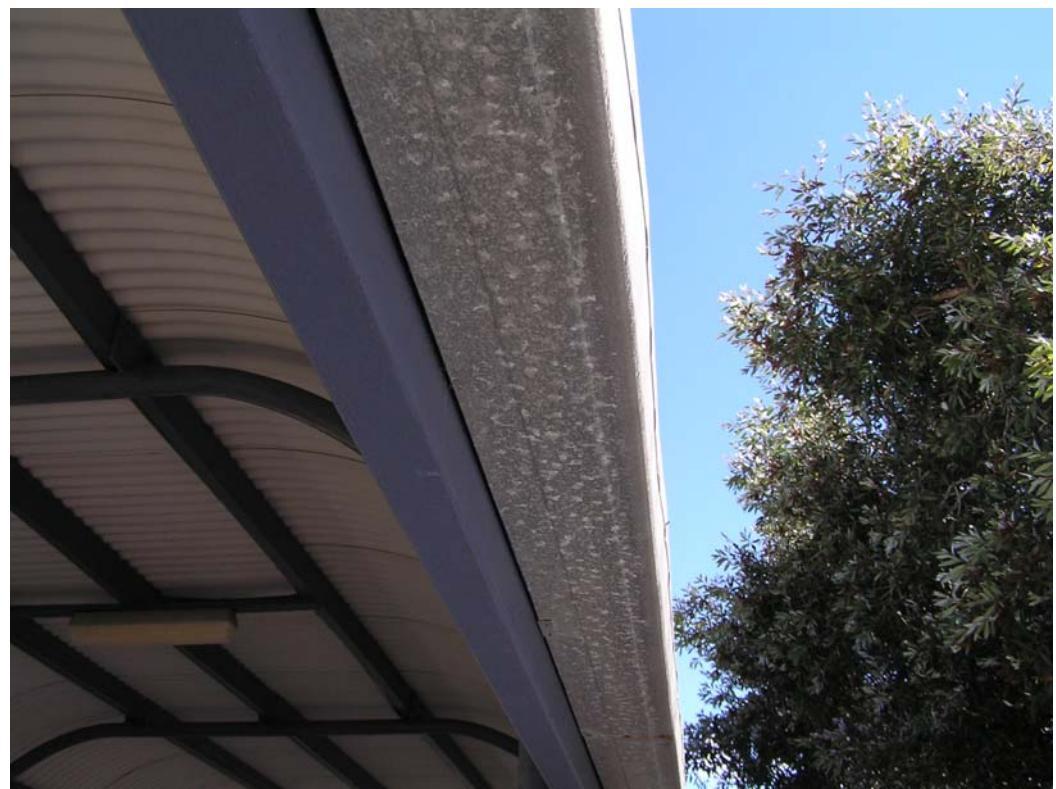
All the aluminium gutters showed corrosion on the underneath side, even on the colorbond walkways. As with the other schools where joins were made in the gutters significant deterioration had occurred.

Figure 86 Underside of all gutters were significantly corroded.

As far as gutters are concerned the problems were from sheltered corrosion or installation practice. Sheltered corrosion is where the underside of the gutters are heavily corroded due to the accumulation of deposited salts. The salts accumulate as the under side of the gutters are sheltered from the rain. The insides of the gutters seemed to be in an appropriate condition. Installation practice included problems associated with joins including the cutting of the guttering and joining by pop rivets

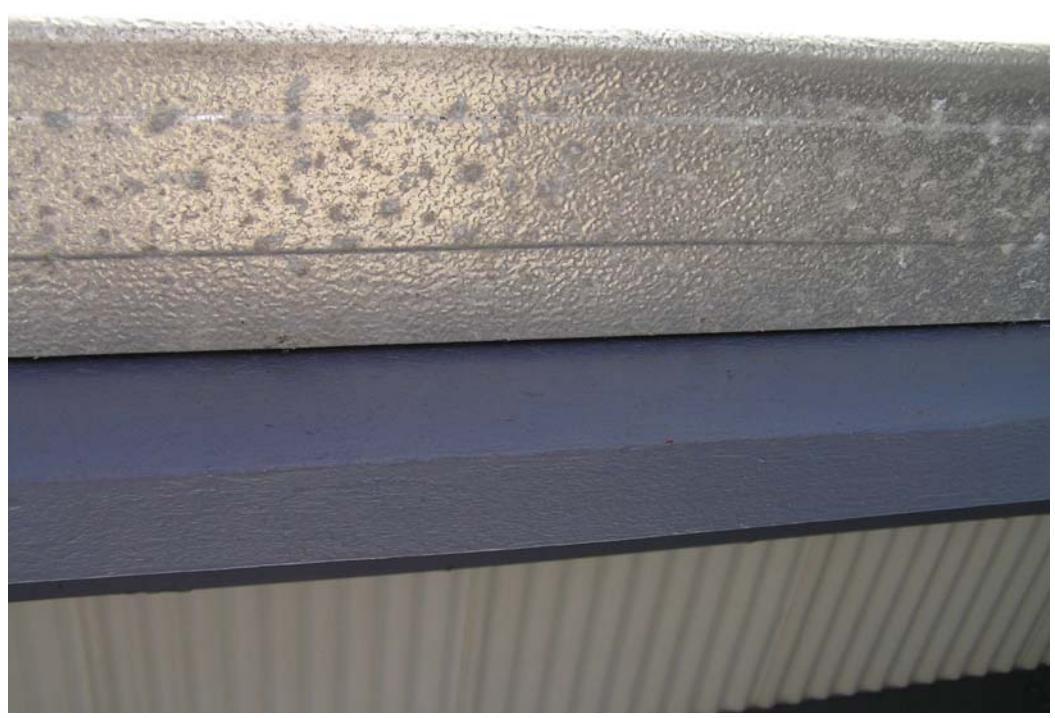
Figure 87 Underside of gutters.

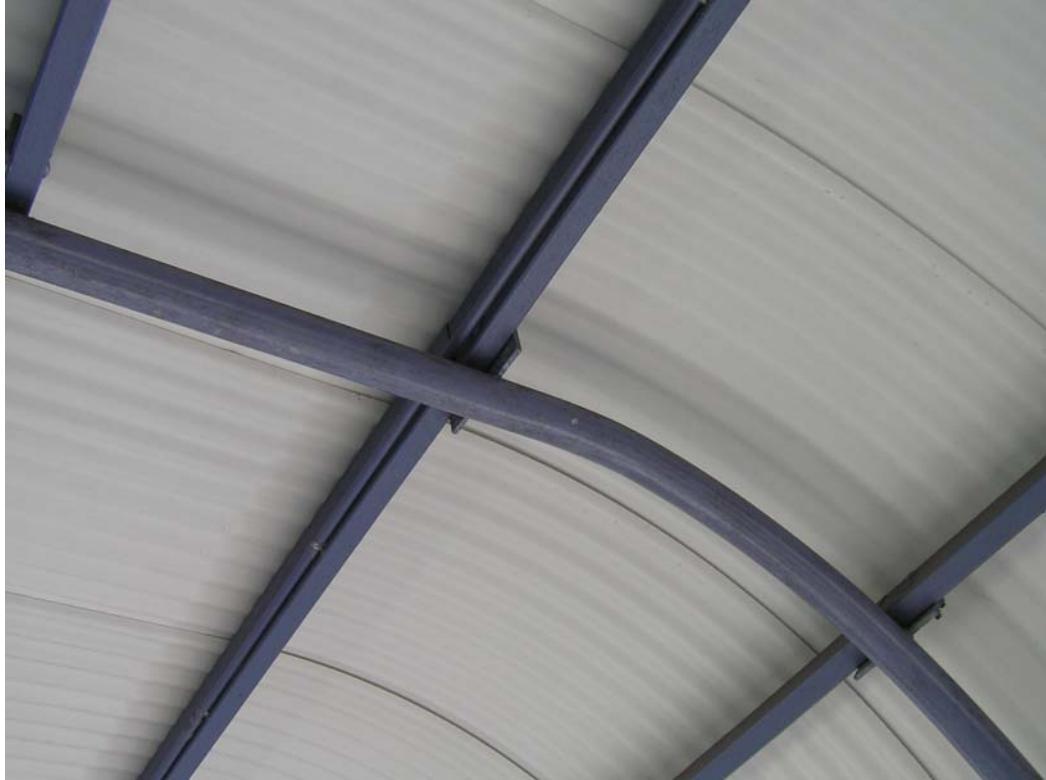
Figure 88 Underside of Colorbond walkways in good condition, some deterioration of painted steel supports.

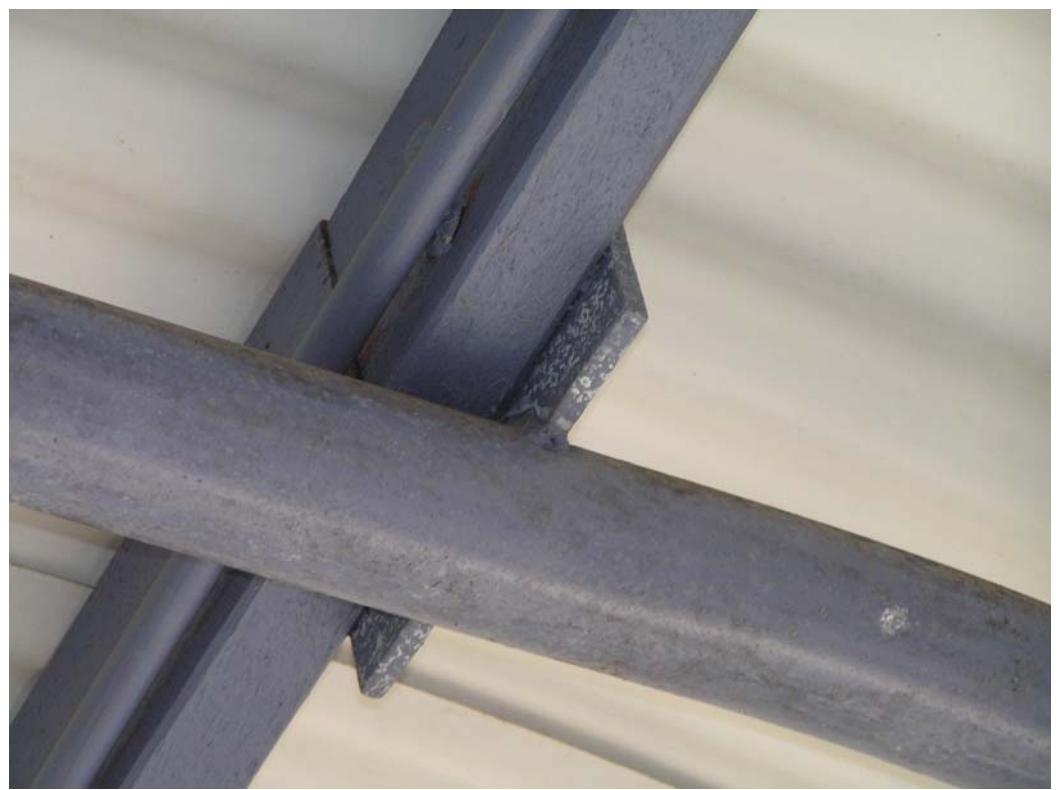
Figure 89 Close up of painted steel supports showing some deterioration of paint and some break through of rust and white corrosion product.

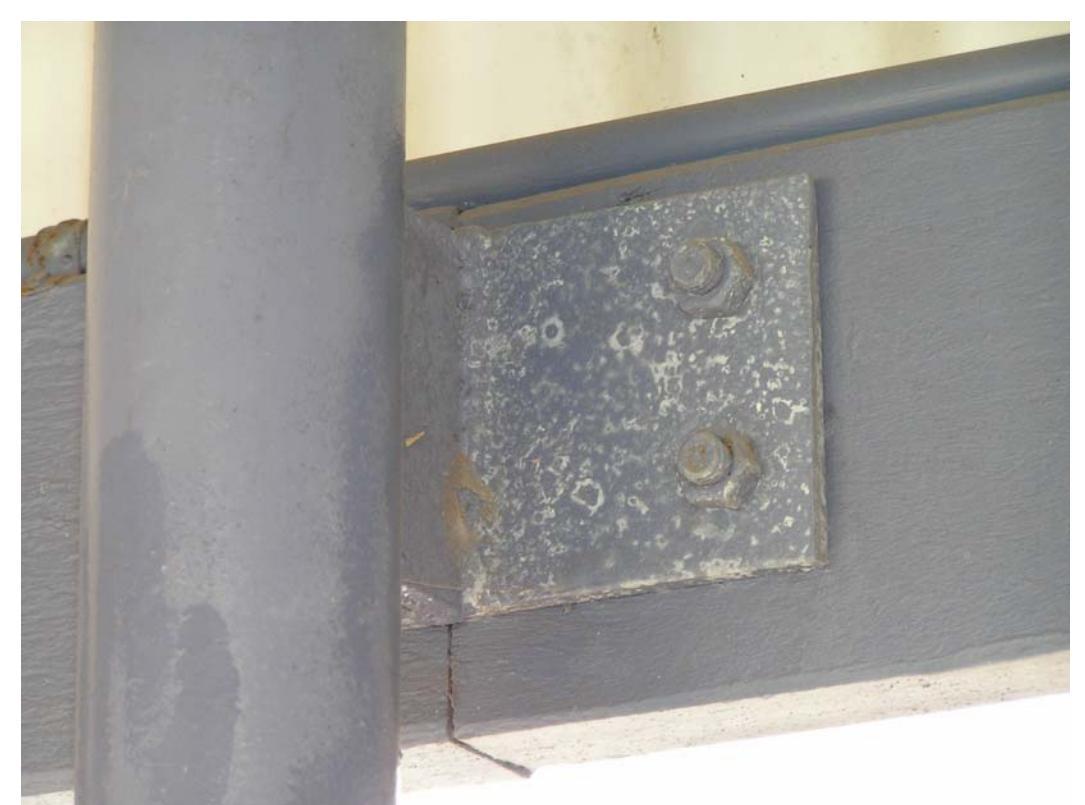
Figure 90 White corrosion product on painted steel brackets.

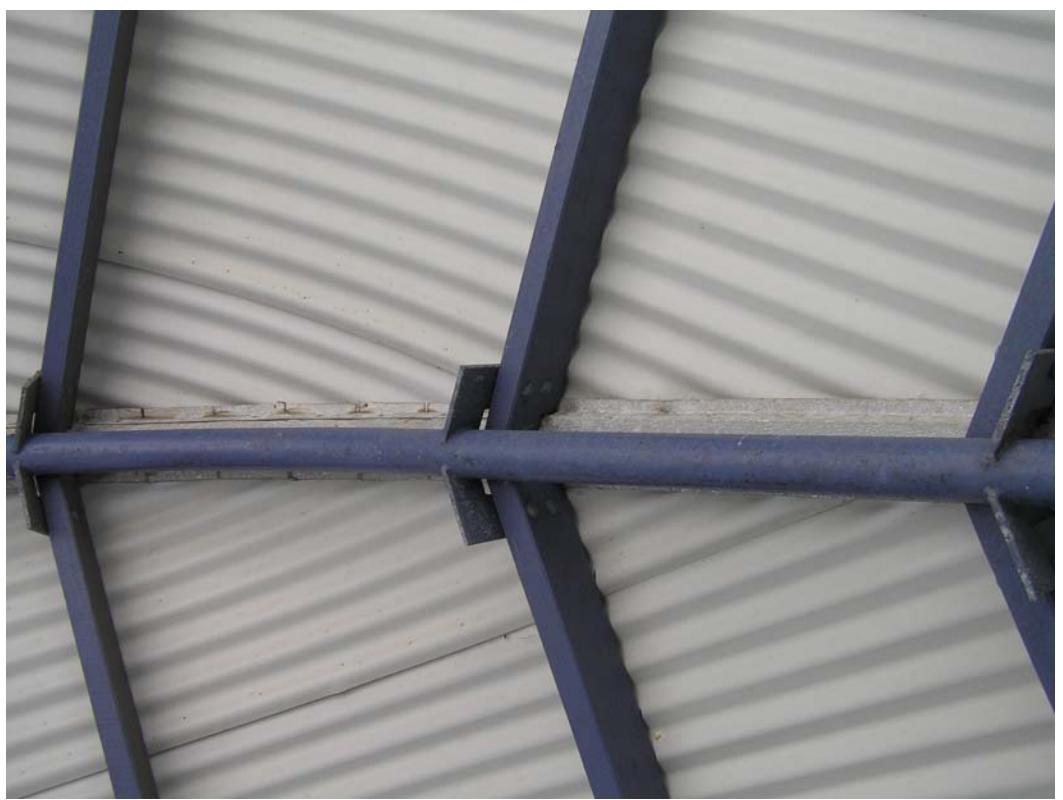
Figure 91 Joint between two walkways showing the used of galvanised flashing which has significant white corrosion product.

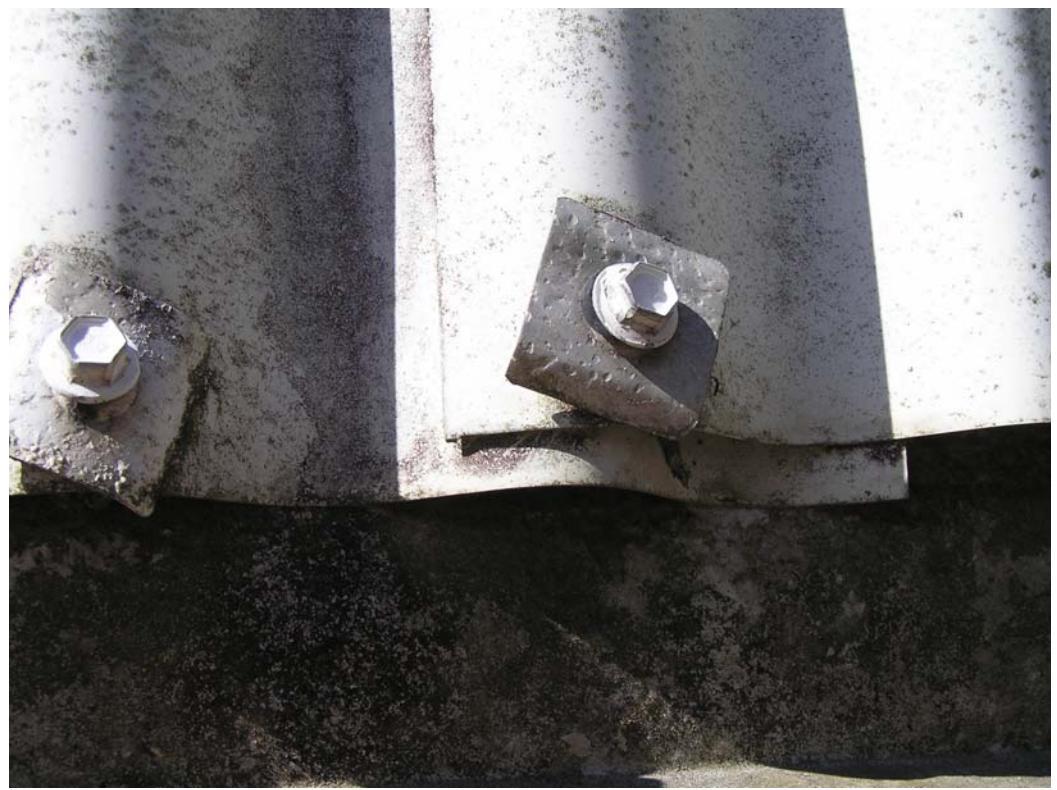
Figure 93 Colorbond sheeting and aluminium gutter showing significant growths.

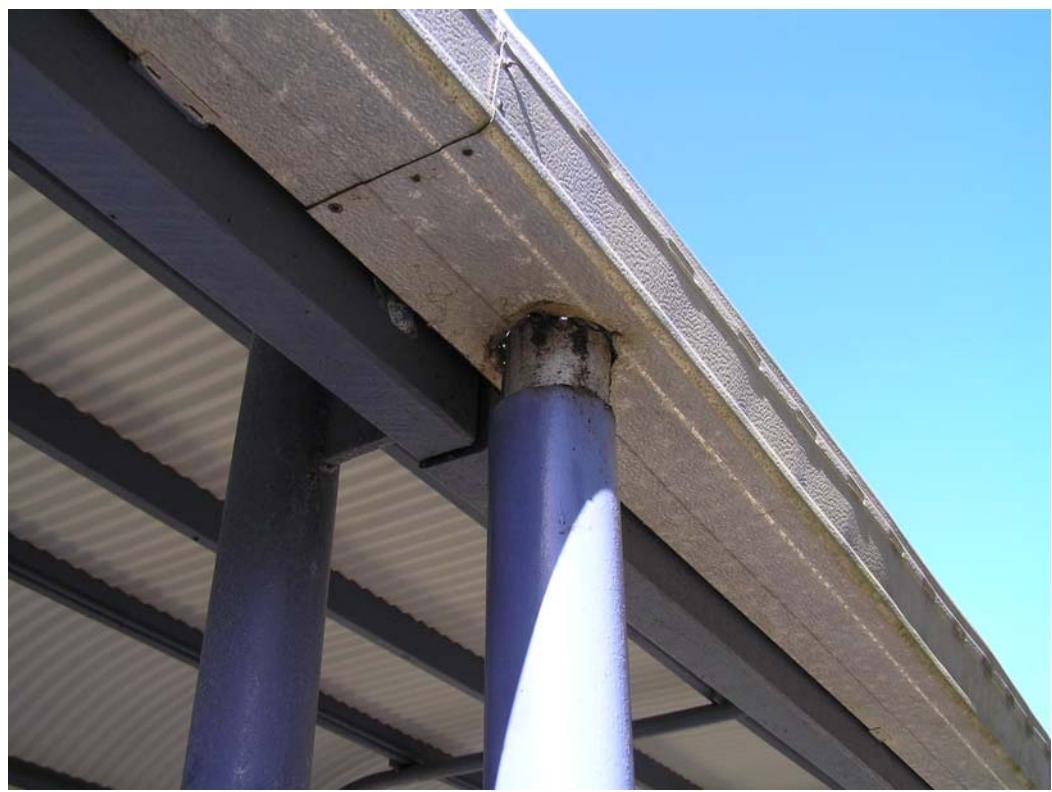
Figure 95 Deterioration around joint between gutter and downpipe (note loss of rivet heads).

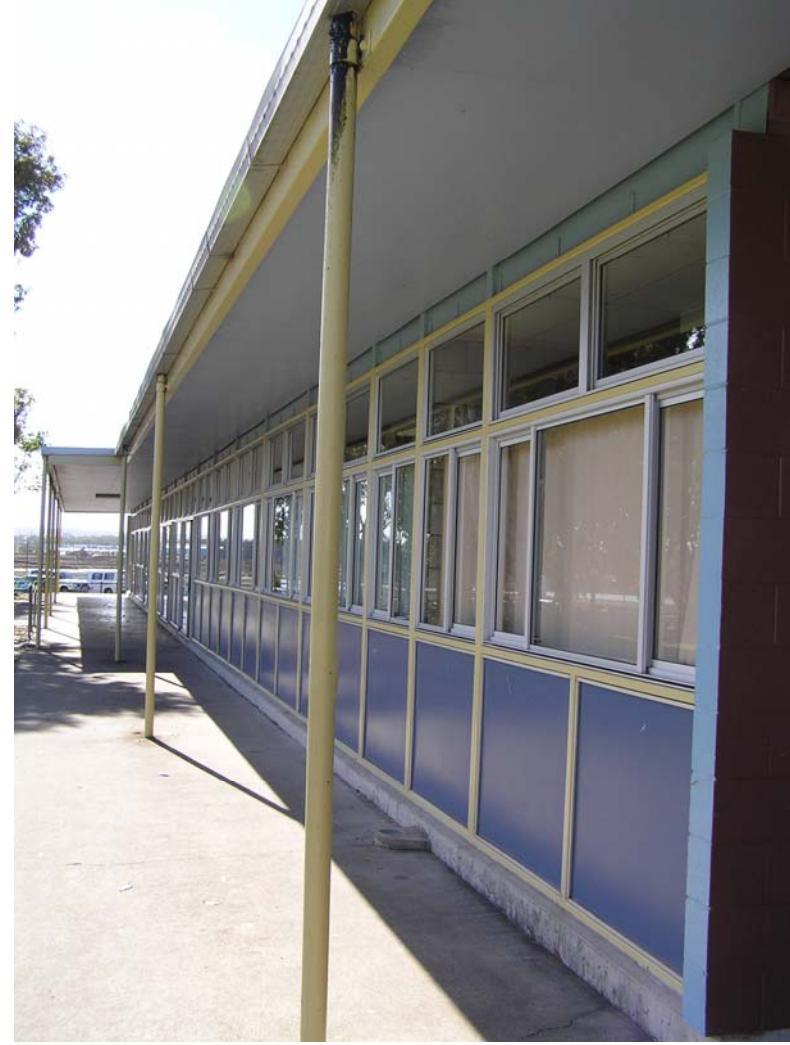
Another problem seen at this school is the use of structural downpipes. This is where as seen in the following figures the downpipe forms part of the structure holding up the eaves of the building. There is a steel U section around the edge of the eave with a piece of timber inside it. The U section is bolted to the downpipe. What seems to be happening is that the gutters, which are a fairly small diameter, block up. The water then overflows at the downpipe onto the U section and corrodes the U section and the timber is wet helping the corrosion. It was said that it costs \$80,000 to replace the steel U sections on one building.

Figure 96 Structural downpipes.

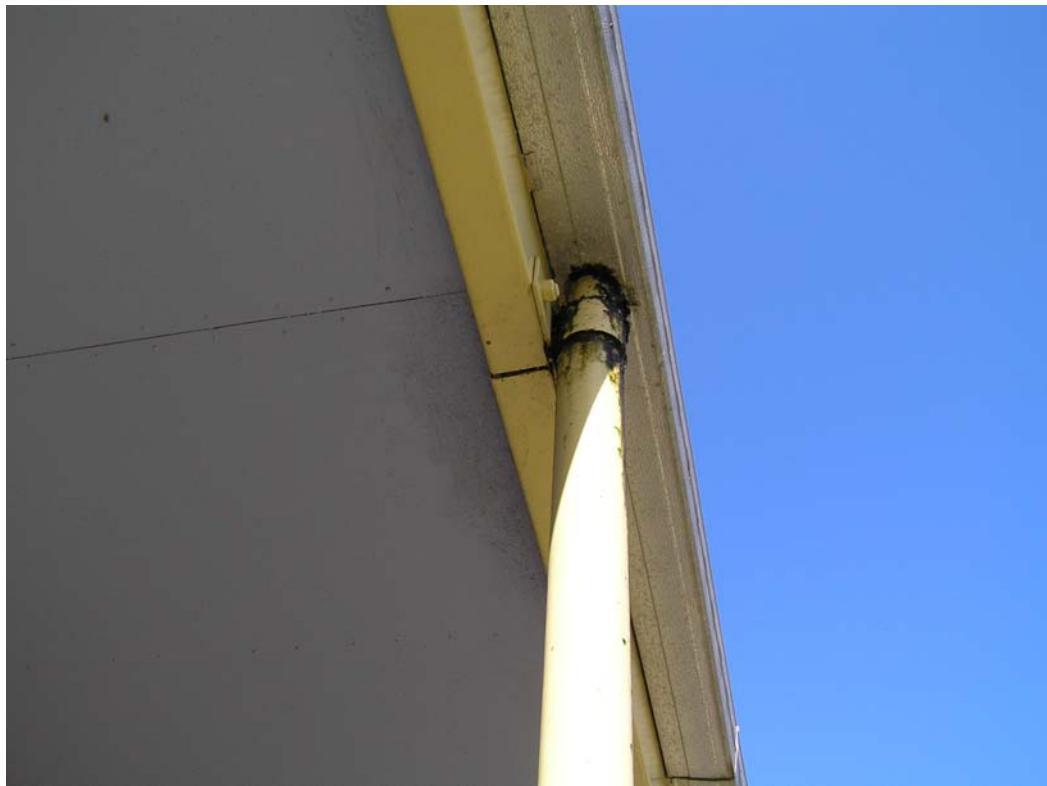
Figure 98 Structural downpipe showing that water has come through the join to the gutter and the infill panel has water damage.

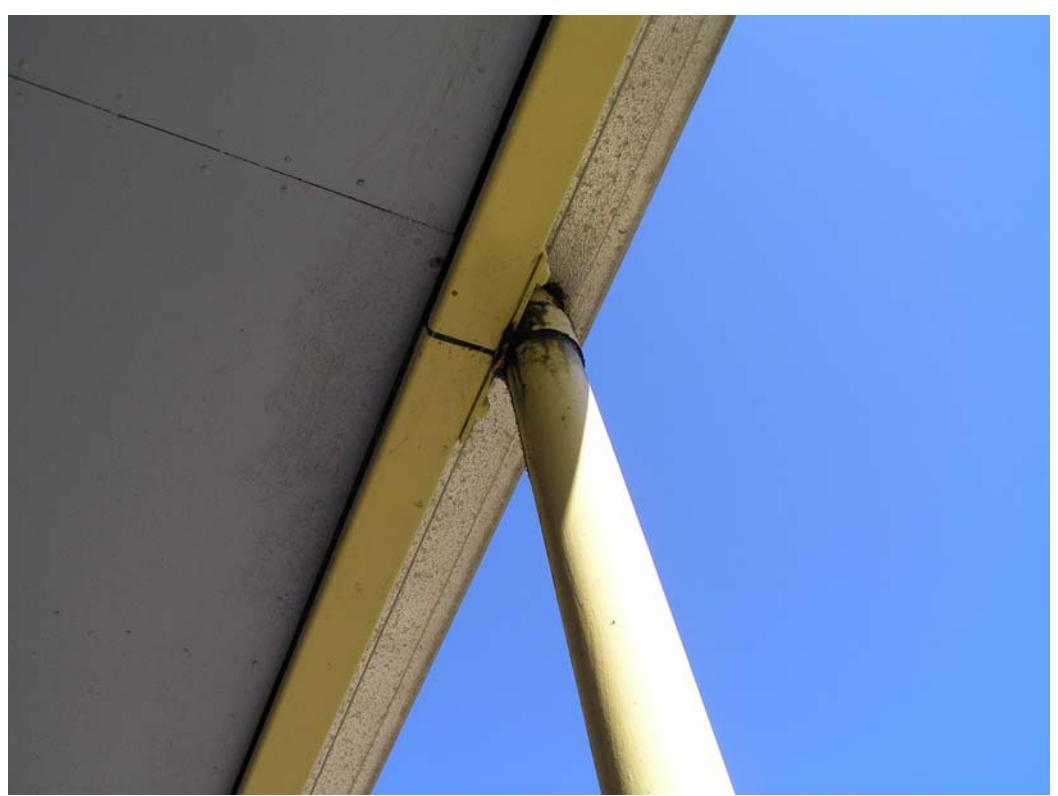
Figure 99 Structural downpipe showing that water has come through the join to the gutter and the infill panel has water damage.

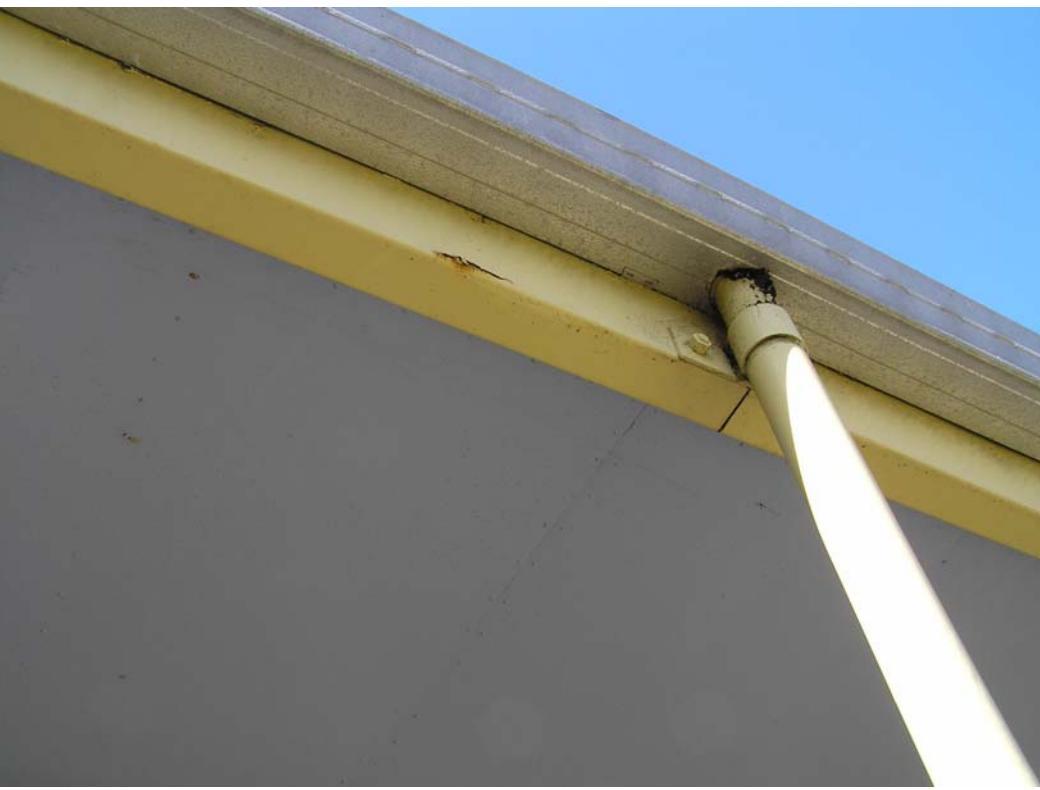
Figure 100 Structural downpipe showing that water has come through the join to the gutter and red rust can be seen in U section.

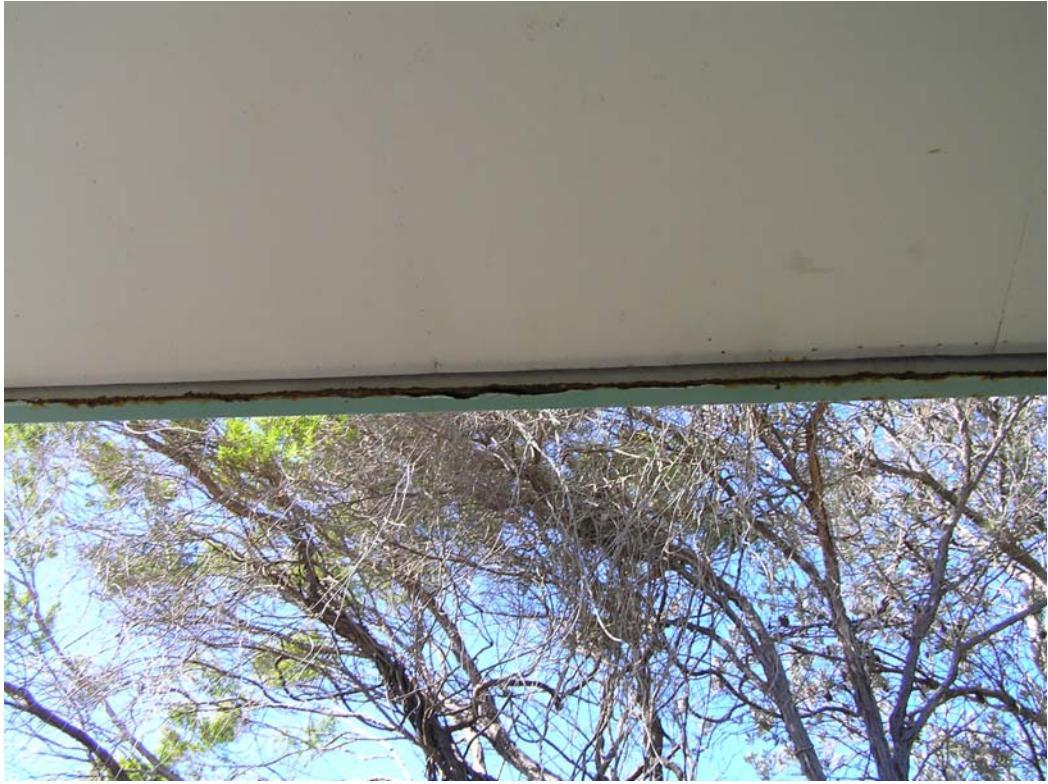
Figure 102 Looking at U section from under the eave, red rust can be seen along steel.

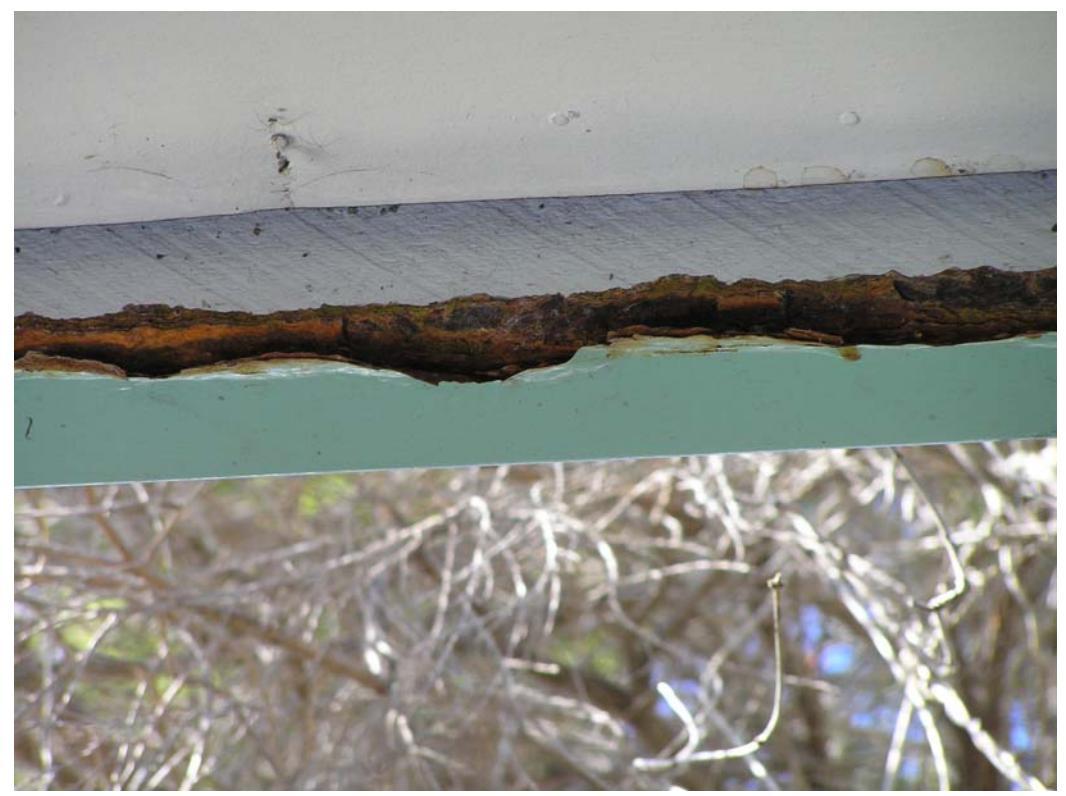
Figure 103 Close up of U section, red rust can be seen and also the wood beam which is rotting.
