Trip to Sunshine Coast Queensland, September 2004 Visit to Schools

Report No 2002-059-B No 7

Research Program: B Program Name Environmental Sustainability Research Project No.: 2002-059-B Project Name Case Based Reasoning in Construction and Infrastructure Projects

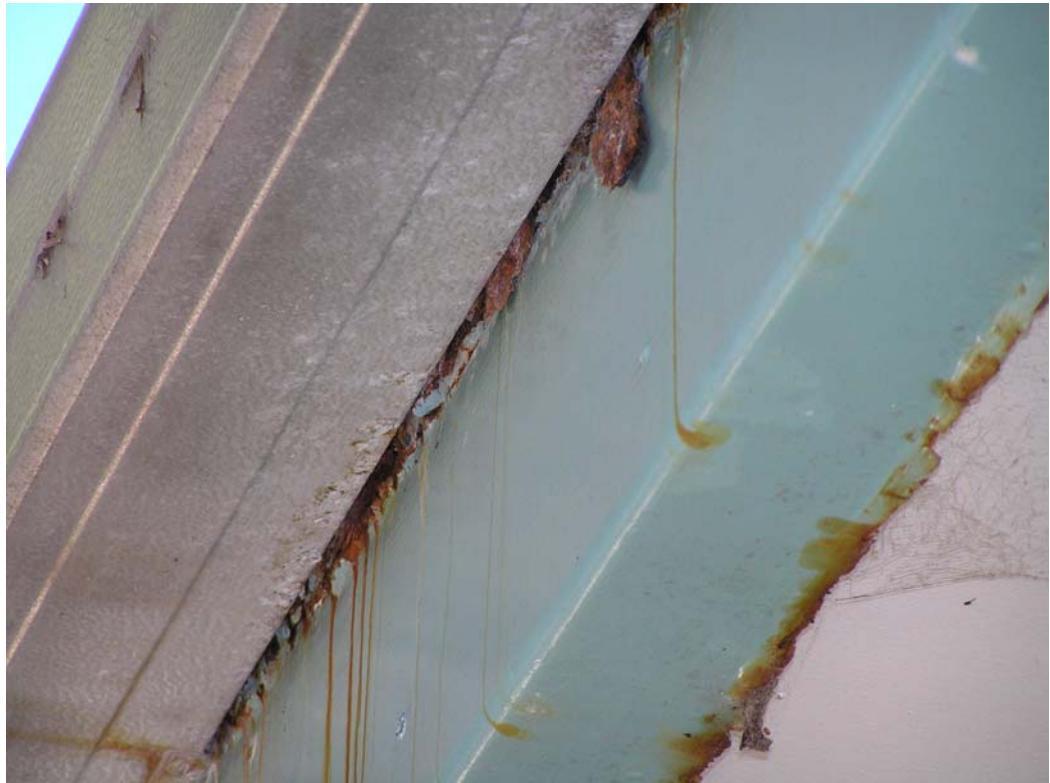
Figure 104 Close up of U section showing significant red rust.
