Ground penetrating radar finds defects in bridge beams

The following paper reports on one of six case studies developed by the BRITE Project of the Cooperative Research Centre for Construction Innovation. BRITE stands for building research, innovation, technology and environment. The case studies demonstrate the benefits of innovation and successful implementation strategies in the Australian Building and Construction Industry. Many highlight the strengths of small and medium-sized businesses in regional areas. This paper was prepared by staff at the CRC for Construction Innovation.

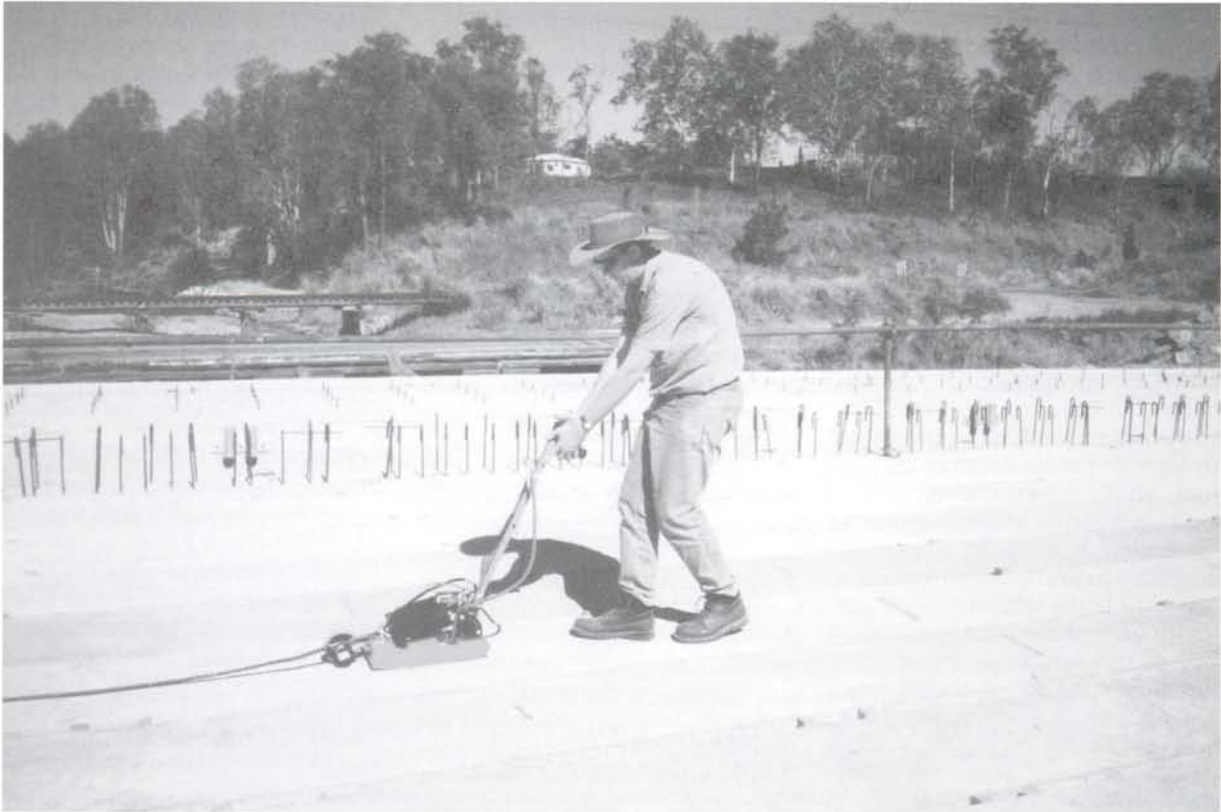
Ground penetrating radar was able to provide accurate images of internal defects in deck beams of the Cattle Creek Bridge, to within five millimetres.

The improvement in image accuracy obtained by the latest generation GPR represents a quantum leap in clarity. GPR was able to provide accurate images of internal defects in the Cattle Creek Bridge beams to within five millimetres. This accuracy was confirmed by drilling small percussion holes in selected beams and using a wirehook test to check that the thickness of concrete around the voids corresponded to the GPR images. Blind tests gave a mean difference of 1.6mm between GPR measurements and core hole

GPR was used to image 180 prestressed concrete bridge beams on the Cattle Creek Bridge. The beams analysed are of a standard design used throughout Queensland. In this design, large polystyrene blocks (called 'voids') are cast internally within the deck beams to reduce the weight of the beams. At Cattle Creek, GPR was used to determine the final location of the voids within the beams and identify any defects caused by movement of the voids during their construction.

The results indicated that over 90% of the beams were 'out of tolerance' due to significant movement of the voids, creating thin top or bottom flanges and air cavities between the lower steel stressing strands, resulting in soffit cracking.
