CRC CI – Second International conference, 2006, Brisbane, Australia.

Evaluation of distress mechanisms in bridges exposed to aggressive environments

Srikanth Venkatesan¹, Sujeeva Setunge¹, Tom Molyneaux¹ and John Fenwick²

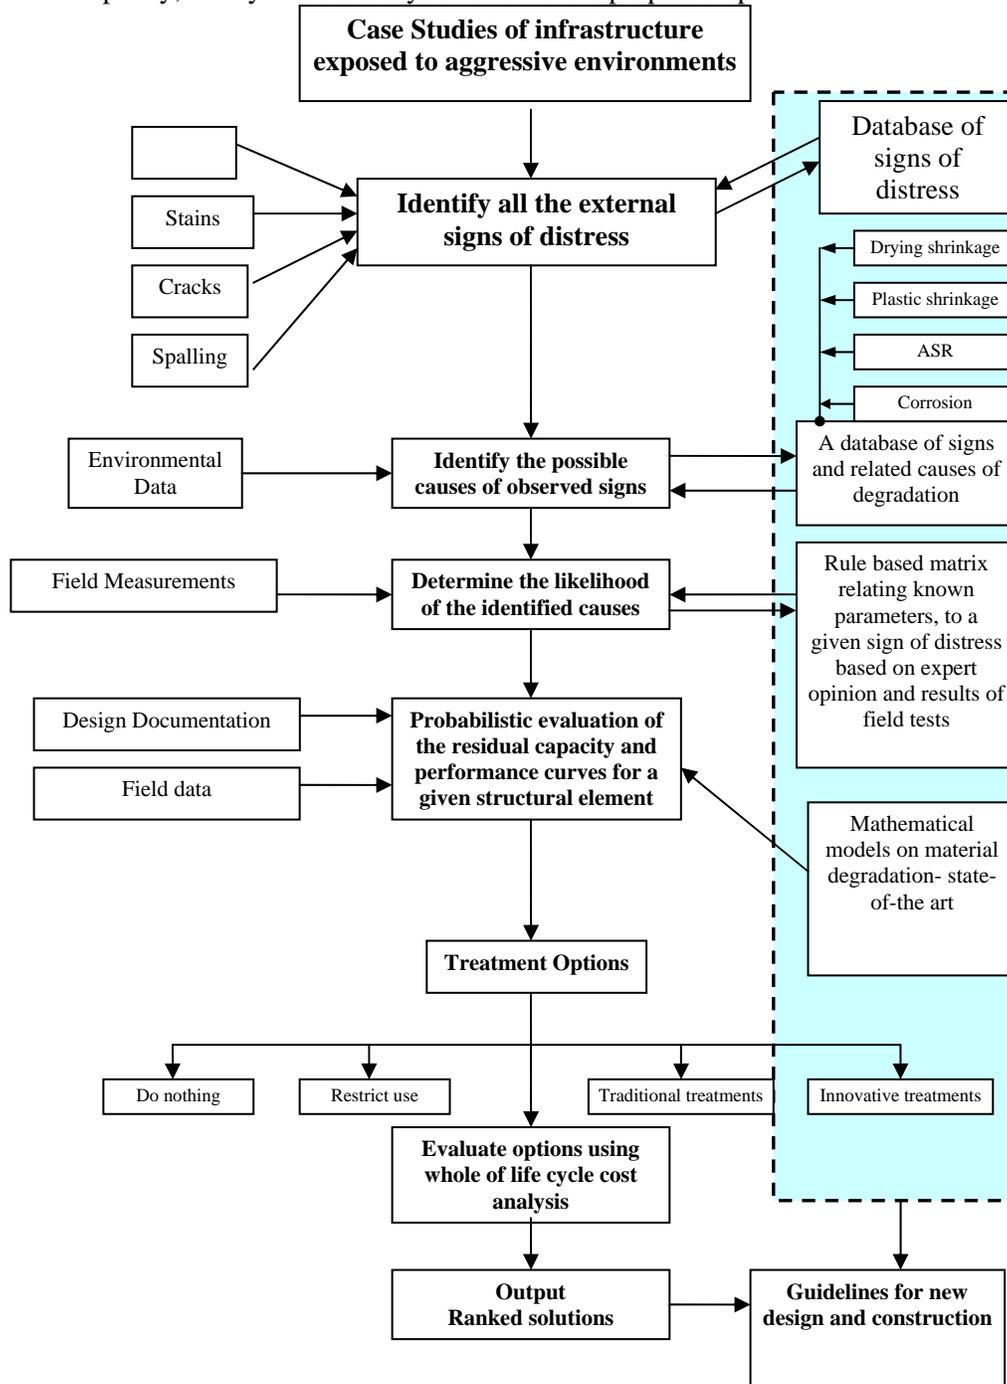
Proposed research methodology is shown in Figure 1. The frame work was developed by Nezamian, et.al (2005) focusing on four major tasks: Case studies of bridges exposed to aggressive environments, Relating the distress mechanisms and causes, evaluation of residual service life capacity, life cycle cost analysis for different proposed options.

Figure 1. Proposed research methodology

The foremost task in the above methodology is in developing a rule-based matrix that can relate a given sign of distress to the most likely cause. Initially, a literature review was undertaken to establish the current body of knowledge. Some of the works by Bungey and Millard (1996), Dhir, (1993), Chan (1996), De Brito (1993), Gannon and Cady (1992), Teng, T.P., (2004) were reviewed and compiled into a research report (Venkatesan, *et.al.*, 2005). Published work mainly addresses research into specific mechanisms causing deterioration. They do not provide diagnostic information needed to identify a certain sign of distress to a related cause. In the second stage the research team examined case studies available through QDMR to identify common signs of distress and associated complexities in diagnosing the related cause. Two such case studies are reported in detail in the subsequent section. These information have been extracted from QDMR records.

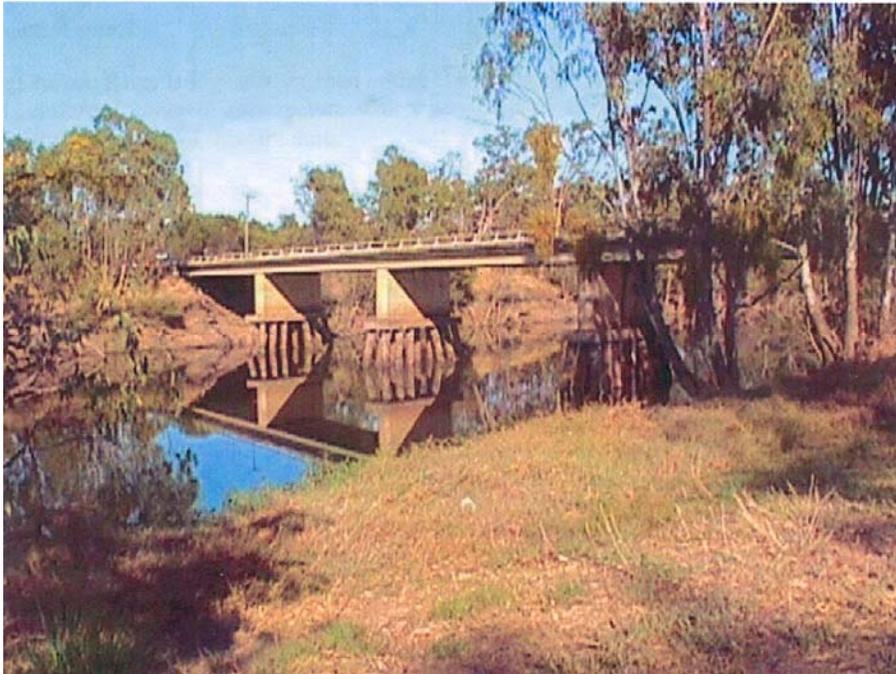
Dawson River bridge is on the Dawson Highway enroute to Rolleston in Queensland, Australia. This particular bridge is a six span prestressed concrete (PSC) superstructure with a reinforced concrete substructure that was built in 1892. The first two spans comprise of 14 PSC deck units which are approximately 11 meters in length. The remaining 4 spans consist of 5 x 1.2 m deep PSC girders approximately 26 m in length. The end piers consist of a headstock on 550 mm octagonal PSC piles arrangement which directly support the superstructure. The mid piers are located in the deep water section and consist of blade piers each supported by 12 composite 550 mm octagonal piles. The design strength of concrete elements such as the Piers, Girders and Piles range from 25 MPa to 45 MPa, whilst the concrete cover to reinforcement ranges from 25 mm to 50 mm. Photo 1 presents a general view of the Dawson River Bridge.

Photo 1. General view of Dawson River Bridge, Queensland

The above bridge experienced significant deterioration leading to visual inspections by an expert and subsequent petrographic examinations of concrete cores in the year 2000. During the visual

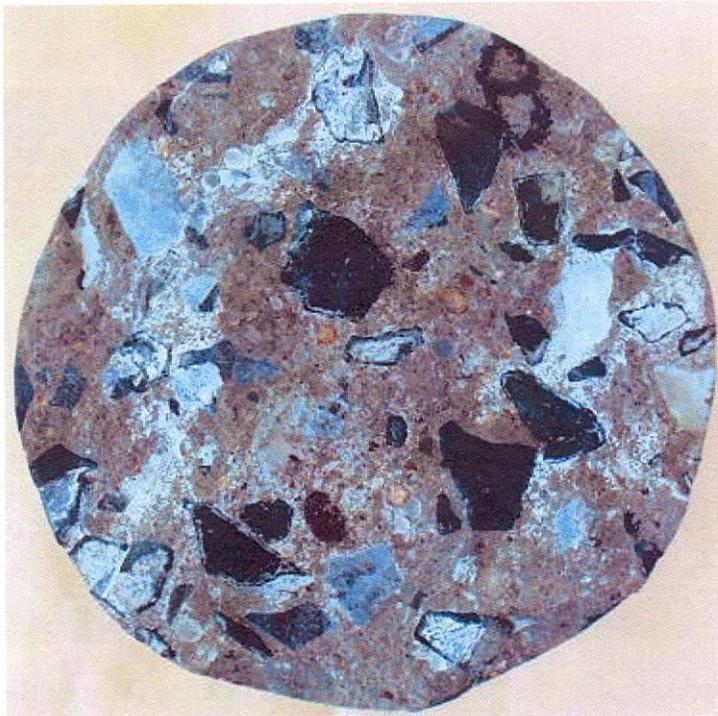
Photo 2. Concrete core sample from Dawson River Bridge (note the ettringite formations)

The petrographic examination of the sample core that has been presented in Photo 2 revealed that the coarse aggregates consisted of crushed, unweathered labile siltstone and related subordinate labile sandstone along with minor acid porphyry and micro diorite /andesite. The materials were closely representative of the materials from nearby quarries. The minor acid porphyry and micro diorite /andesite were observed to carry free silica, but on petrographic examination were predicted to be innocuous in relation to ASR. Further the petrographic examination observed “*Curiously, air bubbles are lined by an acicular, brightly birefringent mineral which appear to be of ettringite formations*”. Without the petrographic examination, ettringite formations would have been considered to be the result of ASR. It was then concluded that the distress had been caused by two mechanisms: ASR and delayed ettringite formation. In one of the studies reported by Nezamian, et.al., (2004), distress due to ASR resulted in the onset of corrosion. Therefore, correct diagnosis is imperative in developing preventative guidelines for new structures.

inspection, vertically propagating cracks were observed in the PSC piles. It was also noted that the spiral ligature intercepted by the coring bit did not appear to have undergone significant level of corrosion activity. The cores exhibited surface cracks that tapered back to zero in roughly perpendicular orientation to the surface and the cracks mostly propagated around the pieces of aggregate. At the broken ends of the cores the presence of a significant amount of white reaction product (similar to the formation of air bubbles) was noted. This was particularly obvious at the aggregate / cement interface (Refer to Photo 2). Based on the above inspections, it was concluded that the major cause of distress in this case would be alkali-silica reactivity. As there were no signs of corrosion activity of the spiral ligatures, and due to the site location being considerably inland, it was interpreted that chloride ingress would not have played a significant role and consequently chloride ingress tests were not recommended. It has to be noted in here, that the white reaction product had appeared to be consistent with the symptoms of ASR, however petrographic examinations proved otherwise.

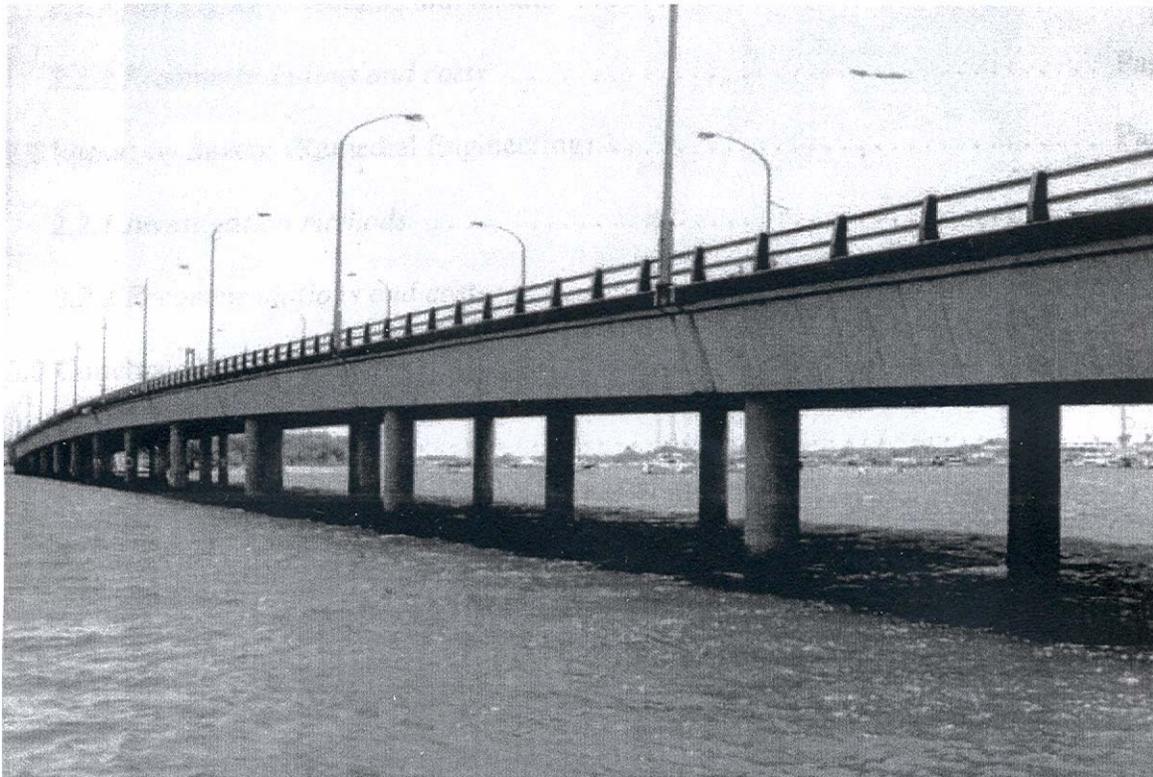
Photo 3 presents a general view of the Nerang bridge in Sundale, Queensland. This is a multi-span long PSC bridge. This bridge was built in 1960's and major inspections to quantify the distress were undertaken in the year 1998. The investigations showed that the concrete in the tidal zone had very high levels of chloride contamination from the sea water environment which had led to corrosion of the reinforcing steel and cracking of the concrete. Photo 4 presents the core samples taken from the tidal zone. Clearly the severity of cracking is apparent from the samples. Further to these tests, diving inspections were undertaken to determine the extent of cracking. The cracks in the central piers appeared to be the greatest around the tidal zone and reducing with the depth of concrete.

Photo 3. General view of Nerang River Bridge, Sundale, Queensland

During visual inspections extensive cracking, spalling and drummy areas of concrete were observed. Carbonation was considered to have less influence with chloride contents being identified to be far in excess of that required to instigate corrosion levels. However, chloride levels measured in girders and diaphragms were lower than that required to commence corrosion. Clear documentation of the width of cracks, location, and extent are available from the reports. Based on the extensive investigations, Impressed Current Cathodic Protection (ICCP) of reinforcements was recommended to ensure long term performance. Without the above repair option it was believed that the structure would survive only 5 or 10 years. It has to be noted that this estimation of residual service life is an assessment based on experience. The first author visited this bridge recently, to assess the performance of the repair work. No major cracks or other form of distress could be noted.

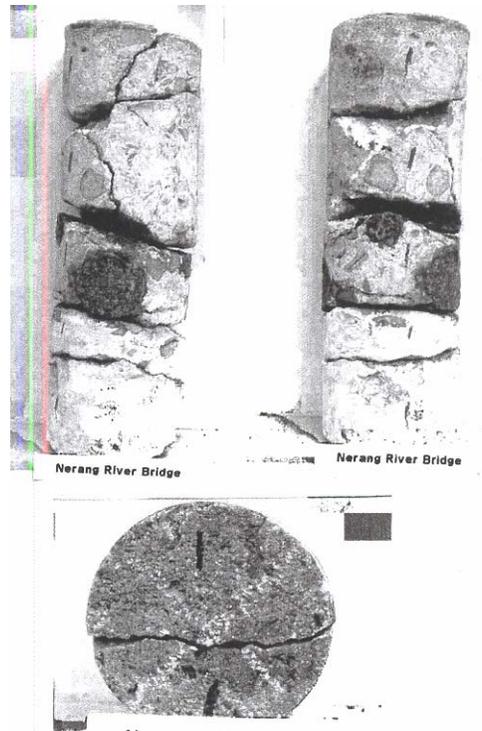
Photo 4. Concrete core sample from Nerang River Bridge (note the severity of cracking)

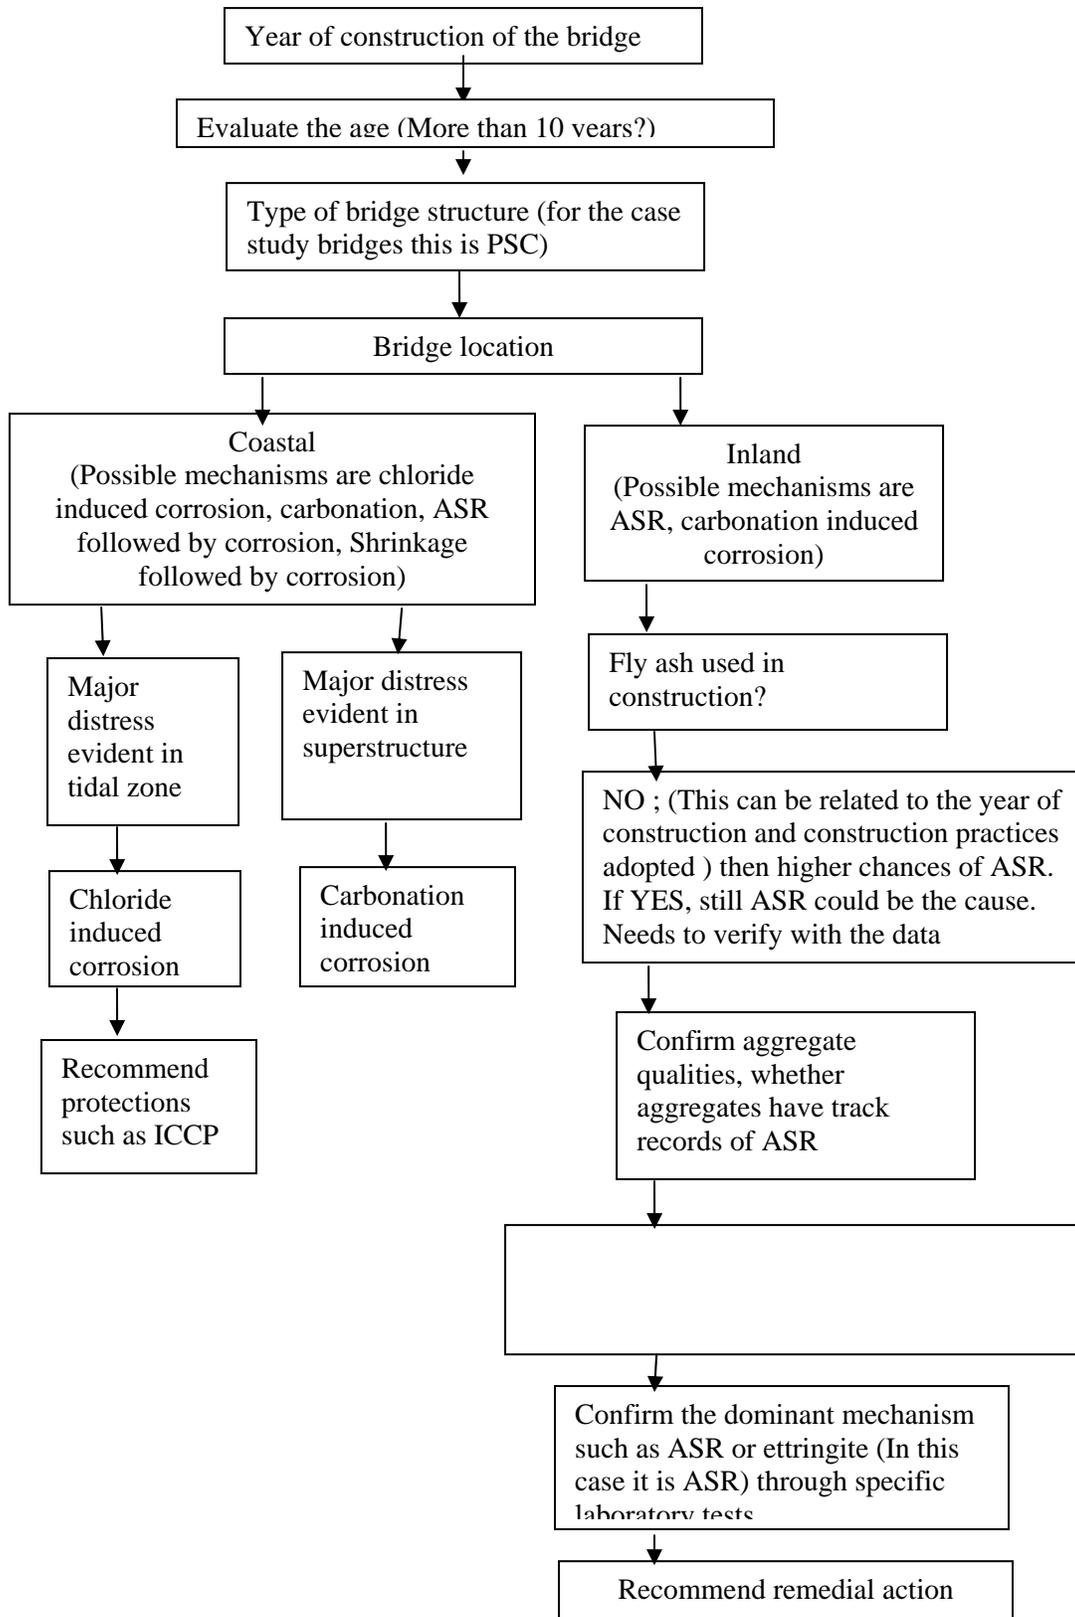
Above case histories assisted the authors in mapping out the format of the diagnostic tool being developed. For example, chloride ingress is less significant for inland bridges and carbonation is less significant for bridge elements close to the tidal zone. This is because; the chloride ingress is caused by the splashing tides or air-borne chlorides with substantial influence of salts whilst carbonation is influenced by the presence of moisture. These information may be well known to experts in the field but are not genuinely known amongst practicing engineers. Specific to the aforementioned discussions, a probable framework for developing a rule-based matrix (based on logical questions) has been presented in Figure 2. The authors wish to compile similar information for the wide variety of case study bridges into a diagnostic tool to evaluate the residual service life of a given bridge structure and to recommend suitable remedial options based on life cycle cost. The important contribution of this research will be in identifying or segregating the synergic effect of the causative mechanisms. Classic example of this case is the Dawson River Bridge in which ettringite mechanism was observed but was not considered as the dominant cause.

Figure 2. Typical format for diagnostic tool

The significant advantage of the above framework is the clear segregation of the expected mechanisms with respect to the location of the bridge. The authors have gone through the reports and have studied the possibility of including distress patterns and signs. At this point in time, considerable clarity could not be established in distress patterns because of the limited number of case studies considered. Authors are investigating bridges other than PSC, culverts and other structures. This will facilitate compiling of the missing information required to present a wholistic picture of understanding the distress mechanisms.
