Towards a Rule-based matrix for evaluating distress mechanisms in bridges

S.Venkatesan, S.Setunge, T.C.K.Molyneaux & R.J.Gravina

RMIT University, Melbourne, Australia

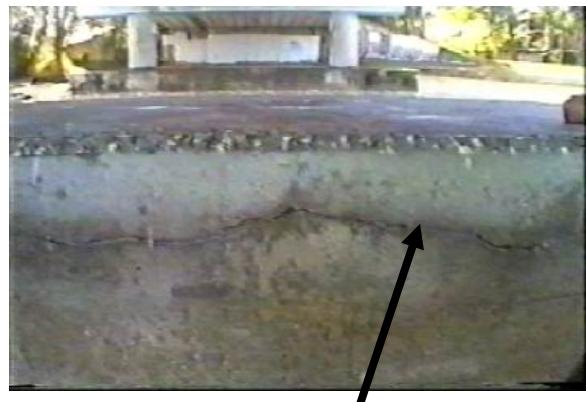
Photo 2. Cracking observed on pilecap sides

In 2001, severe cracking was noted within the top 300 mm of each pilecap during an inspection undertaken by means of boat access. Cracks were noted on the top faces, extending down to approximately mid-depth of each pilecap. Tapping with a hammer revealed that much of the cover concrete in these ar-

The delamination observed in the cover concrete was believed to be the effect of expansive corrosion of the reinforcement. The sizes of cracks and the extent of delamination varied from location to location and pier to pier. This was attributed to changes in the degree of concrete compaction, differences in concrete batching and variability in the depth of concrete cover. Thus construction issues were considered as “possible” causes. The type of cracking observed especially within the tidal zone (this refers to the height up to which the waves splash on the structure from normal water level) has been attrib-

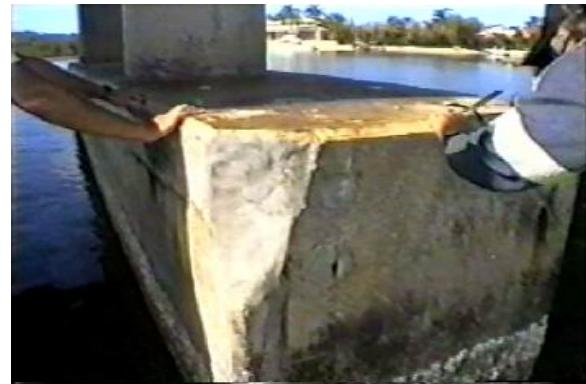
Photograph 3. Cracking and Spalling at the corners due to “Double diffusion”.

uted to the ingress of chlorides due to the saline water environment. Particularly the cracks taper with respect to the height within the tidal zone. In addition the similarity of cracking observed at the corners is attributed to the ingress of chlorides from both directions - known as "double diffusion". (Refer to Photograph 3). Based on the above observations and hypotheses, ten concrete samples were extracted and analysed for chloride profiles, petrographic analysis, strength test and density tests. In particular, the chloride profile analysis (Figure 1) revealed that chloride contents in the concrete samples exceeded the "threshold" levels by a factor of 2 on an average. Threshold levels are determined based on the mix design and concrete content during the time of construction. Thus the mechanism affecting the pilecaps was confirmed to be chloride induced corrosion.

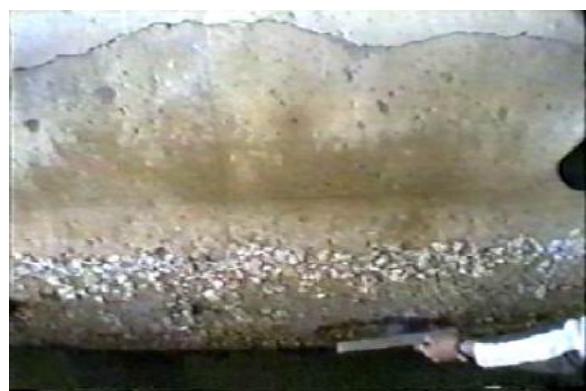
Photograph 4. Cracking and Spalling of concrete cover on sides of pilecap

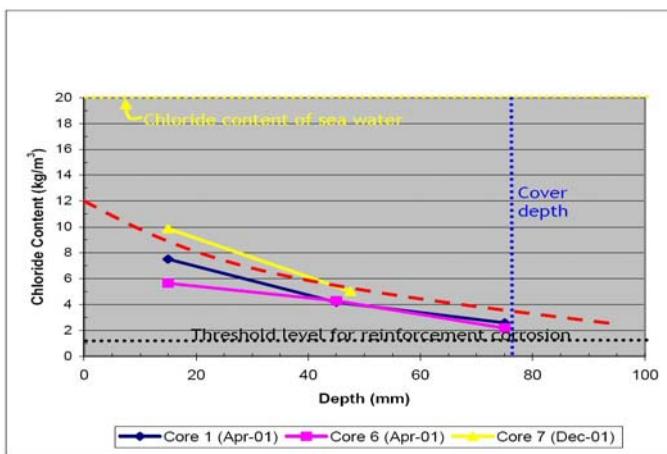
Figure 1. Chloride profile analysis on concrete samples

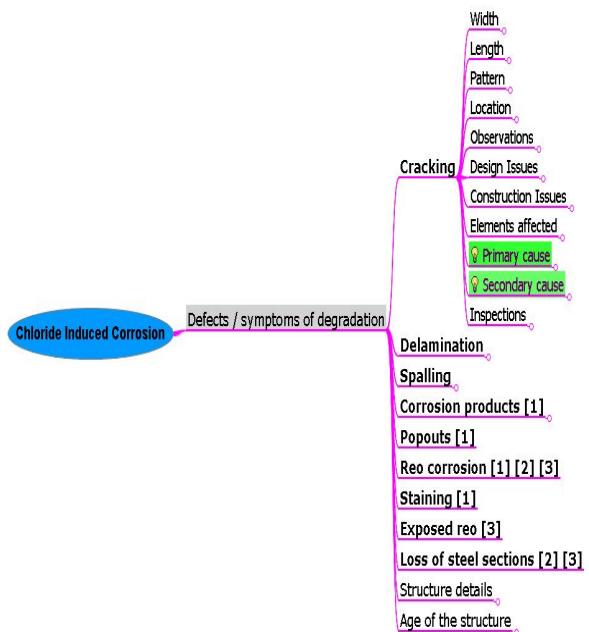
Figure 2. Schematic representation of mind map

Note: Numbers in brackets denote case study bridge number – the case study presented here is number 1.

In addition it was observed that particular types of construction (hollow spun piles for example) exhibited similar distress symptoms. Although construction issues were noted as possible influences, the degree of certainty as to cause was not clear in all cases. The influences were analysed under three levels of confidence: high, medium and low. A schematic representation of part of the mind map is presented in Figure 2.

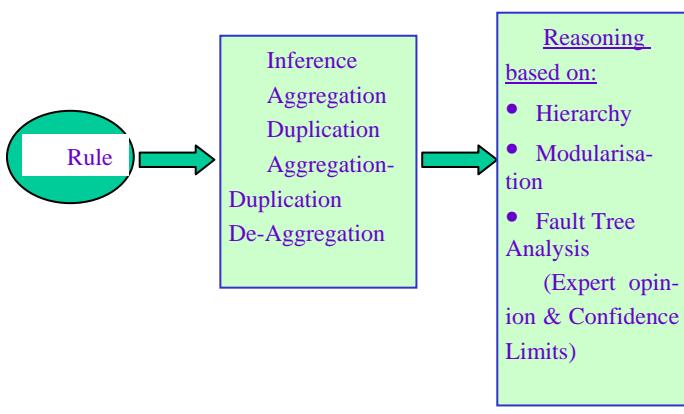
Figure 3. Reasoning based on developed rules

In the above figure, inference is a direct evidence of the rule relating to a known fact. Aggregation is the process of several rules leading to a conclusion. Duplication is the re-occurrence of known information that does not enhance the present level of conclusion. Aggregation-Duplication is a combination of the above two, that can be used to link to a common variable. De-Aggregation is a process of acquiring more information, to augment the inadequate

information supplied. For example, the High probable rule of “Inadequate concrete cover” would need extra information on the size of aggregate; mix design; exposure class of the given element or it would need to be related to a codified provision at the time of construction.

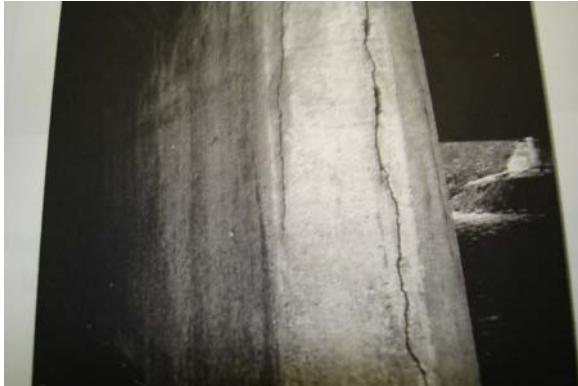
Photograph 5. Cracking observed on the chamfered edges of the pier.

This (test) case study bridge was constructed in the 1940’s and subsequently widened in the 1960’s. It comprises a four-span RC deck, steel I-girder bridge, supported by pier walls founded on cast in-situ piles. The affected pier elements have vertical cracks at the chamfered edges (Refer to Photograph 5) and consistent symptoms of rusting, staining, delaminations are apparent (Refer to Photograph 6). The cracks and other associated distress are observed to be greater in the tidal zone.

- The affected element is under the influence of the tidal zone.
- Significant cracks at the chamfered ends of the pier are due to the double diffusion of chlorides.
- Evidence of spalling, rusting, staining.
- Age of the structure.

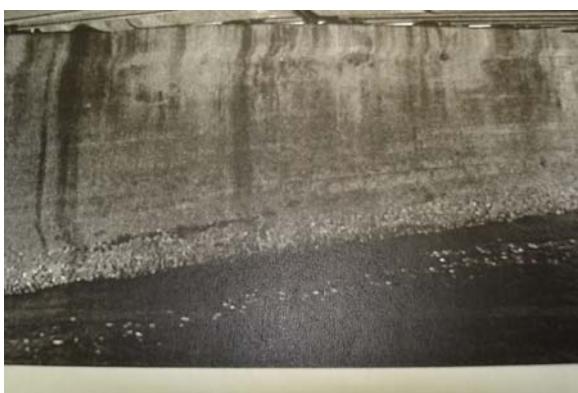
Photograph 6. Evidence of staining, rusting and delaminations on the sides of the pier
