CRC Construction Innovation
BUILDING OUR FUTURE

Holistic Model Modifications for Selected Building Elements

Research Project No: 2005-003-B-06

Project: 2005-2003-B
Learning System for Life Prediction of Infrastructure

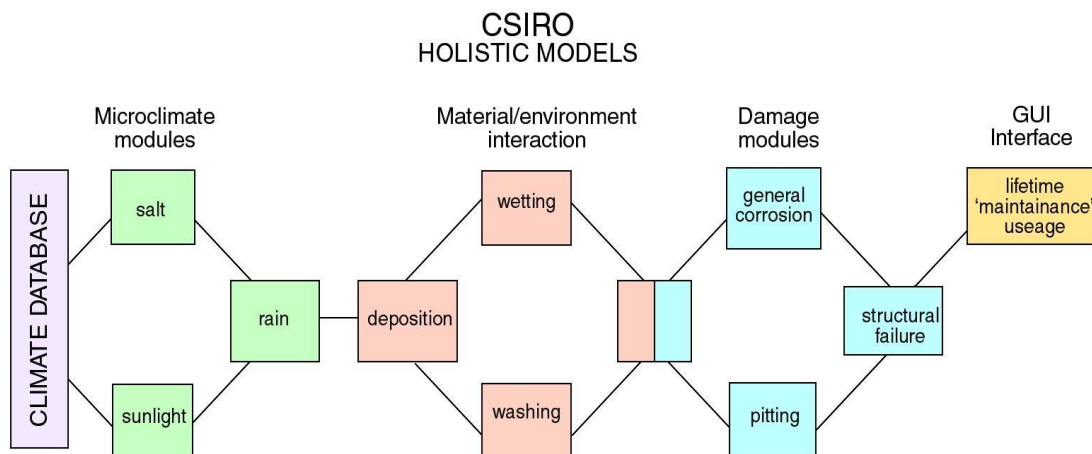
Figure 1: Structure of the modules of the holistic model for predicting corrosion

One of the databases was created using the CSIRO-developed holistic model of metallic corrosion which is based on an understanding of the basic corrosion processes ranging in scale from atomic electrochemical reactions to the macro scale of continental environmental factors. Figure 1 illustrates the modules of the holistic model which are divided into three broad groups: microclimate, material-environment interactions and damage modules.

The holistic model as shown in Figure 1 contains a number of modules that:

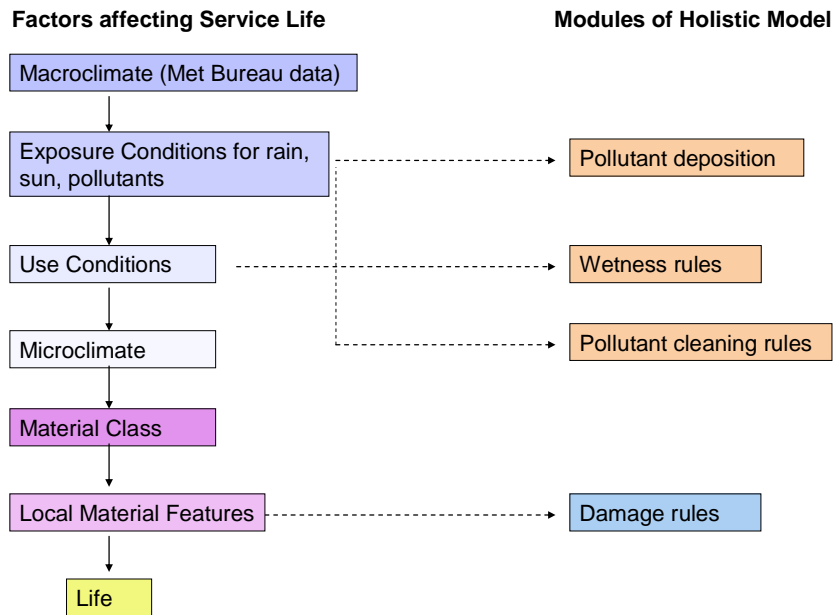
Figure 2 illustrates the different factors affecting the service life of a building component. These are shown on the right hand side of the diagram. The different modules of the holistic model that may need modification for factors specific to different building components are shown on the left side of the diagram with arrows indicating which factors are likely to affect which modules.

Figure 2. Factors affecting service life of metallic components and how they relate to modules of the holistic model.

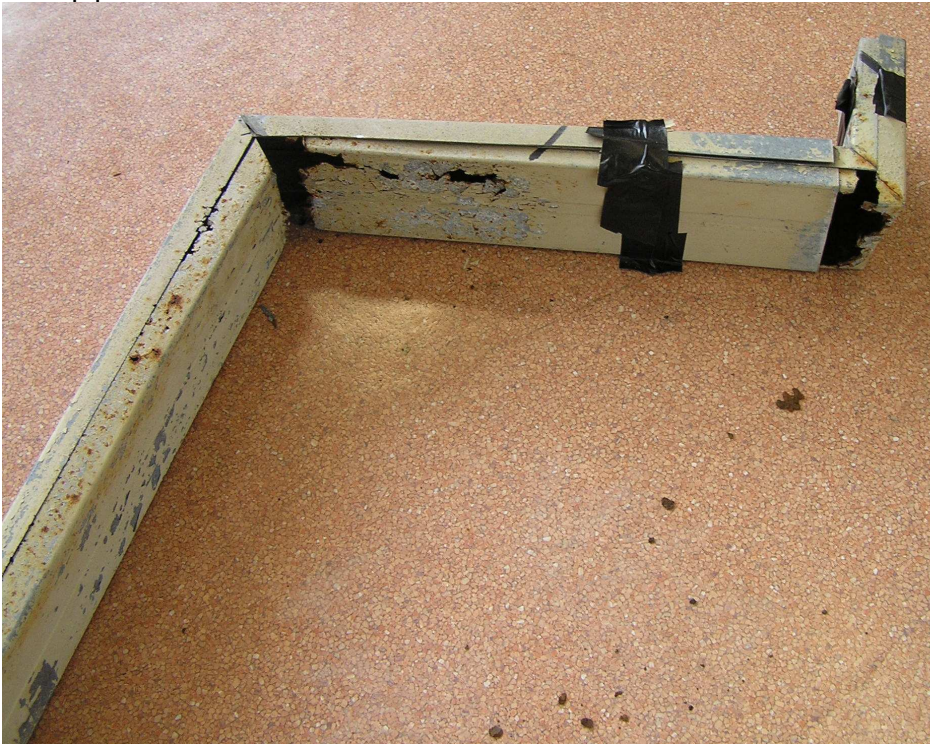
Figure A8, Top section of downpipe

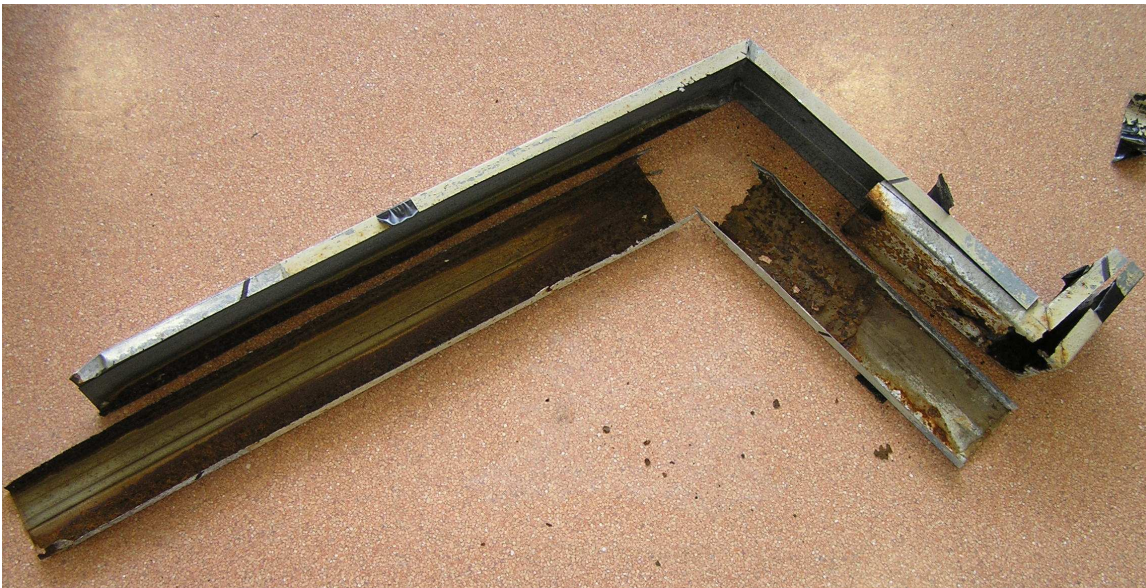
Figure A9, Inside of downpipe

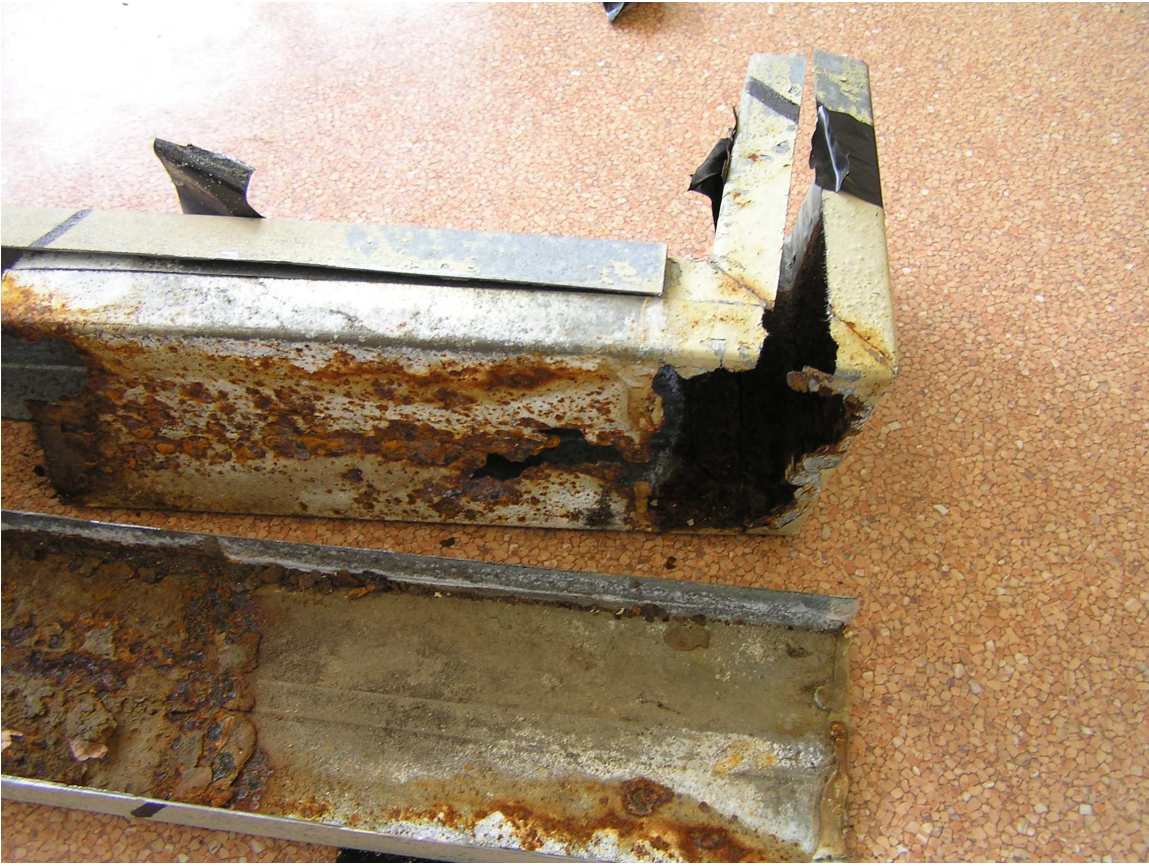
Figure A5, Top section of downpipe showing insert section that connects to gutter

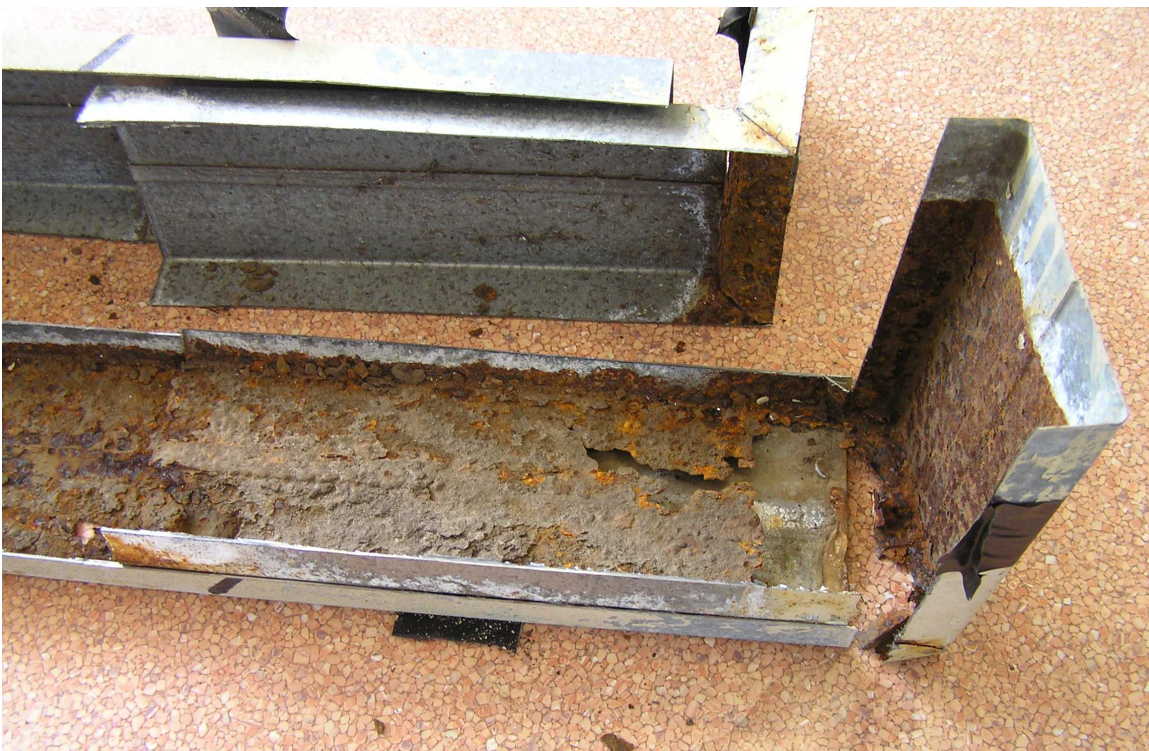
Figure A6, Inside insert which connects to gutter

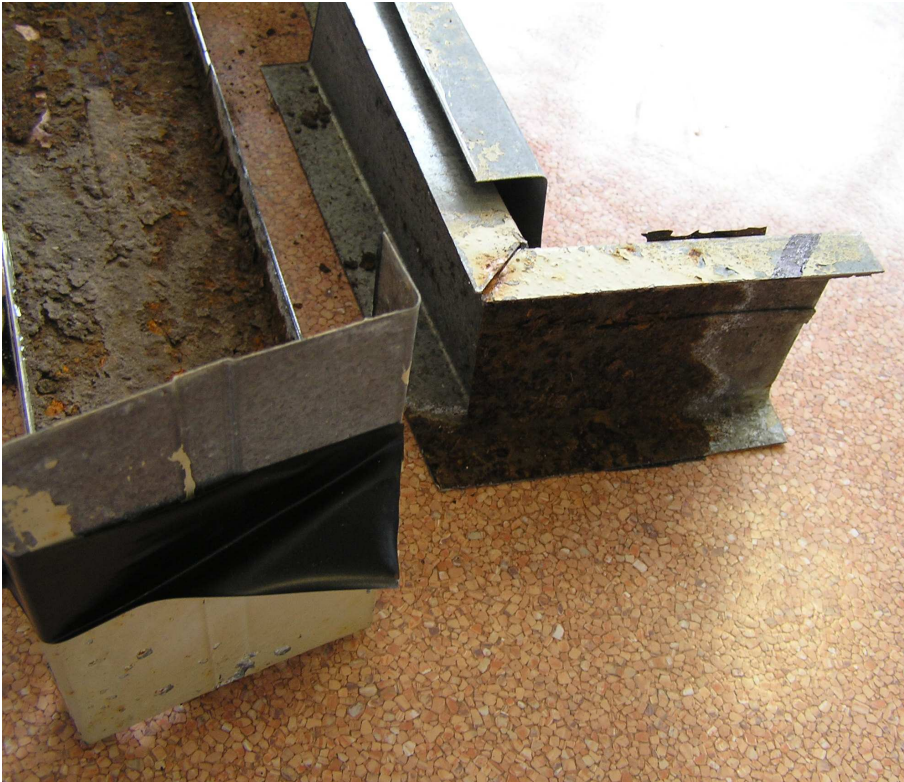
Figure A7, very top section of downpipe

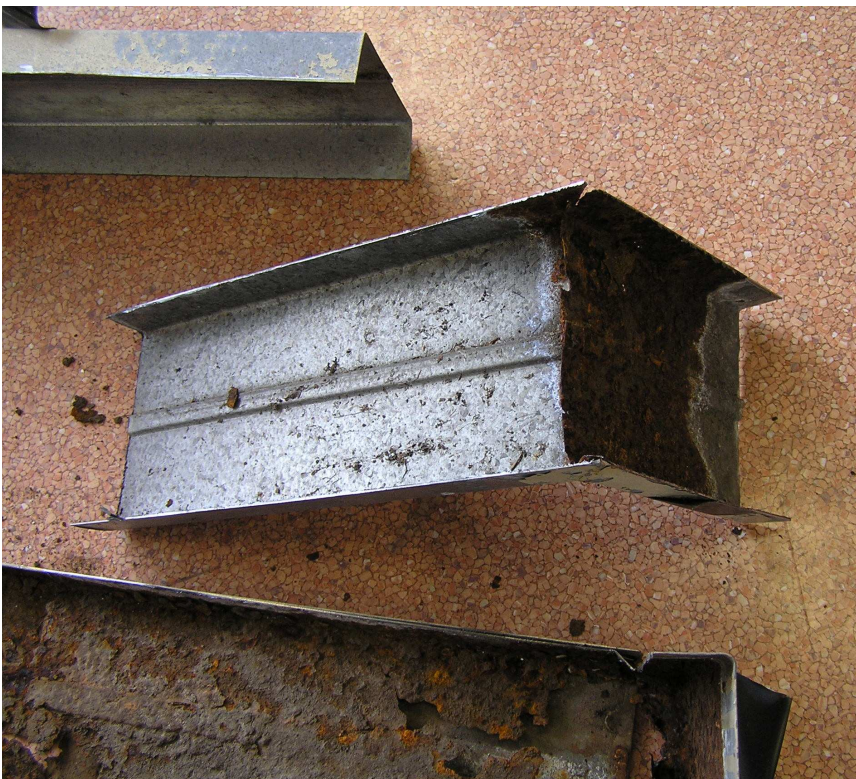
Figure A8, Top section insert showing no corrosion on the upper surfaces of the insert or the main part of the downpipe

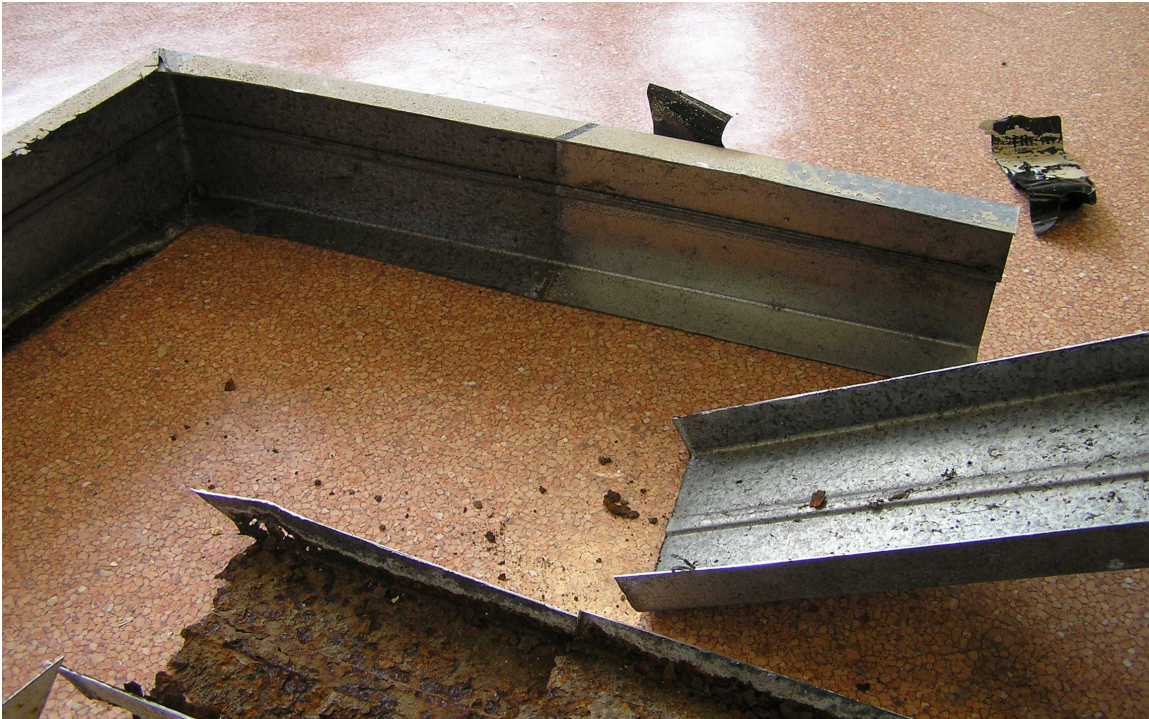
Figure A9, Top section insert showing no corrosion on the upper surfaces of the insert or the main part of the downpipe

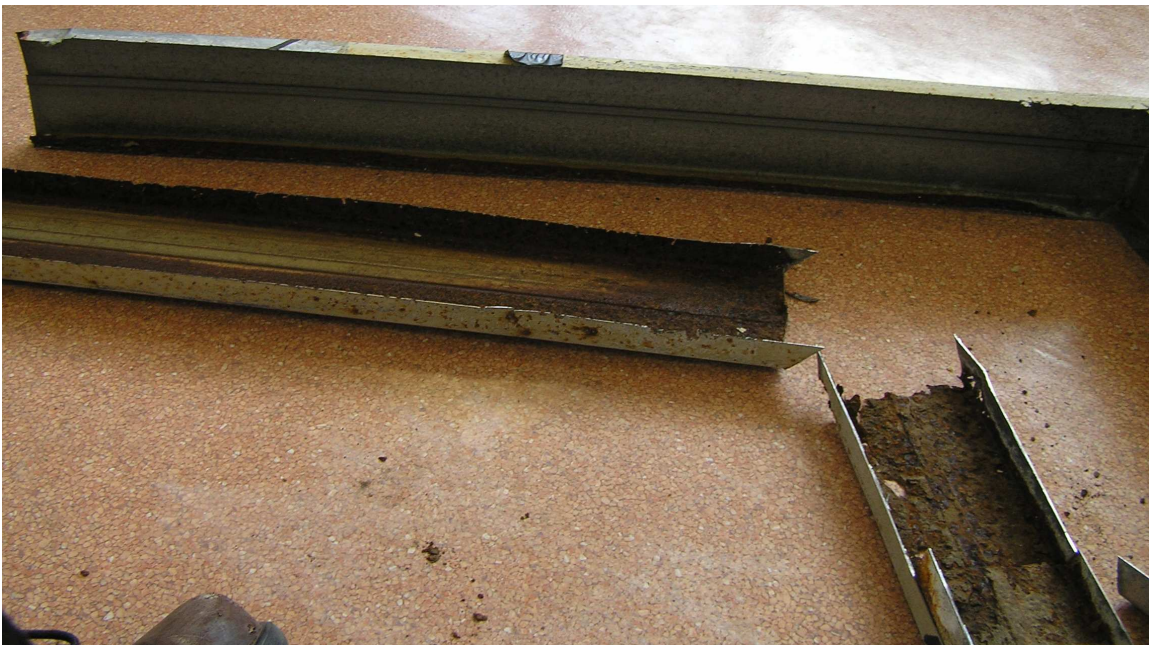
Figure A10, lower section of the downpipe

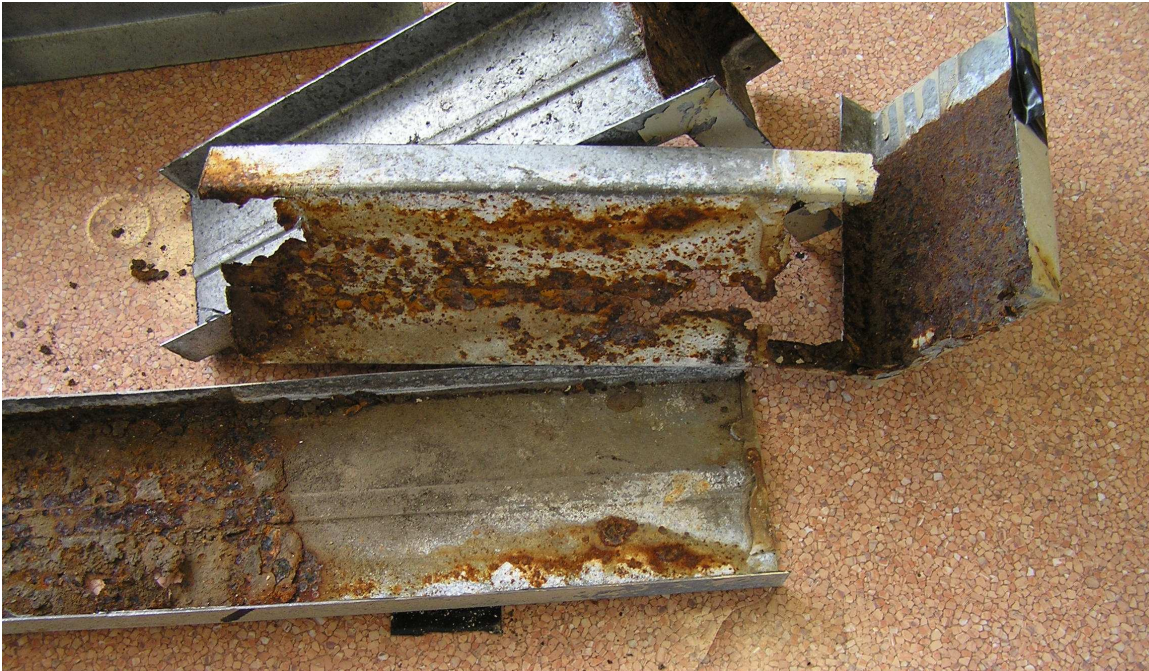
Figure A11, Insert used to connect the downpipe to the gutter, showing significant corrosion on lower surface.

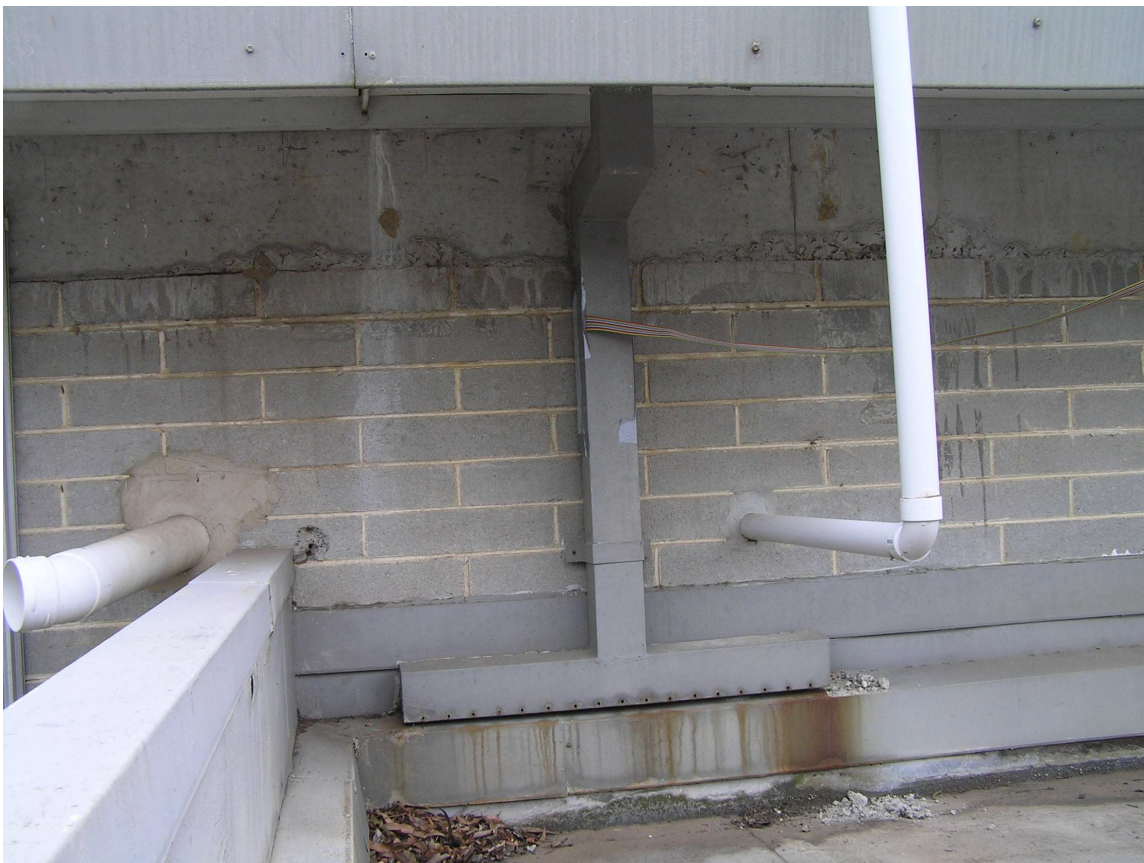
One downpipe was selected near some other monitoring to be used for instrumentation. A piece was removed from the non corroded side for access to install sensors.

Figure A13, Downpipe *insitu*

It can be seen inside the downpipe looking through the ends and in the access hole, that the water follows a certain path through the downpipe. This is shown by the rust patterns inside the downpipe. Figure A13 to Figure A18 show the rust patterns inside the downpipe.

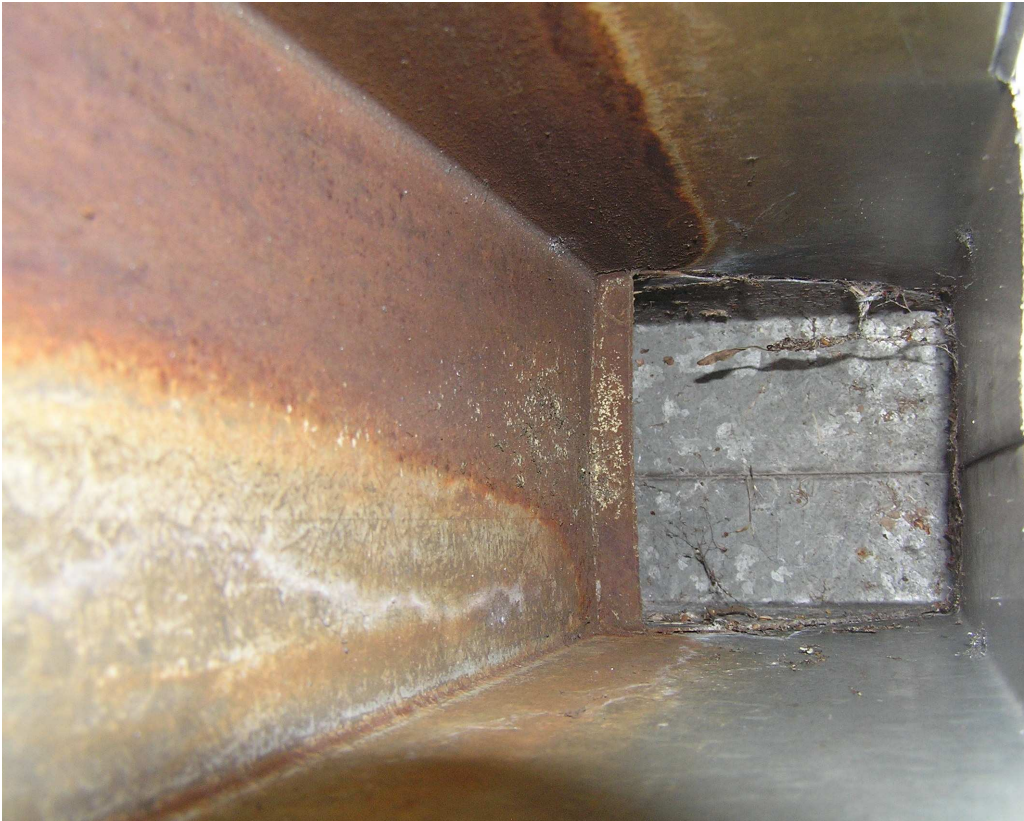
Figure A16, from inspection opening looking up to bend before gutter connection

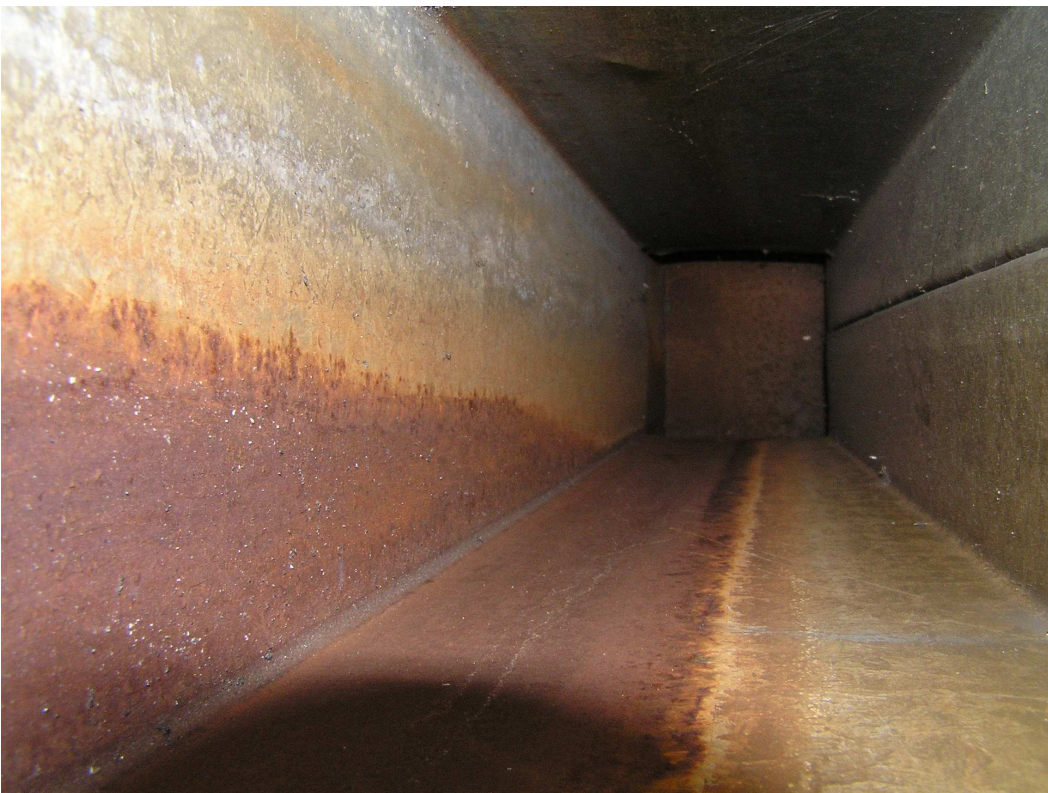
Figure A17, from inspection opening looking down

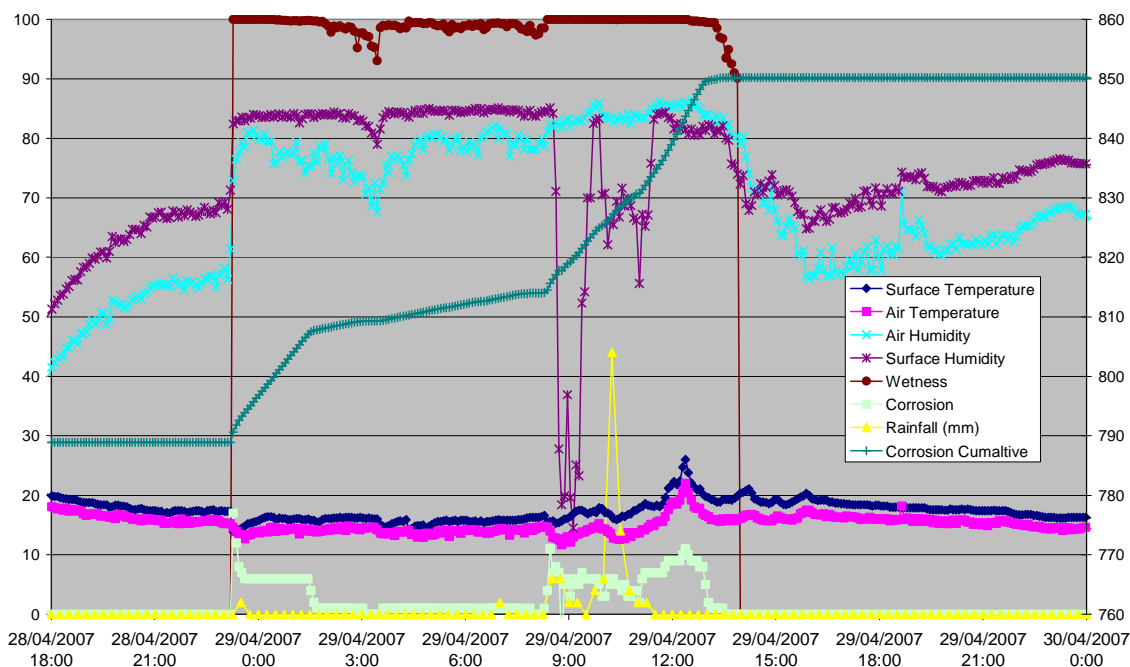
Data has been collected from the downpipe over a number of months. Due to the extreme environment created in the downpipe the reliability of the sensors is not as good as would be liked. The relative humidity (RH) sensors are the least reliable as they do not work and are damaged when they get wet. The RH sensors can recover when they are dried but the reading becomes unreliable. Even with these problems the data collected does provide some interesting trends. A sample of the data collected is shown in Figure A20.

Figure A20, Sample of Data from the instrumented downpipe

The data shown in Figure A20 is complex but there are a few trends that are obvious. The yellow line is the rainfall readings from a weather station located within 250 metres of the downpipe, the readings have been multiplied by 10 so that there are clear on the graph, (a reading of 40 is actually 4mm). The rainfall readings are taken every 15 minutes and a rain depth of 0.2 mm is needed before the gauge reads, which means that light drizzle may not be recorded but could run off the roof and down the downpipe. Two main rain events occur in the graph. The first is before midnight on the 28/4 and the second is around 9am on the 29th. The rain event at 9am was a significant amount of rain and it can be seen that the surface humidity sensor has recorded incorrect readings probably due to being wet from the rain. It would have been expected that inside the enclosed area of the downpipe that the RH would have been closer to 100% than has been recorded. While the RH sensors are still recording trends in RH the sensors have probably been damaged by water at some stage and the readings, while showing the correct trends are most likely inaccurate. Further work will be taken to install some protection for the RH sensors.

green line cumulative corrosion) shows that the sensor is corroding at different rates probably with the different amounts of water flowing through the downpipe.
