Report Colorbond Degradation Model

Research Project No: 2005-003-B-10

Project: 2005-2003-B Learning System for Life Prediction of Infrastructure

Date: September 2007

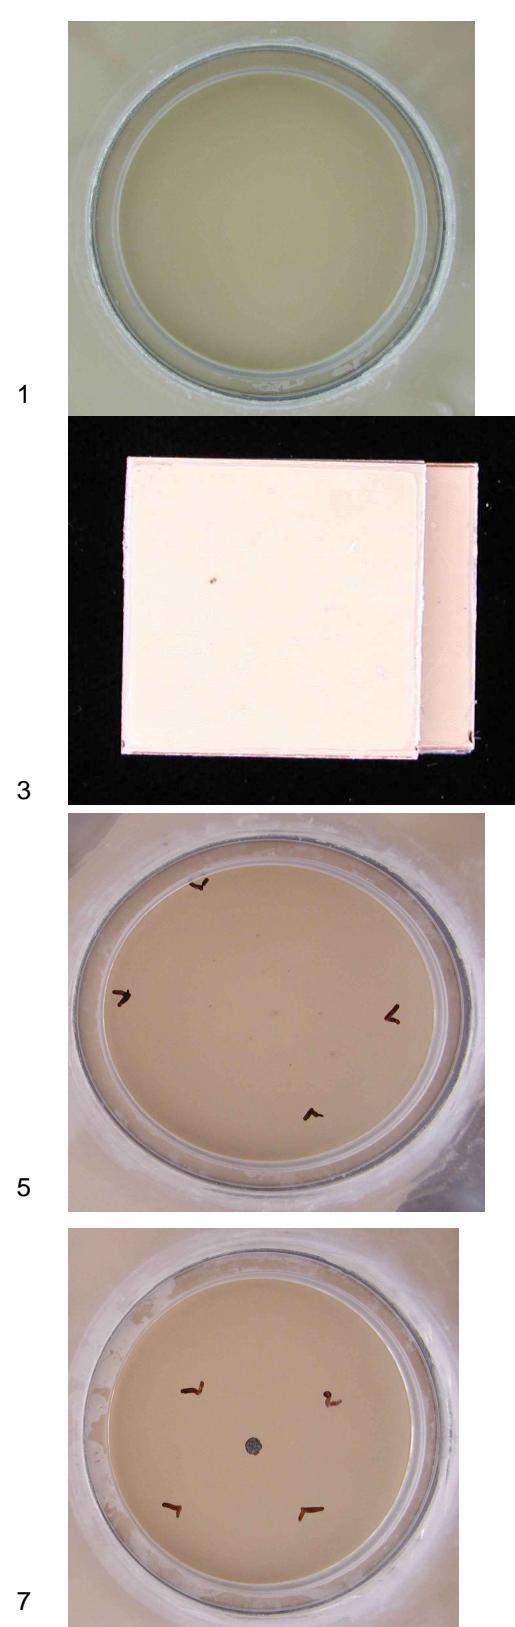
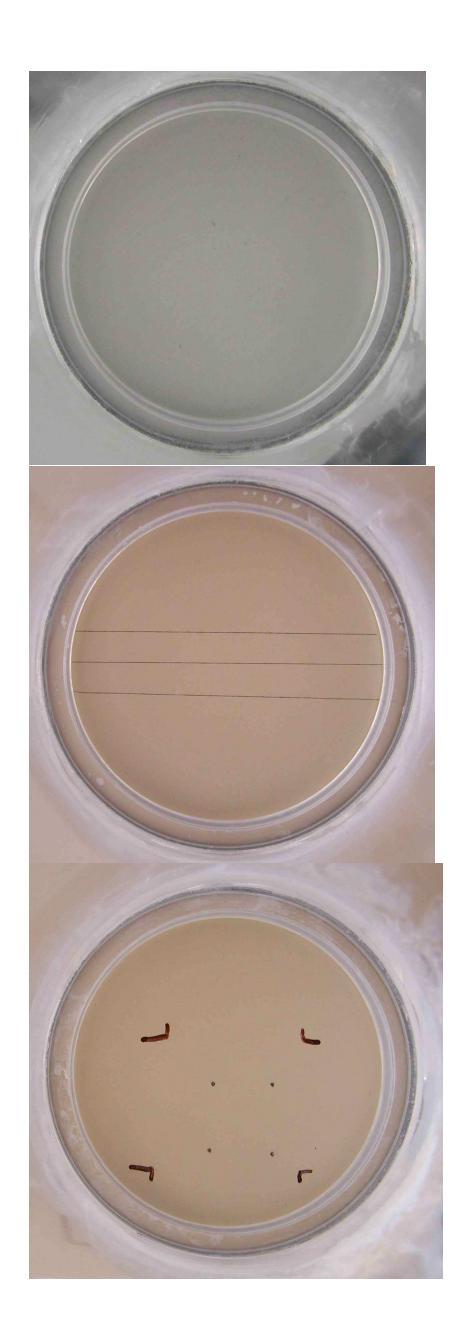
Figure 1. Photographs of the seven cells after two leaching cycles.

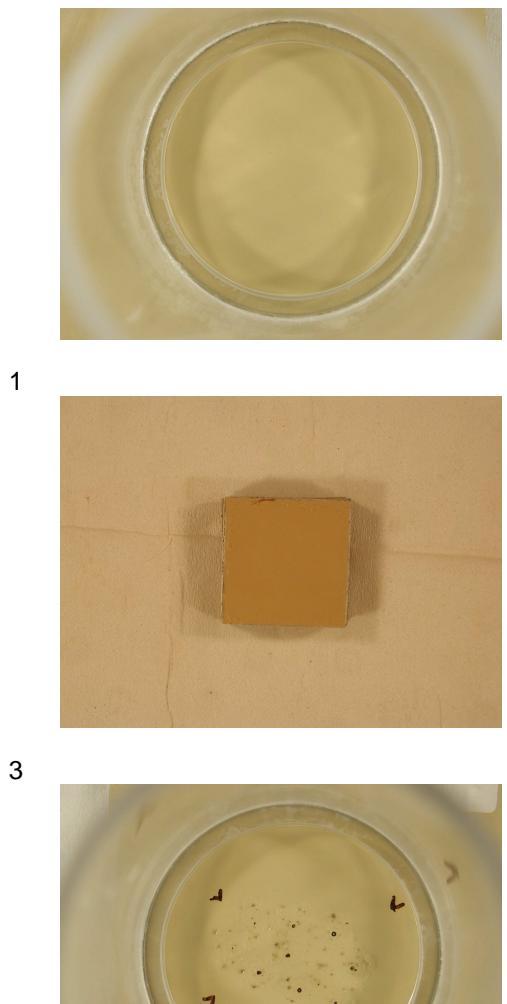
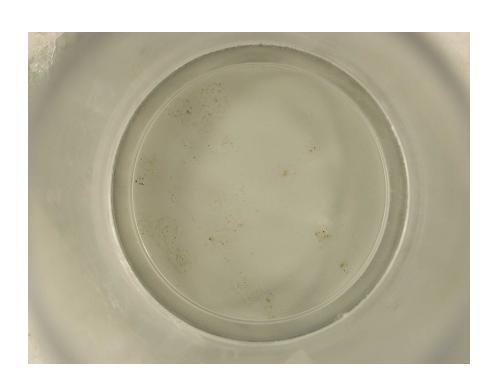
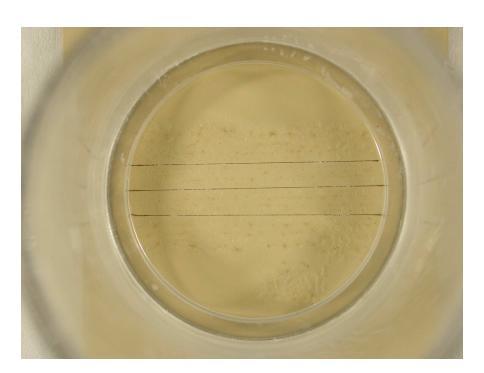
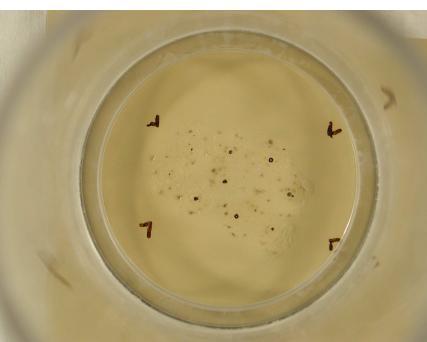
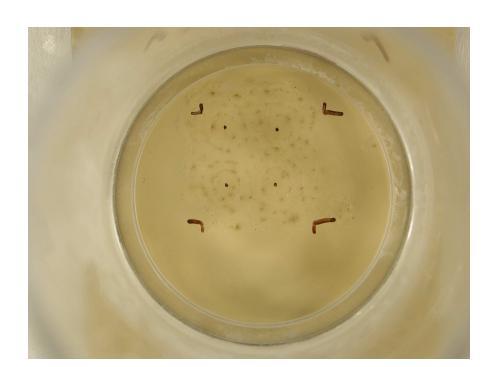
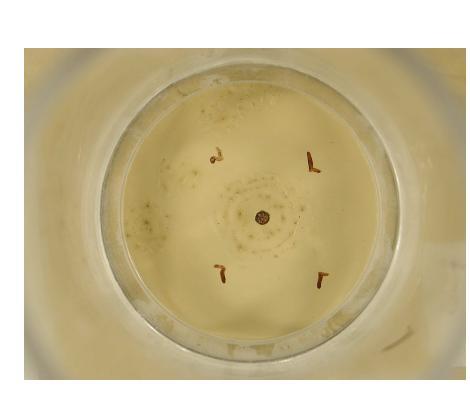
Figure 2. Photographs of the seven leaching cells after seven leaching cycles.

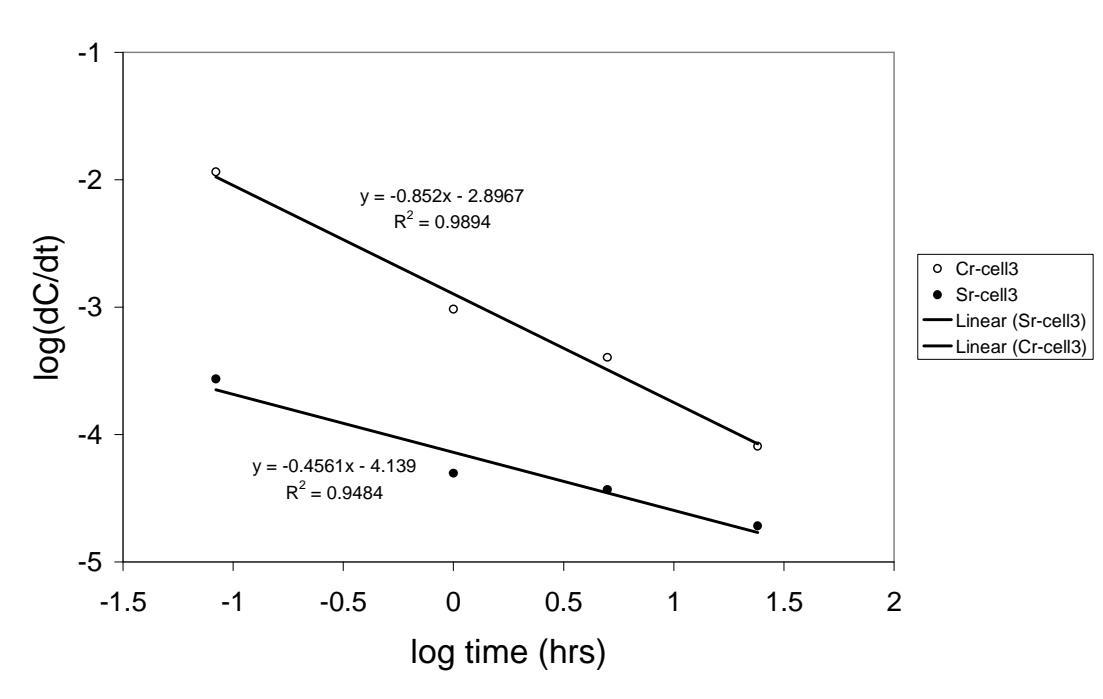
Figure 3. The leaching rate of chromium as a function of time from the cut edge of Colorbond XRW.

Chromate release from cut edges was more significant than from planar faces of Colorbond. Cell 3 contained an edge length of 64 cm. Assuming a 5 μ m thick primer, this equates to a primer area of 0.032 cm². In the first 24 hours the Cr release is estimated to be approximately 405 μ g/cm², a release that more closely matches the reported value of Scholes *et al.* [2]. The release over the first 24 hours was modeled against Fick's second law of diffusion [3], whereby a plot of log[dC/dt] (the concentration change over time) against log t gives a slope that represents the exponent of the inhibitor release. Fickian diffusion is represented by a slope equal to -0.5 (assuming a constant surface concentration of diffusing species) whilst anomalous diffusion is a collective term given to concentrations that do not change as t^{0.5}. Figure 3 shows that chromate is initially released from a cut edge with a slope of -0.85 = n-1, resulting in an exponent of t^{0.15}, indicating a rapid release of chromium. In contrast, strontium was found to release with an exponent of t^{0.55}, which is a close approximation of Fickian diffusion behaviour.

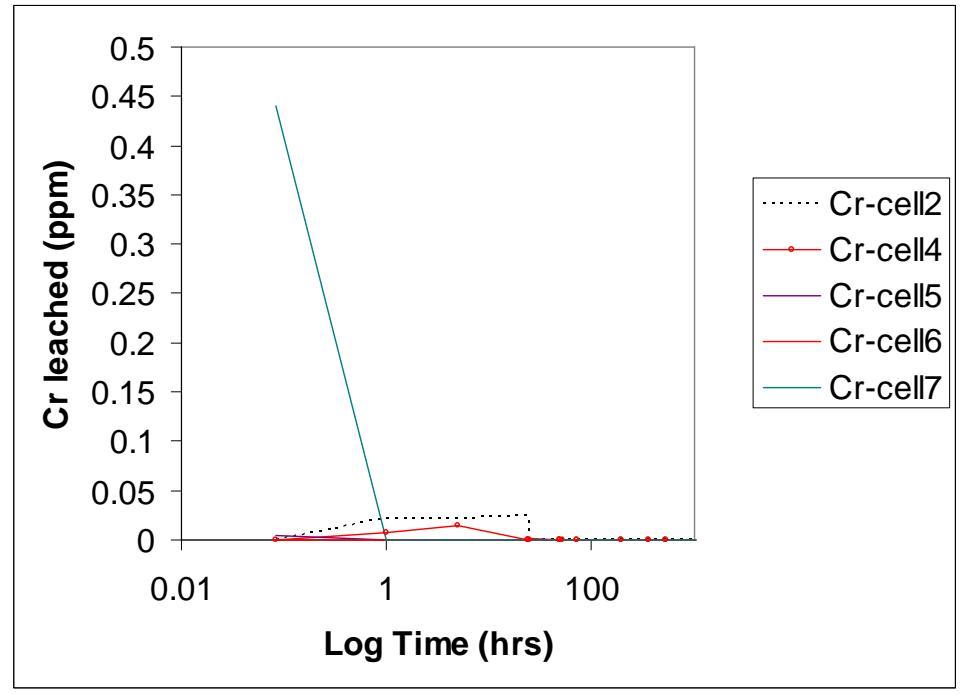
Figure 4 below shows that cell 7 (with a 2 mm diameter area of damage) produced a significant amount of soluble chromate after 5 minutes. A second sample taken after one hour showed no detectable chromium concentration. Cell 5 also showed some chromium in the initial sample but none thereafter. No soluble chromium was present on cell 6. Both cell 2 and cell 4 showed a gradual release of chromium for 5 to 24 hours, and thereafter no chromium was released into solution.

Figure 4. Leaching of chromate from paint films with various damage sites.

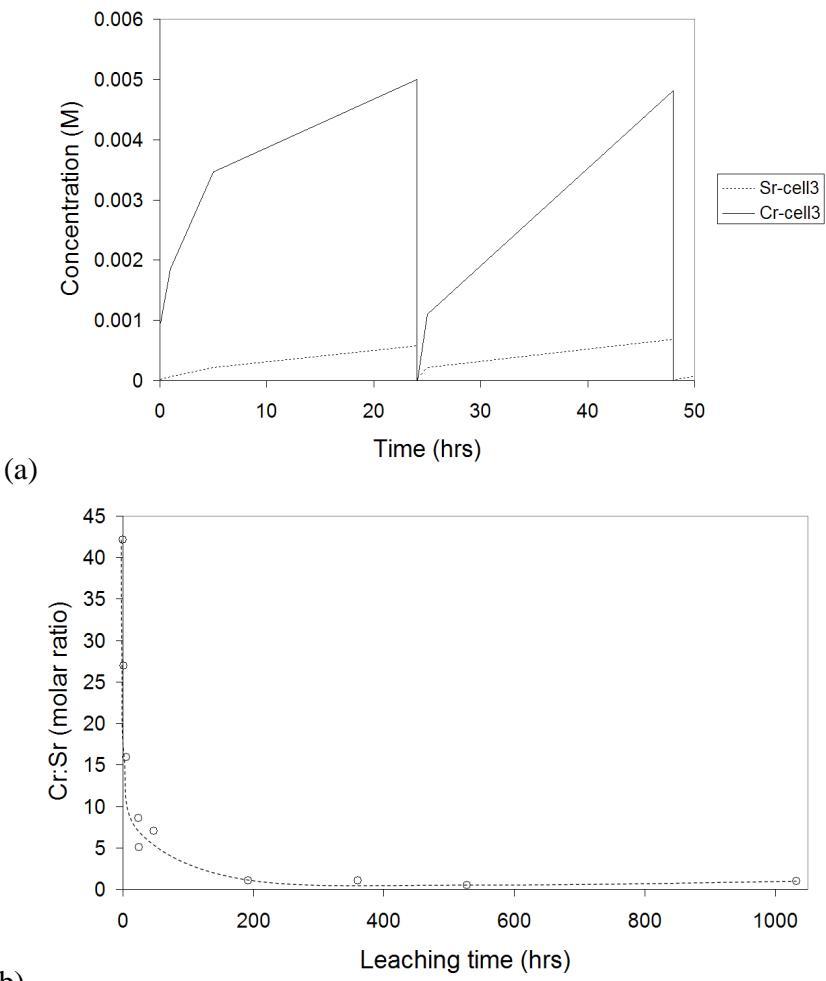
Figure 5. (a) Concentrations of Strontium and Chromium during the first 48 hours of leaching from the cut-edge of Colorbond XRW in 50 mL aqueous solution at pH 2. (b) Cr:Sr ratio for leaching from the cut-edge over a longer time period.

Strontium and zinc concentrations, unlike most other species measured by ICP analysis appeared to be unaffected by an increase in pH. Therefore, the relationships existing between strontium and chromium concentrations in the measurements taken during the first 24 hours were extended to longer time periods in order to predict longer-term chromate concentrations. SrCrO₄ should ideally be dissolved to give a 1:1 ratio of Cr:Sr, however, as Figure 5 shows the initial release of chromium is significantly higher than for strontium. For the cut edge, the 1:1 ratio is obtained after longer leaching times, approximately greater than 300 hours.

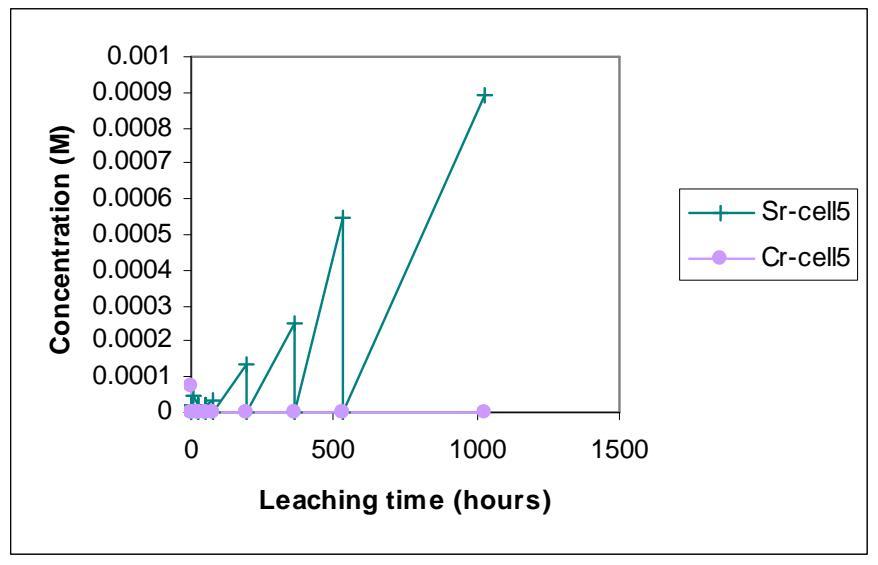
Figure 6. Leaching data for strontium and chromium from cell 5 (topcoat with pinhole defects) as a function of leaching time. Note that a return to zero concentration occurs when the pH 2 leaching solution is refreshed.

Estimations for the rate of chromate leaching were obtained from strontium chromate leaching data, which showed consist changes in concentration as a function of time, as shown in Figure 6.

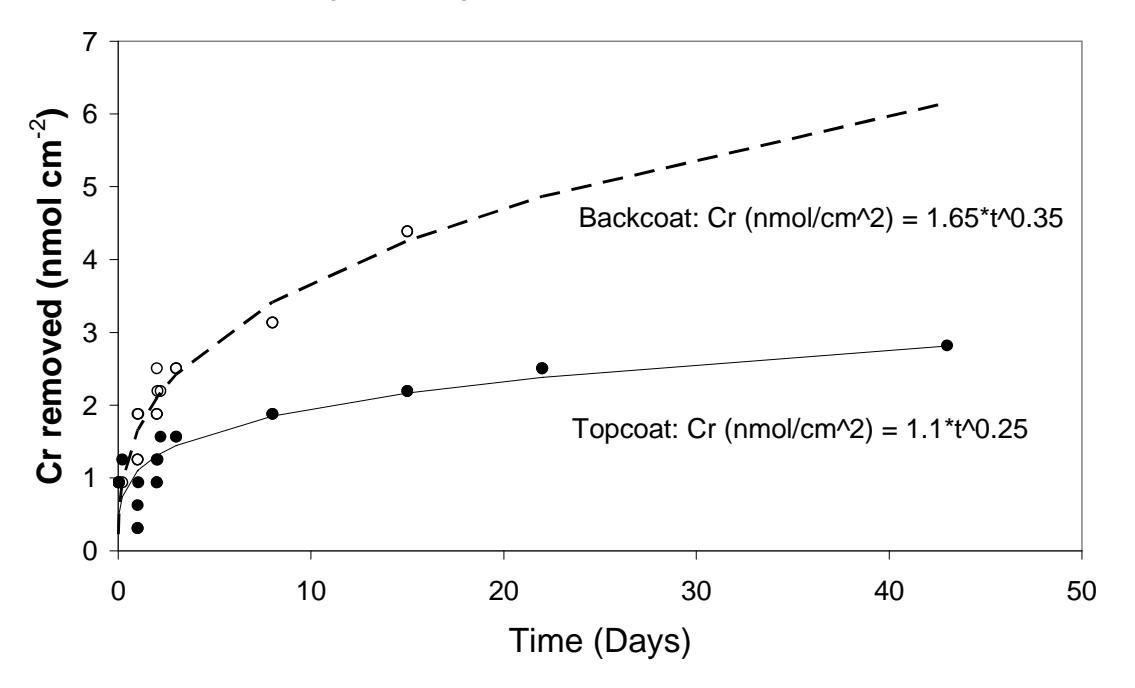
Figure 7. Chromium concentrations removed from Colorbond after short time periods and those estimated from strontium ion concentration after longer time periods.

The rate of chromate depletion from a damaged topcoat (with pinholes according to Cell 5) and undamaged backcoat of Colorbond materials was determined for the first 24 hour period, after which it was estimated from the solution concentrations of strontium ions. The resultant dependence upon time is given in Figure 7.

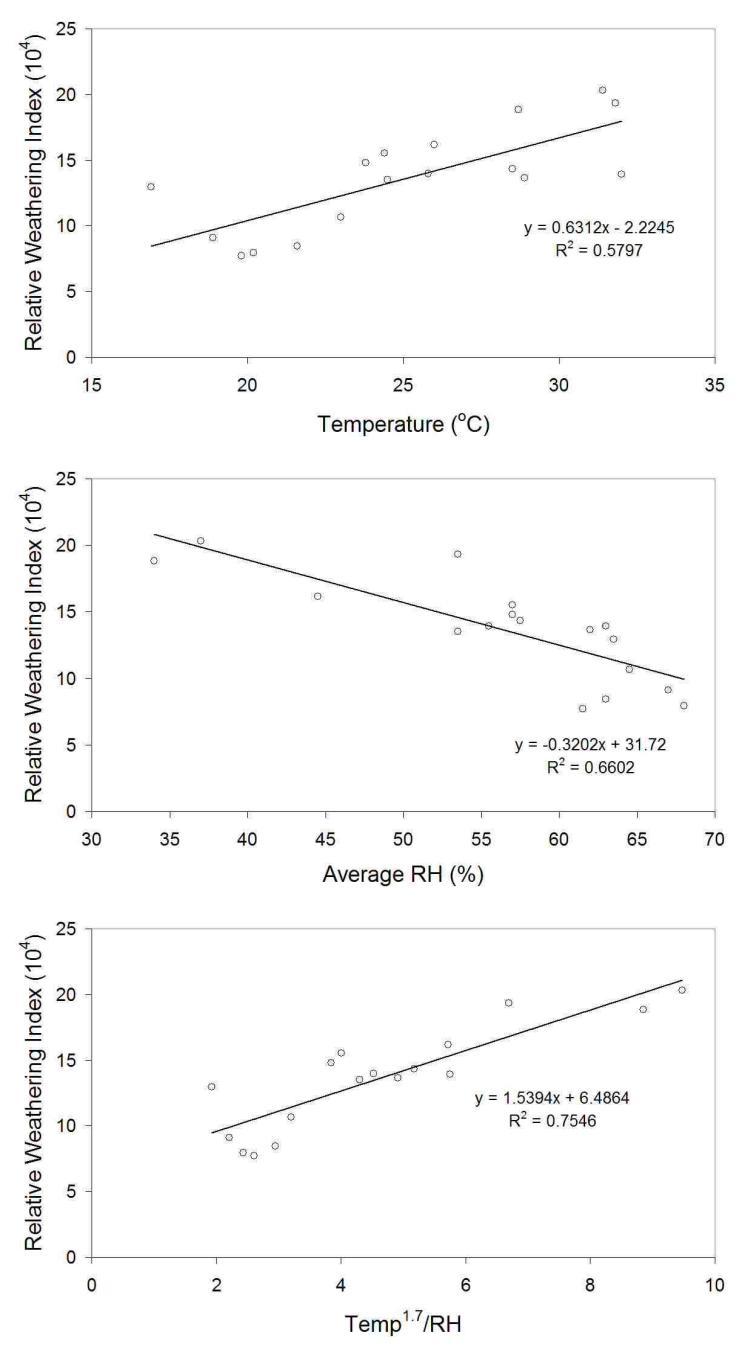
Figure 8. Relationships between simple climatic parameters (average daily maximum temperature and average daily relative humidity [9am and 3pm]) and the solar weathering index of Martin [5].

Figure 8 shows the dependence of the solar weathering index on average maximum daily temperature, average relative humidity (9am and 3pm) and a combined variable of average maximum daily temperature^k/average relative humidity (T^k/RH, which has an optimised regression of 0.75 where k = 1.7).

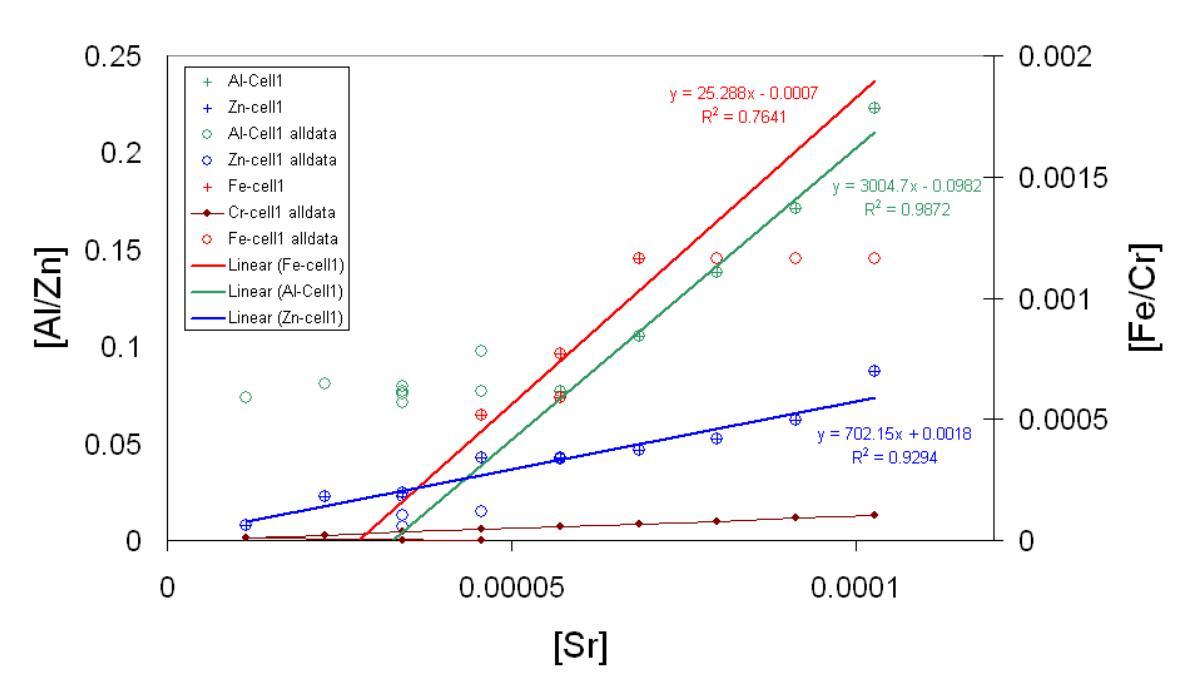
Figure 9. Correlations between the concentration (in mol L-1) of strontium released into solution and those of zincalume and steel in aqueous solution acidified to pH 2 using HCI.

Where $(Cr_t \times 0.0643)$ accounts for the loss of zinc, $(Cr_t \times 0.3)$ accounts for the loss of aluminium and the remainder of the equation is the scaling factor that links the rate of zincalume loss from laboratory tests in 0.01 M chloride to the daily average salinity in the field (mg/m².day). Figure 9 below demonstrates the correlation between strontium chromate removal and that of the underlying zincalume and steel.

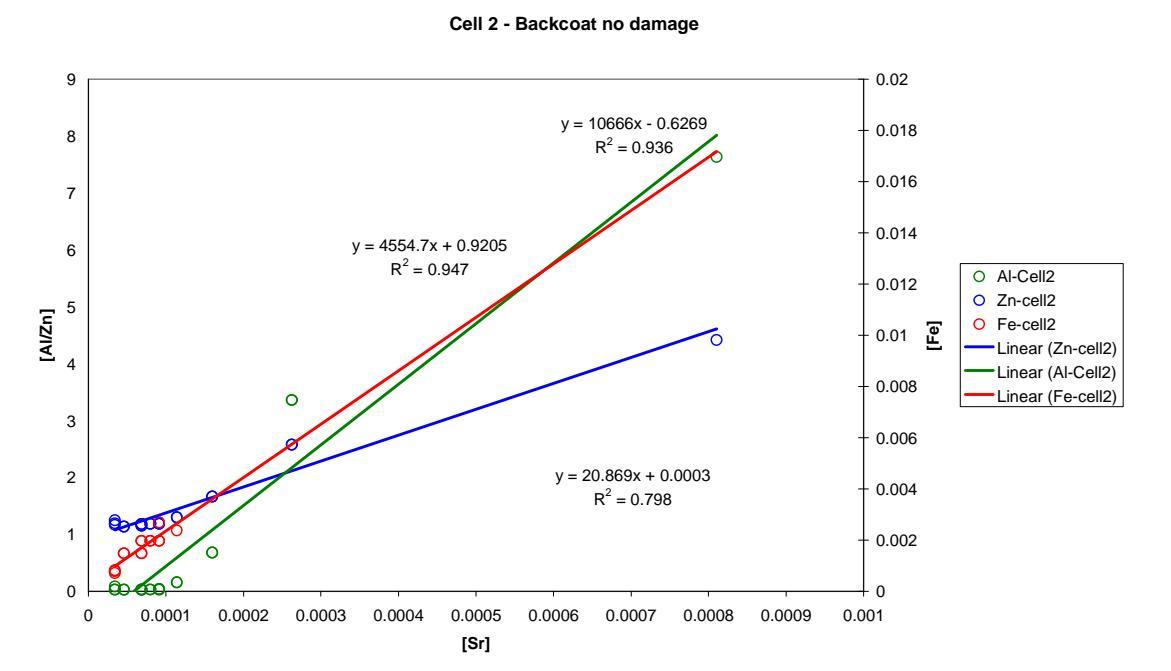
Figure 10. Correlations between the concentration of strontium released into solution and those of zincalume and steel in aqueous solution acidified to pH 2 using HCI.

Figure 10 below demonstrates the correlation between strontium chromate removal and that of the underlying zincalume and steel.

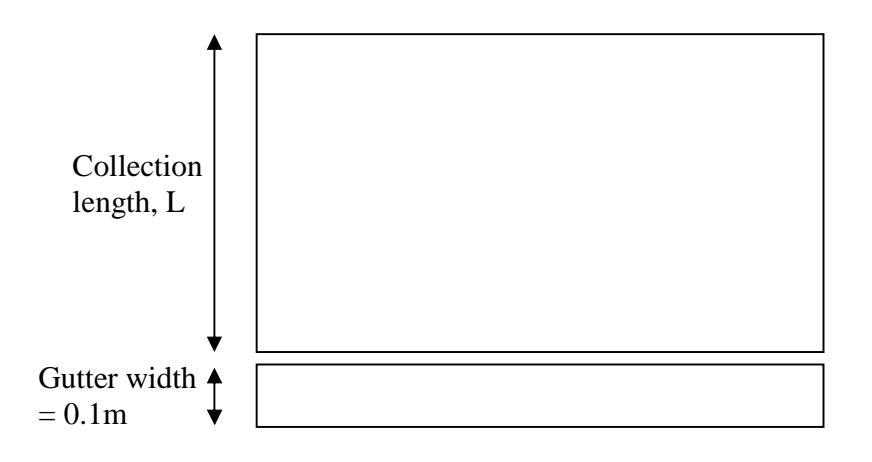
Figure 11. The relationship between roof area and gutter area. Roof area = L/0.1 (or 10 × L) times the gutter area.

The accumulation of salt in gutters is modeled by assuming that all salt entering the gutters has its origins from the roof. As figure 10 demonstrates, the amount of salt being deposited onto a roof (mg/m^2) can be translated to a salt concentration within the gutter with knowledge of the volume of moisture runoff (mm) and the collection length of the gutter (L). The width of the gutter is assumed to be 0.1 m.

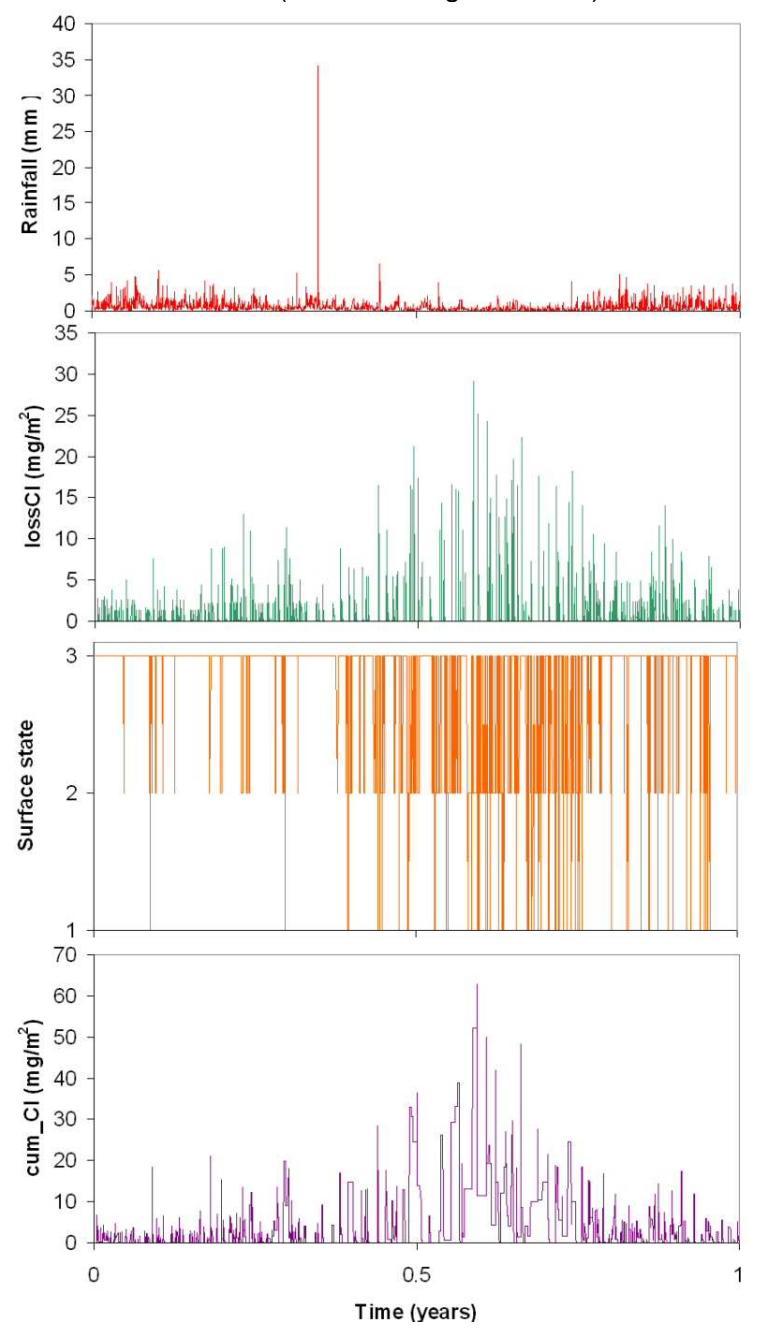
Figure 12. Estimations of the accumulation of salt in gutters at Brookfield State School calculated from rainfall runoff and accumulation using the old model.

An example of the performance of the model is given by the calculated data for Brookfield State School in Queensland (152.913, -27.495). Figure 12 shows the data inputs of rainfall, chloride loss (from the roof), the surface state (old model) and accumulated chloride (cum_Cl using old model).

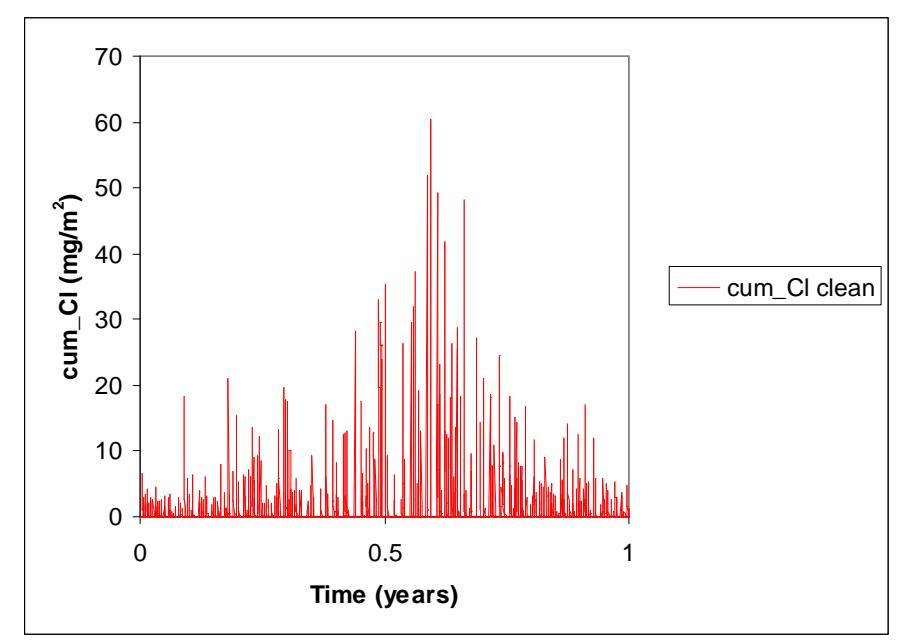
Figure 13. Accumulated chloride in a clean gutter over a one year period predicted using the revised methodology and assuming a collection length of 5m.

Figures 13 and 14 show the revised chloride accumulation for clean and dirty gutters, respectively.

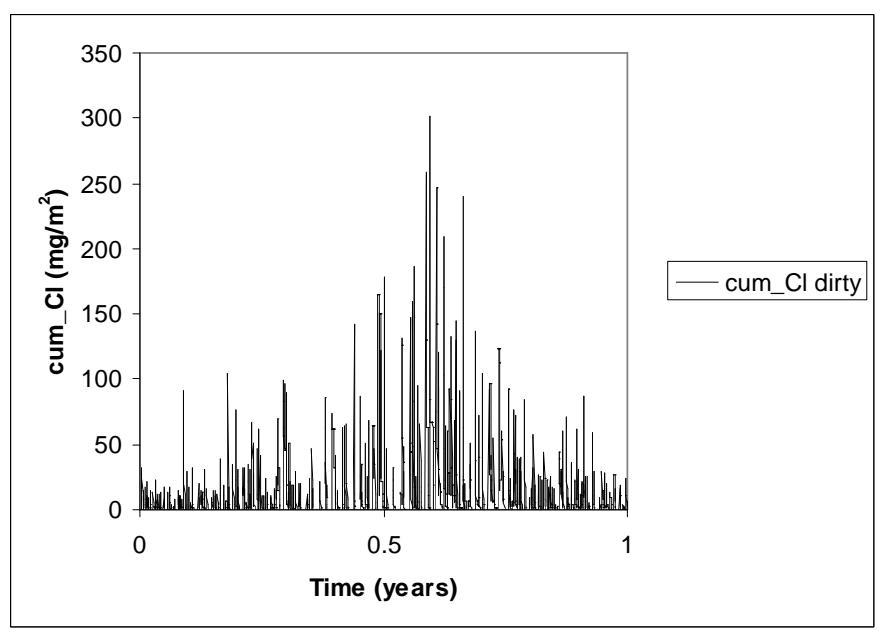
Figure 14. Accumulated chloride in a dirty gutter over a one year period predicted using the revised methodology and assuming a collection length of 5m.

There is a large different in the levels of accumulated salt in gutters. The old model has an average accumulated salt concentration of 10.7 mg/m^2 whilst the new model

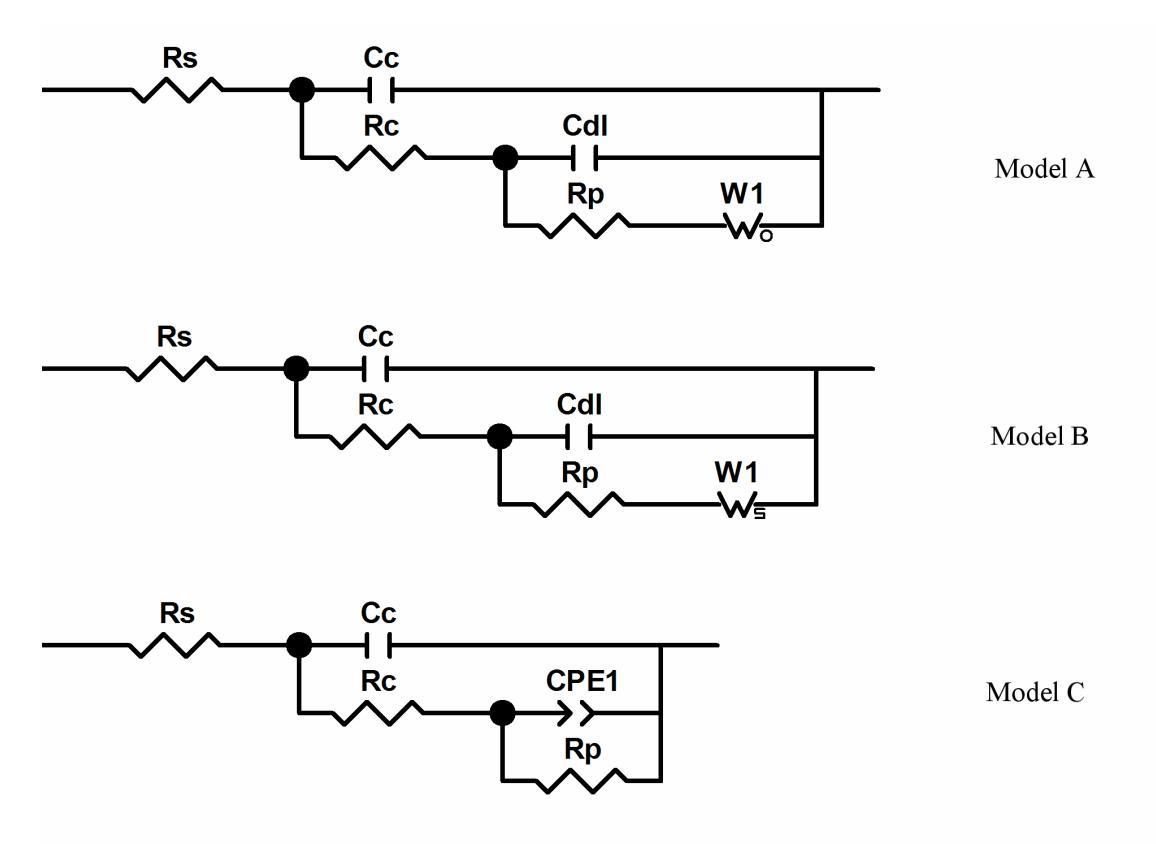
Figure 15. Common equivalent circuits used to describe a metal-coating-solution interface using EIS measurements.

The data generated from EIS measurements was fitted to a common equivalent circuit for a metal-paint-electrolyte system. The models were considered to be relevant to the Colorbond system: A, B and C, in Figure 15.

Model 'C' was chosen as a standard analysis for the performance of coatings.

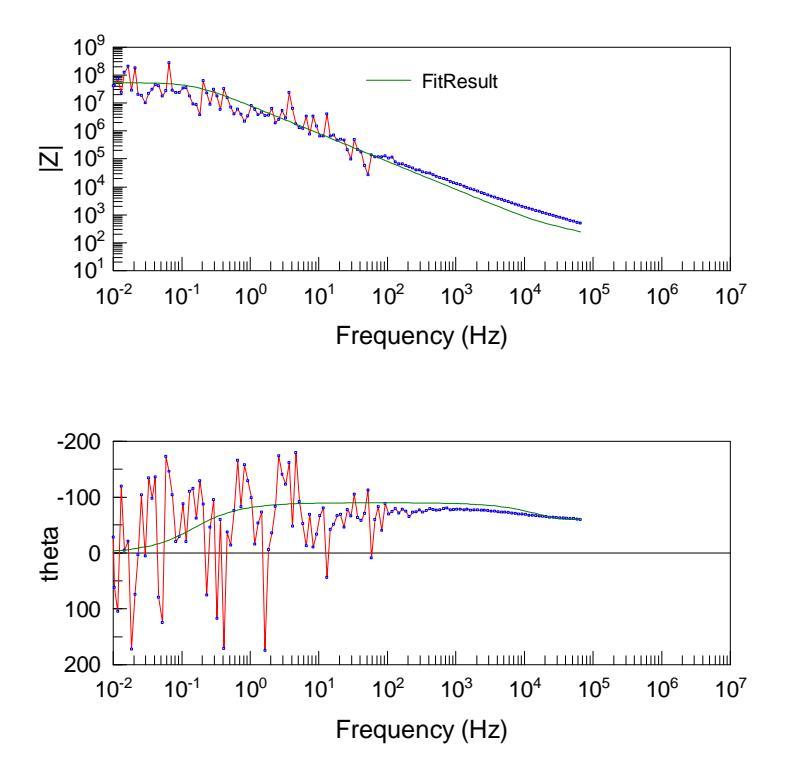
Figure 16. Typical fit of data to model 'C'. $R_s = 29.5 \Omega$, $C_c = 8.45 \times 10^{.9}$ F, $R_c = 585.2 \Omega$, CPE-T = $C_{dl} = 1.11 \times 10^{.8}$ F (where CPE-P = 1) and $R_p = 5.34 \times 10^7 \Omega$. Surface area = 18.4 cm².

At the interface between the electrode and the counter electrode an electrical doublelayer exists, which creates a capacitive impedance. Normal values for the capacitance are of the order of 30 μ F cm⁻², although these values are highly dependent upon the characteristics of the metal. Figure 16 shows typical data for an undamaged topcoat.

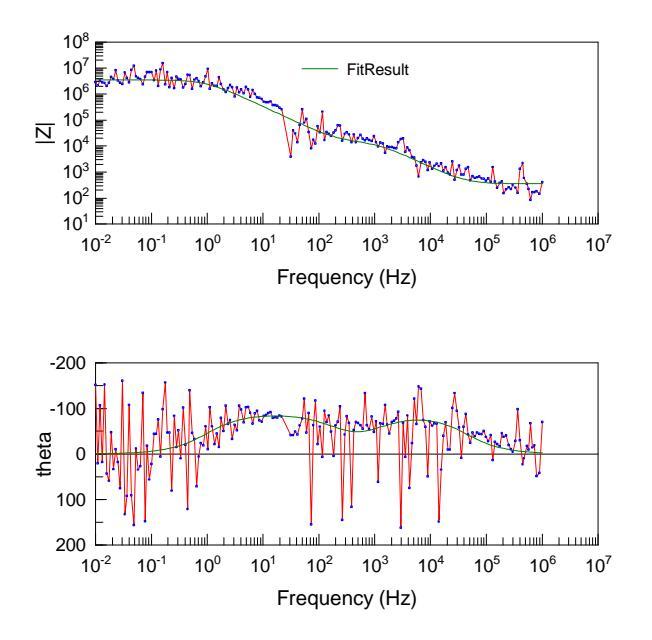
Figure 17. Typical fit of data to model 'C'. $R_s = 358.5 \Omega$, $C_c = 1.038 \times 10^{-8} F$, $R_c = 18930 \Omega$, CPE-T = $C_{dl} = 3.74 \times 10^{-8} F$ (where CPE-P = 1) and $R_p = 3.42 \times 10^6 \Omega$. Surface area = 12.6 cm².

The undamaged backcoat was analysed according to model 'C', as shown in Figure 17.

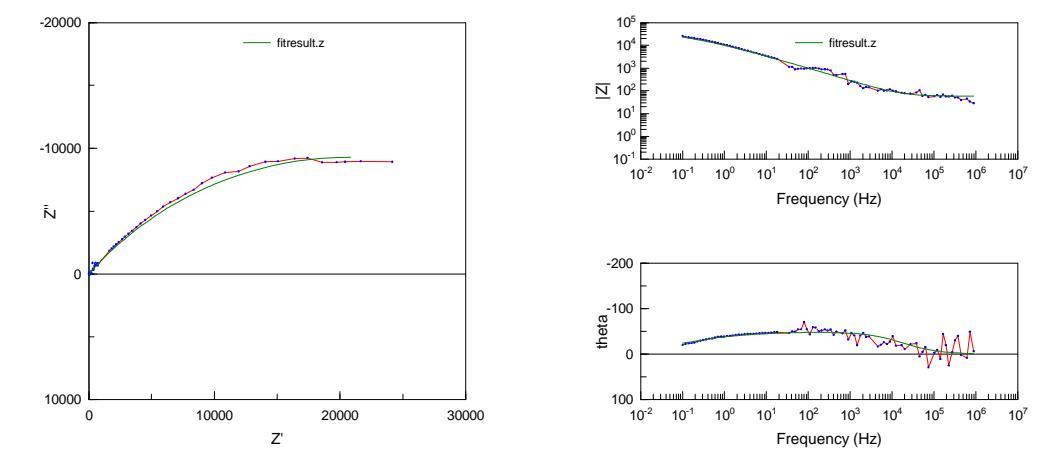
Rs(+)	Cc(+)	Rc(+)	CPE1-T(+)	CPE1-P(+)	Rp(+)	Estimated Icorr (A cm- 2)
Brookfield	58.44	1.38E-07	3.508	3.07E-05	0.5352	41384	7.59132E-06

FigureA1. Left: Nyquist plot, Right (top): Bode plot, Right (bottom): Phase plot.

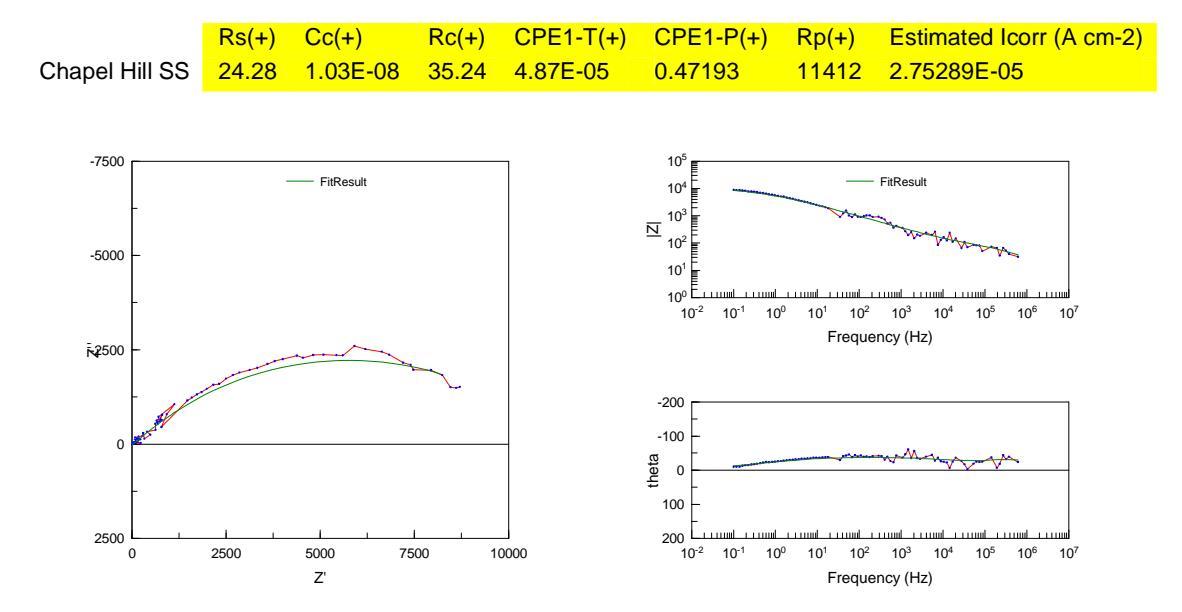
FigureA2. Left: Nyquist plot, Right (top): Bode plot, Right (bottom): Phase plot.

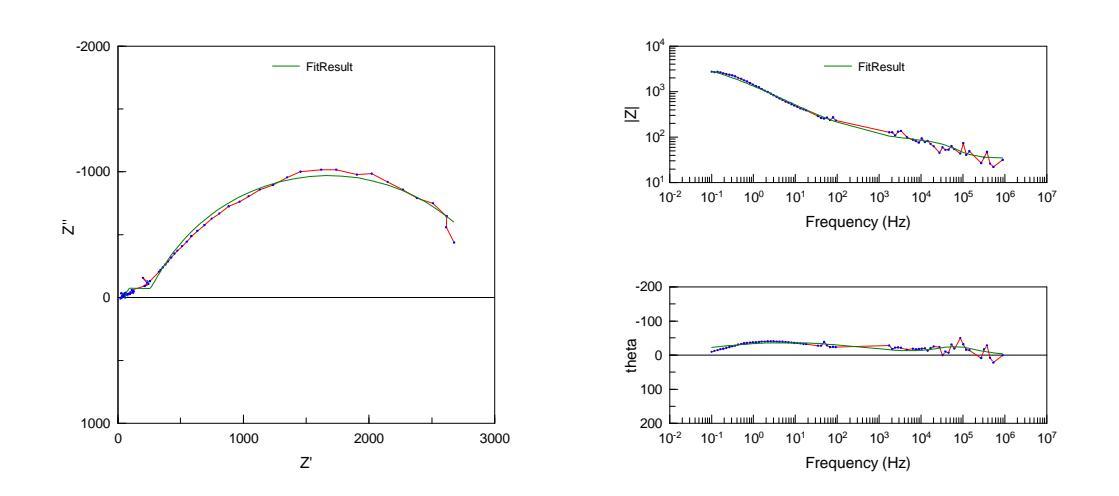
FiguresA3. Left: Nyquist plot, Right (top): Bode plot, Right (bottom): Phase plot.

Latitude: 27°26'53.51S Longitude: 152°57'05.81E Product: Colorbond backcoat Age: 9 years. State: Near the down pipe of a gutter full of leaves. Wet for the majority of time. There was visible damage to the backcoat, with approximately 30 % coating loss.

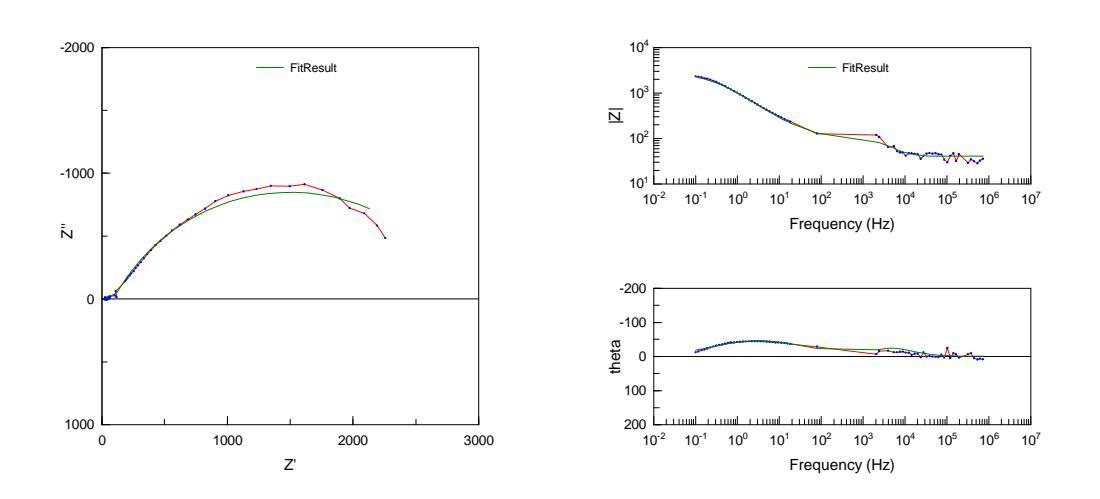
FigureA4. Left: Nyquist plot, Right (top): Bode plot, Right (bottom): Phase plot.

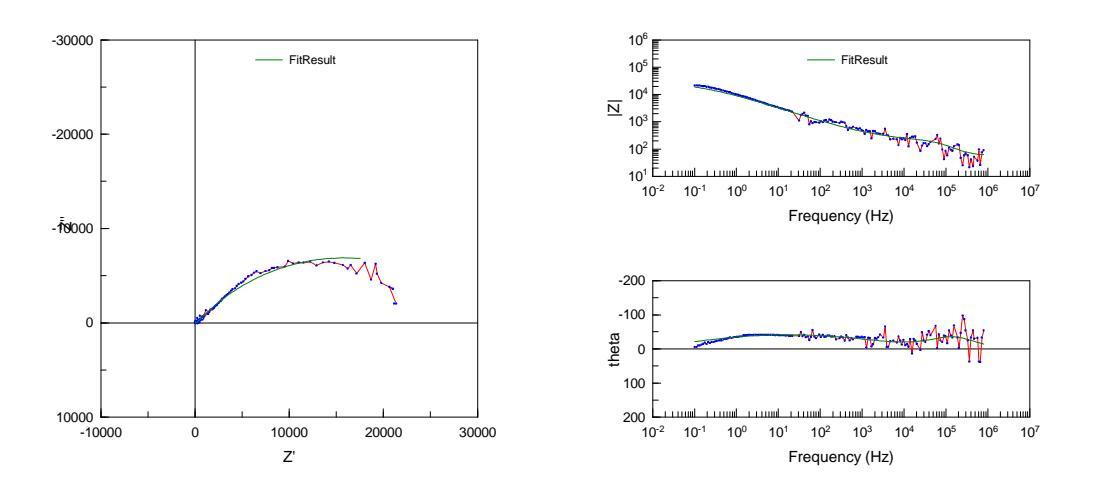
FigureA5. Left: Nyquist plot, Right (top): Bode plot, Right (bottom): Phase plot.

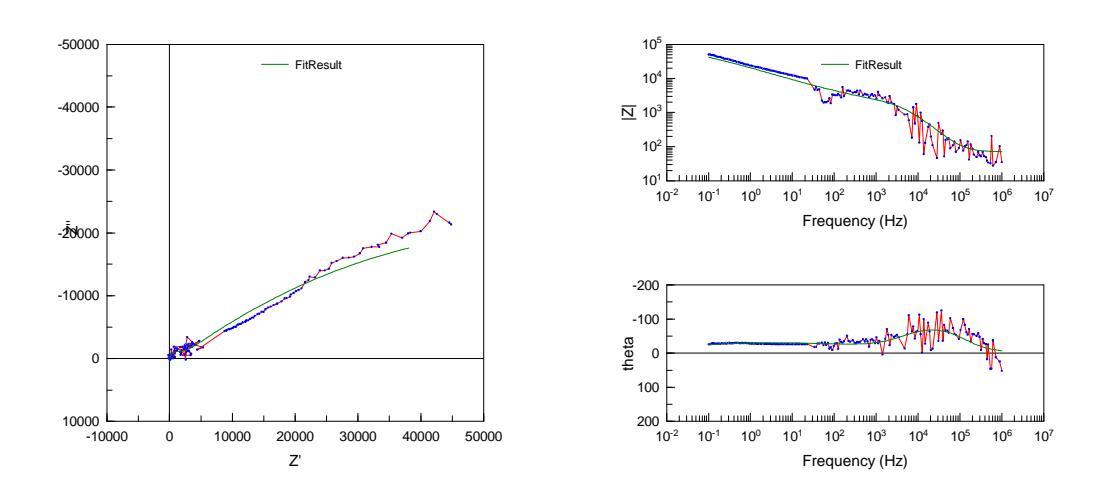
FigureA6. Left: Nyquist plot, Right (top): Bode plot, Right (bottom): Phase plot.

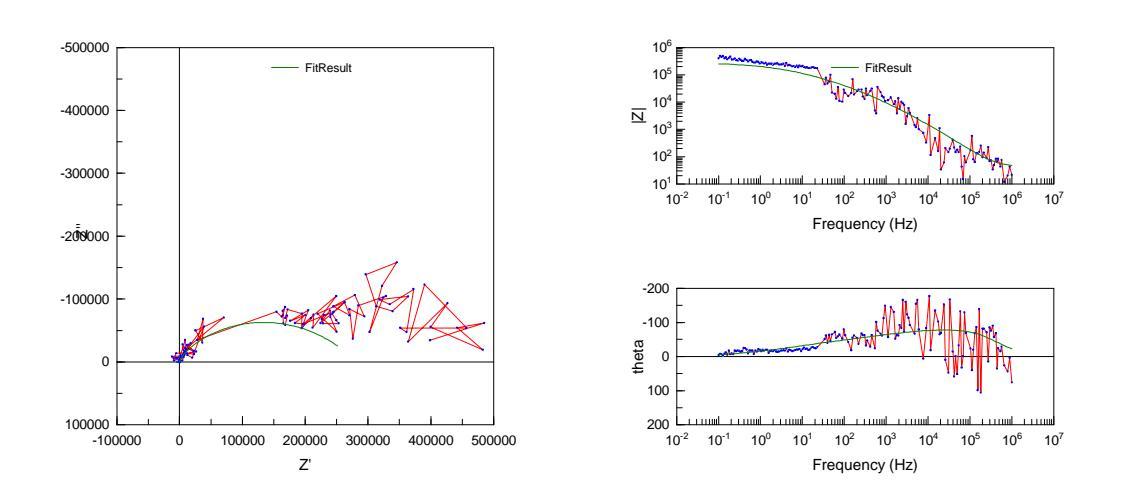
FigureA7. Left: Nyquist plot, Right (top): Bode plot, Right (bottom): Phase plot.

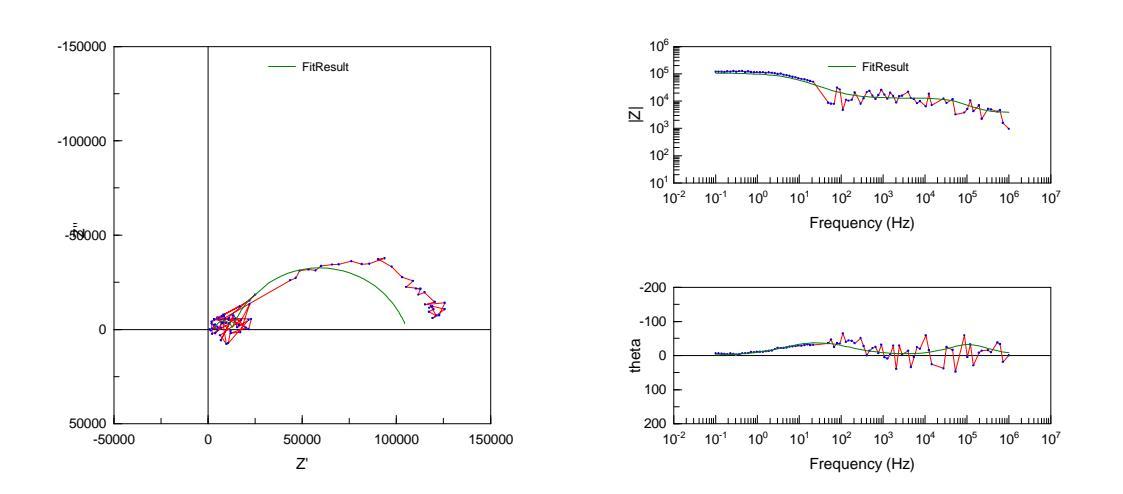
FigureA8. Left: Nyquist plot, Right (top): Bode plot, Right (bottom): Phase plot.
