Trip to Sunshine Coast Queensland, September 2004 Visit to Schools

Report No 2002-059-B No 7

Research Program: B Program Name Environmental Sustainability Research Project No.: 2002-059-B Project Name Case Based Reasoning in Construction and Infrastructure Projects

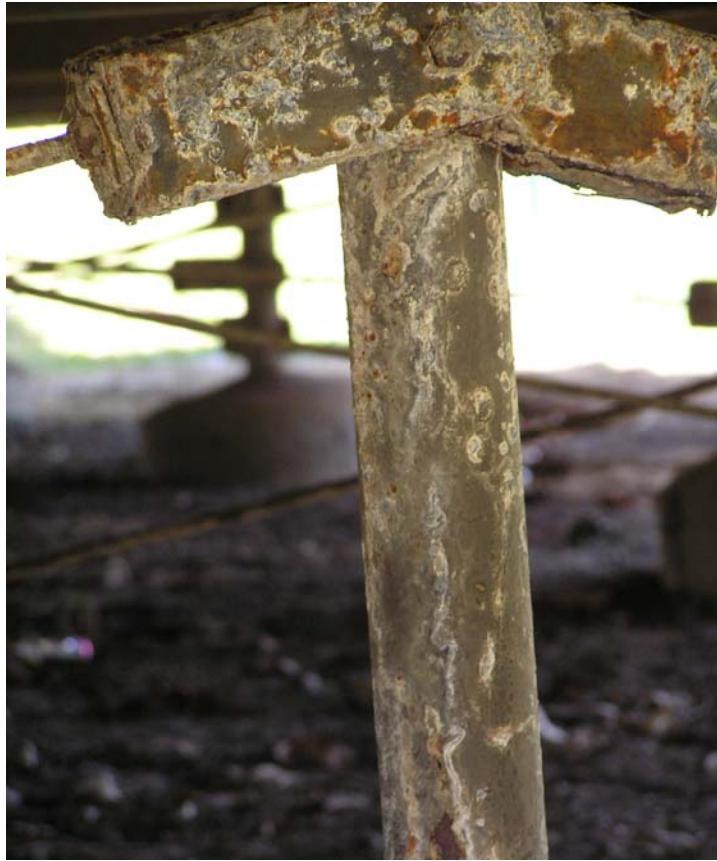
Figure 9 Stump support of Modular 1.

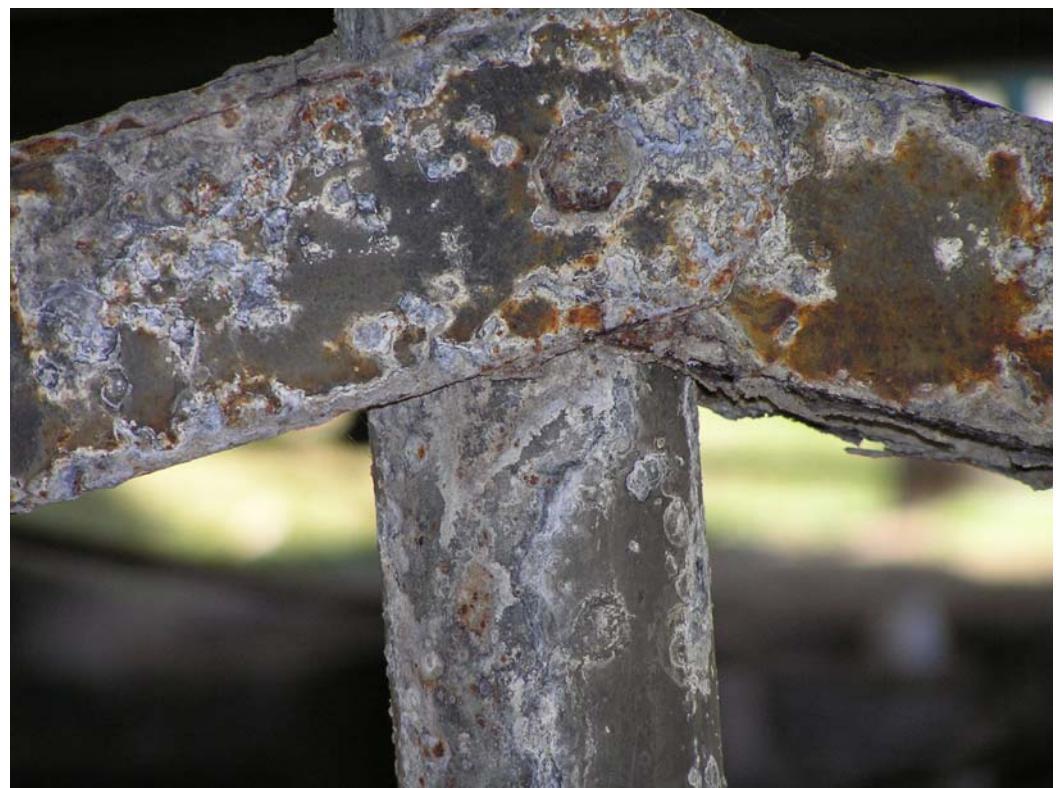
Figure 10 Close up of stump of Modular 1.

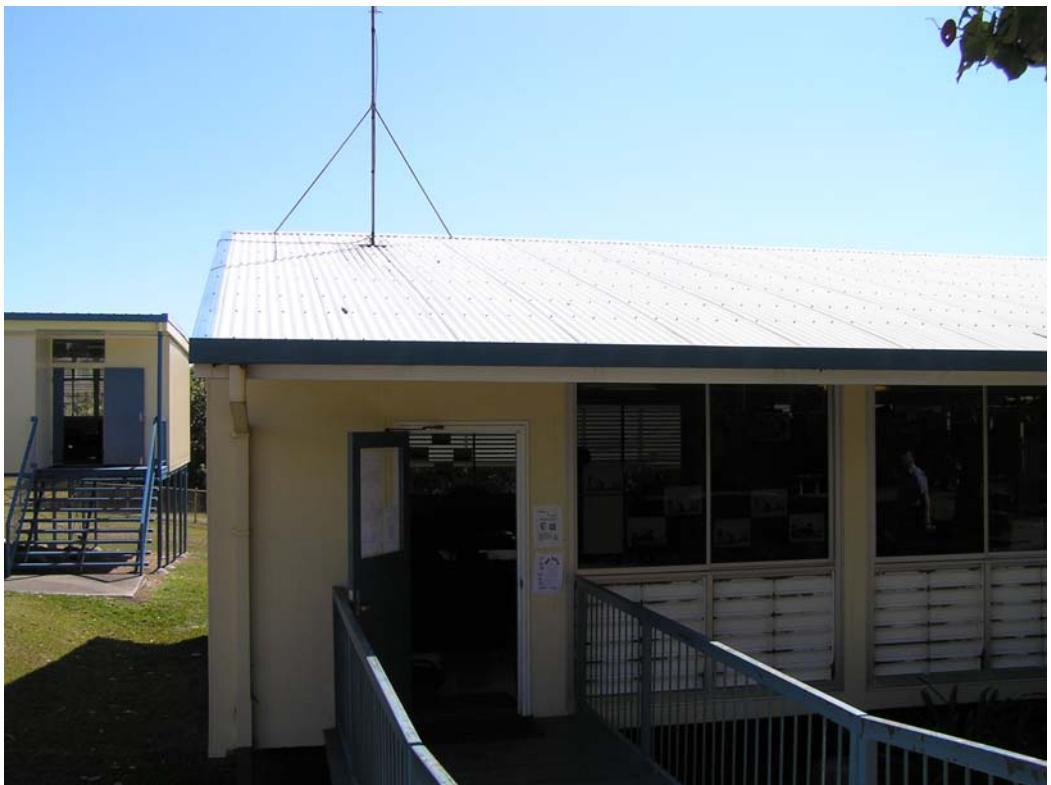
Figure 11 West end of roof of Modular 1.

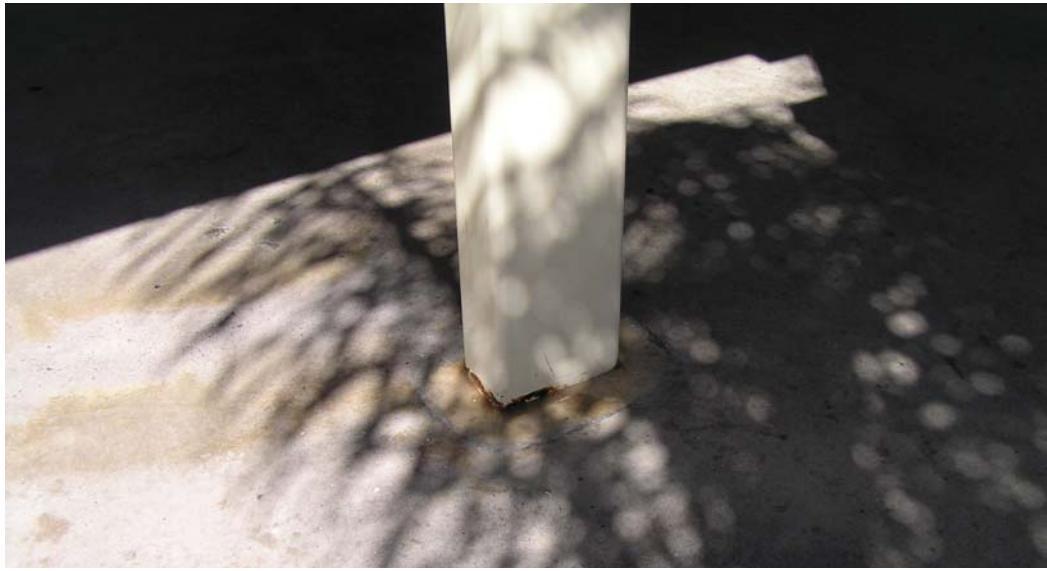
Figure 15 Footing of steel support showing red corrosion product.

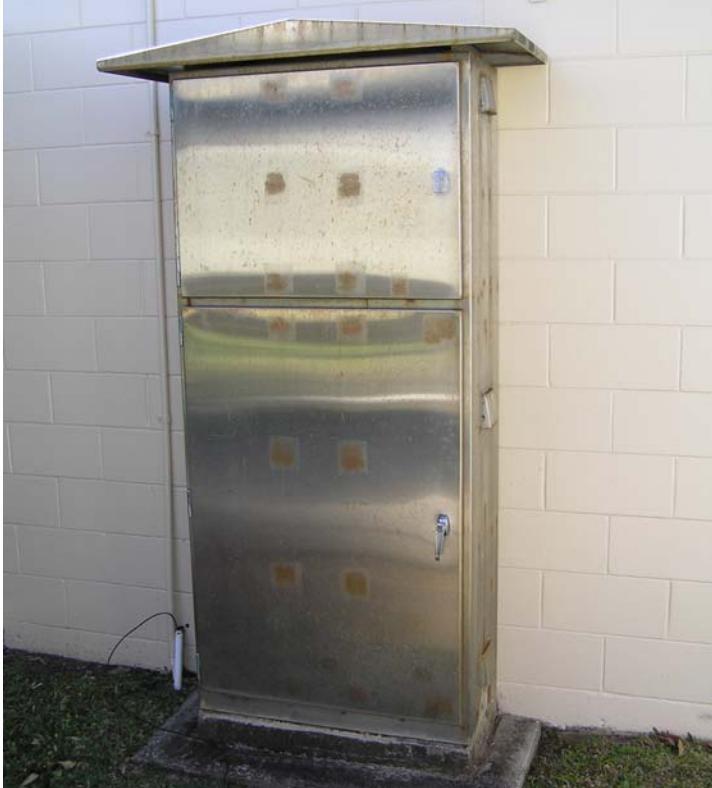
Figure 23 Stainless steel equipment box showing signs of rust where signs were affixed with tape.

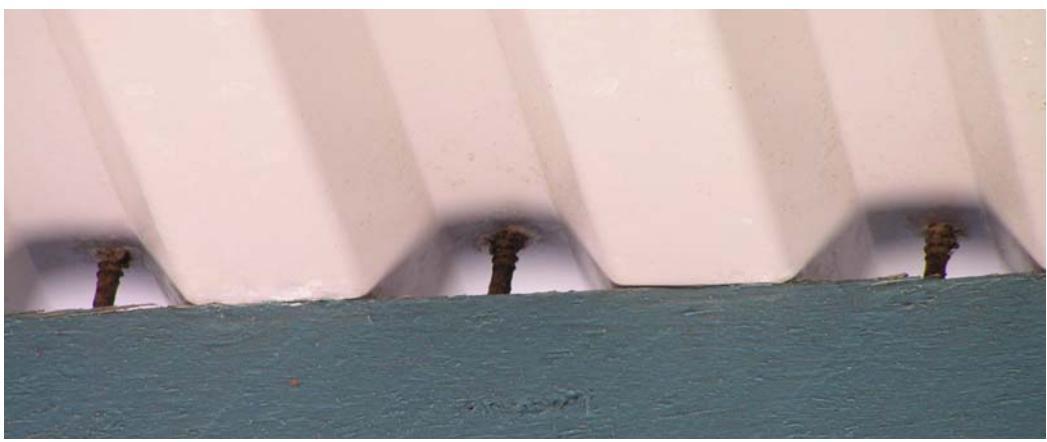
Figure 27 Covered walkway, fastener shanks are red rust and undercutting seen on Colorbond sheeting.

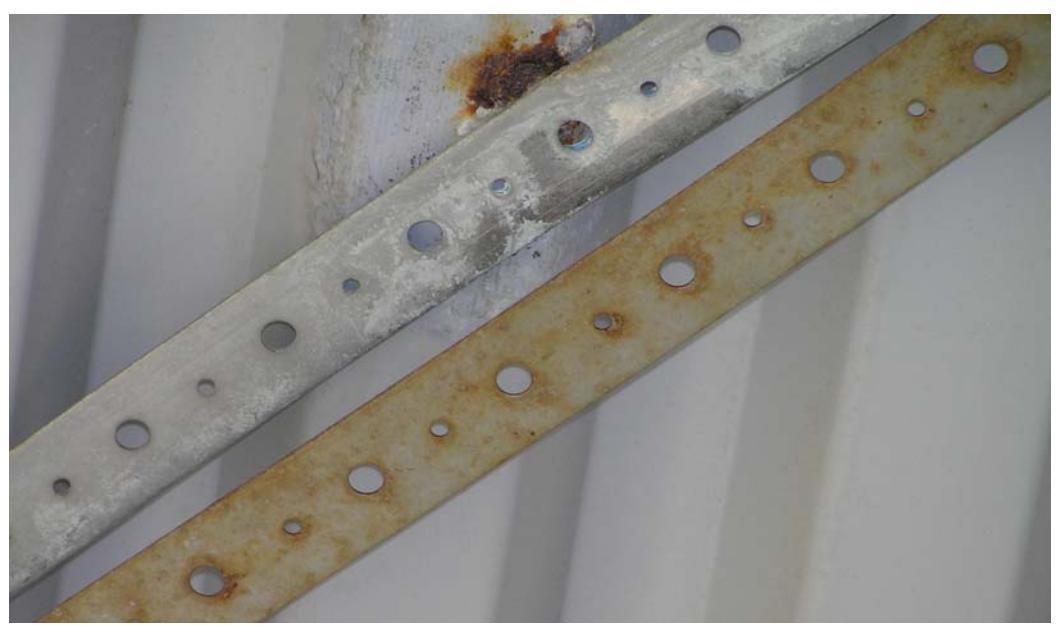
The following figures show an attempt at building with more corrosion resistant components but actually causing additional problems. Stainless steel strapping was used in the construction of the Covered set down but it is in contact with the Colorbond roof sheeting. The strap that is not in contact is corroding and the strap in contact with the Colorbond is causing the Colorbond to corrode. The Colorbond is showing significant red rust and will in the near future if it hasn't already, corrode through. This could have been avoided by making sure the strapping did not touch the Colorbond sheeting.

Figure 31 Close up showing red rust of stainless steel strapping not in contact with roof sheeting and red rust on roof sheeting where stainless steel strapping is in contact.

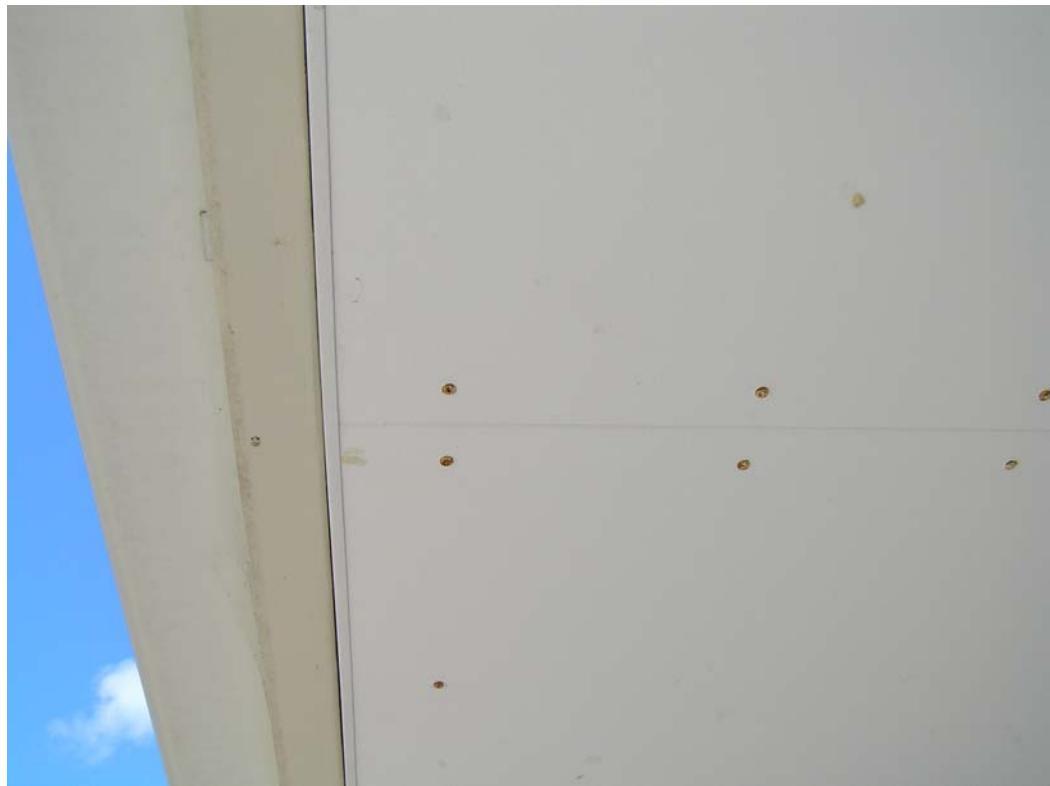
Figure 37 Fasteners in sheeting on porch of Administration Block.

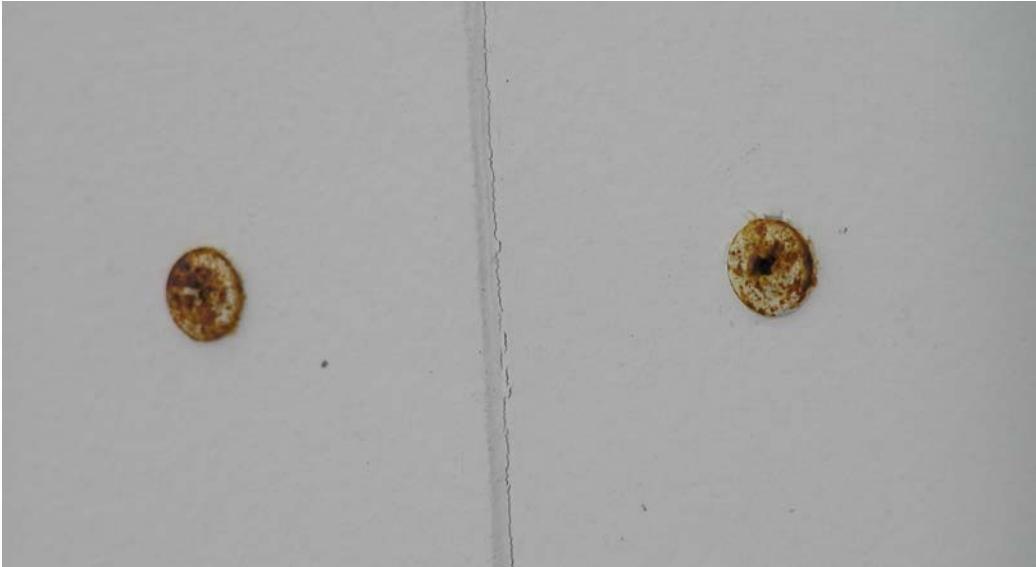
Figure 38 Close up of Fasteners in sheeting on porch of Administration Block.

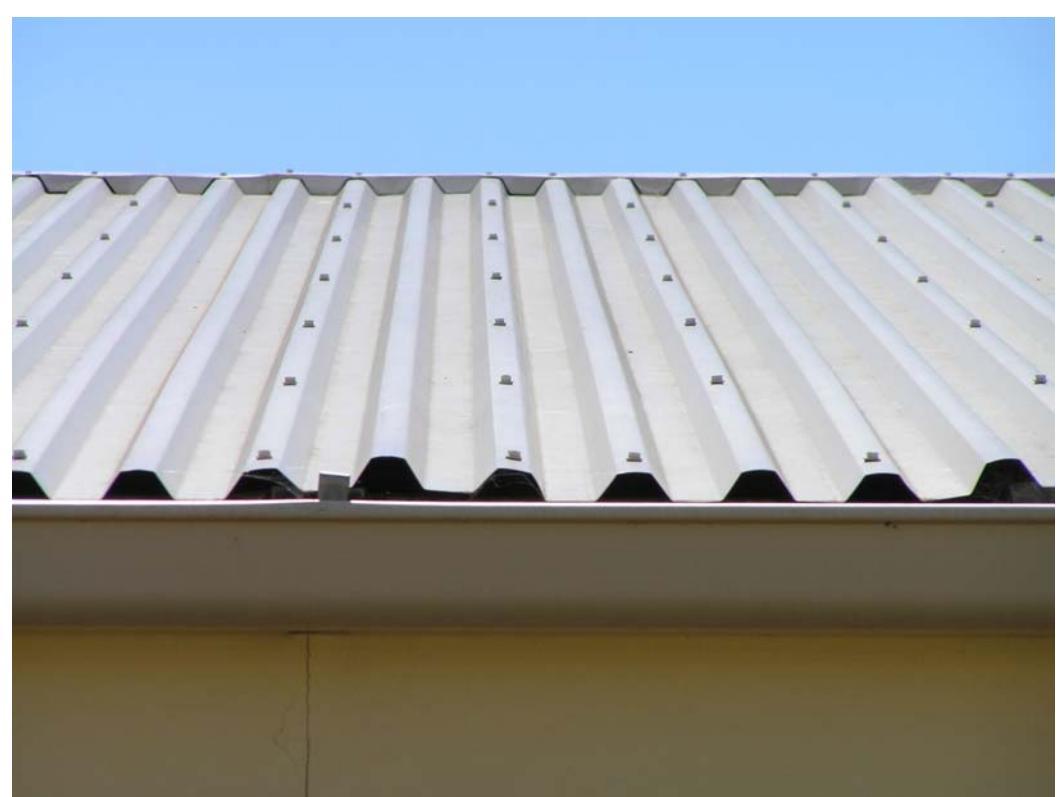
Figure 46 Roof of building, heads of fasteners and roof in good condition.

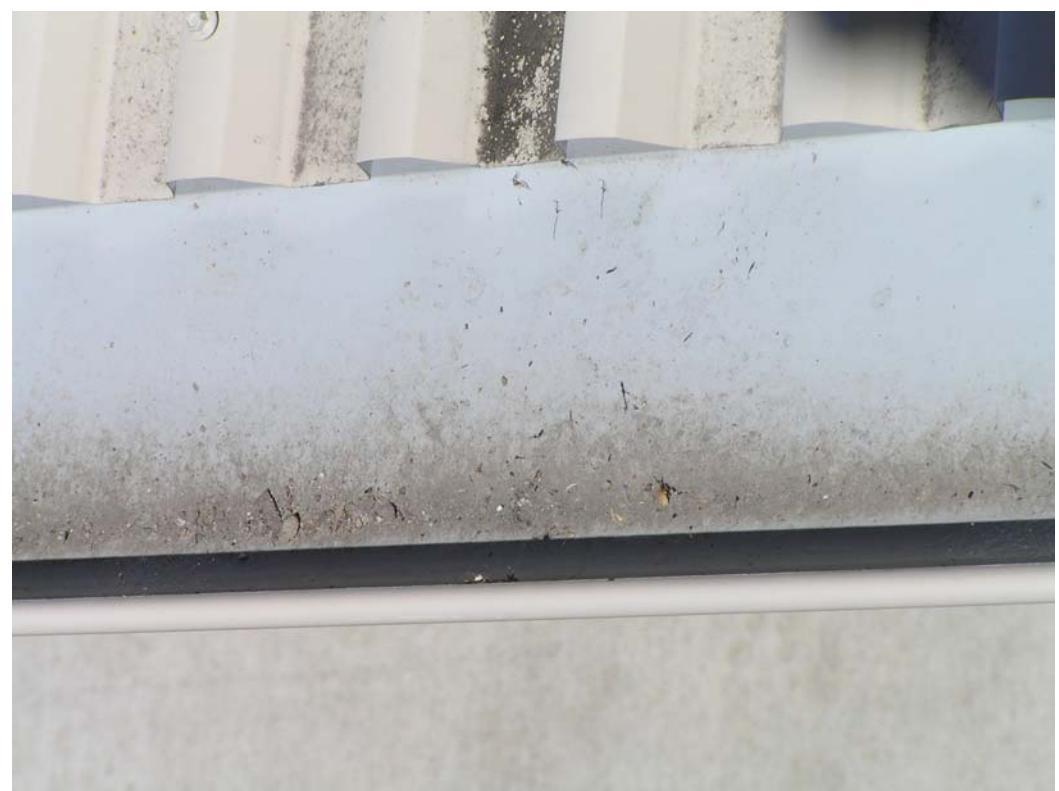
Figure 49 Inside gutter of walkway from block E.

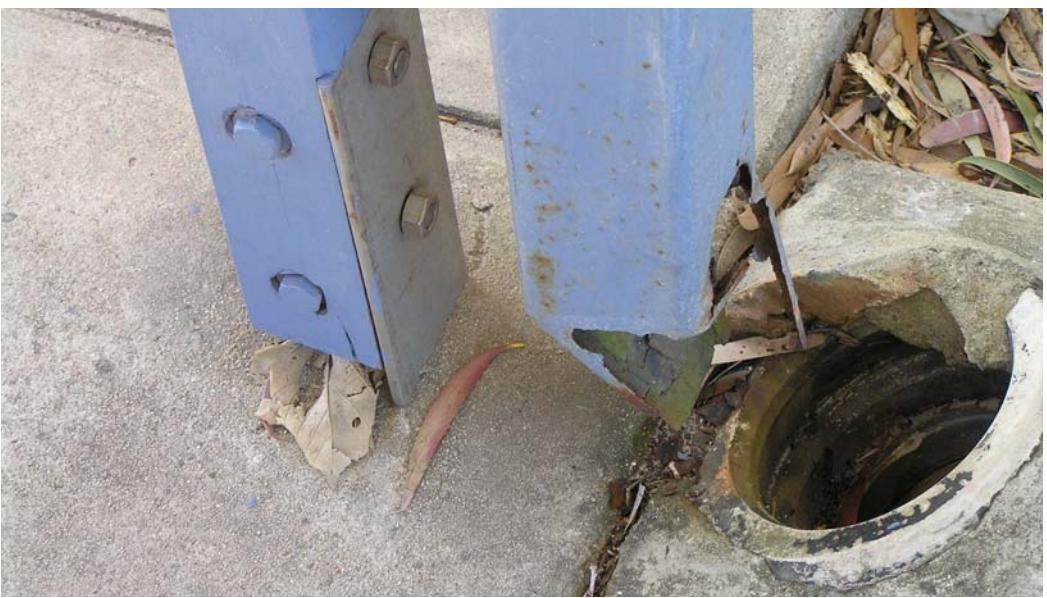
On some covered walkways square section steel was used as downpipes. It is assumed the steel was used as standard downpipes would be destroyed by the students. It can be seen in the following figures that the painted steel is corroding from the inside out.

Figure 65 Bottom of square section, steel completely rusted away.

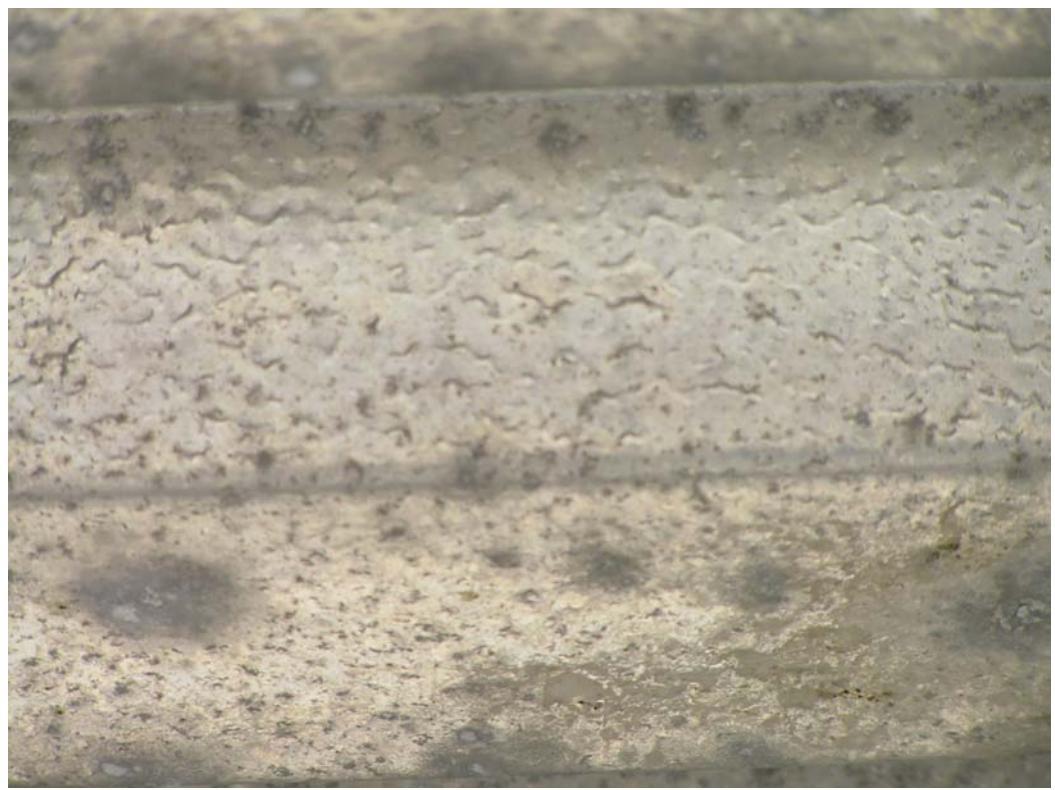
The aluminium sheeting used on the walkways looked ok on the exposed outer surface but underneath there was significant corrosion. It looked like galvanised fasteners were used to fasten the sheeting and these where corroded on the heads, some to 100% red rust. The shanks of all the fasteners where heavily corroded.

Figure 69 Close up of underside of aluminium roof sheeting of covered walkway.

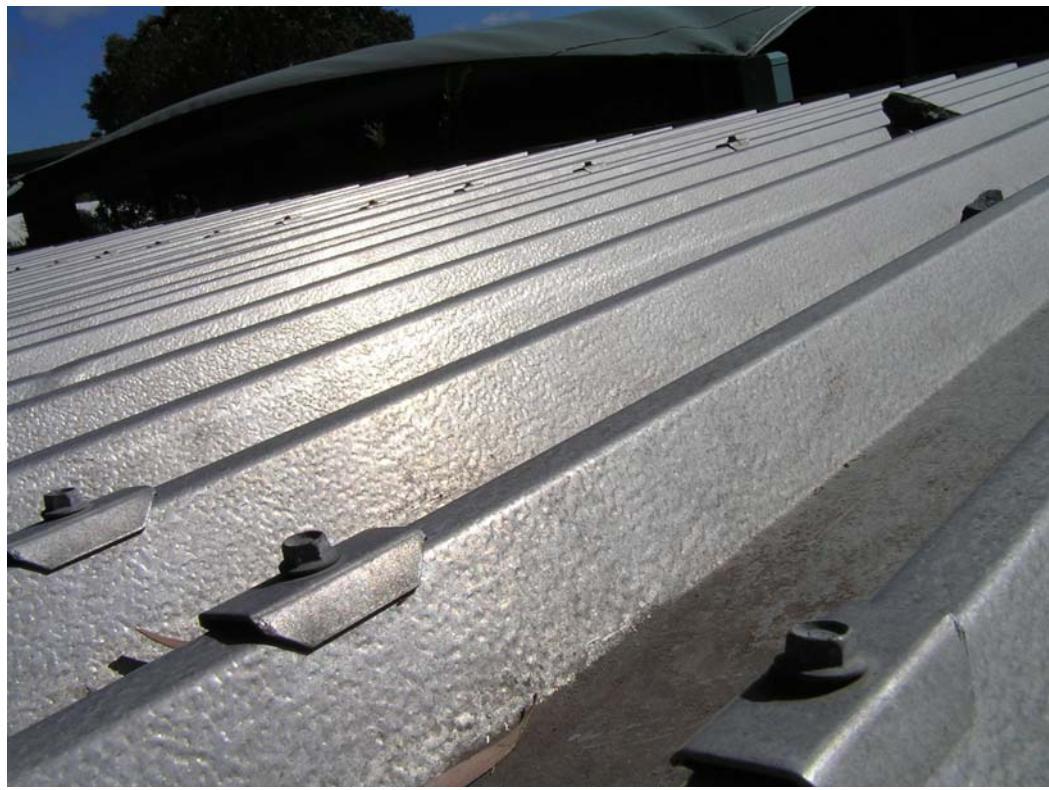
Figure 73 Exposed surface of aluminium walkway in good condition, note cyclone plates.

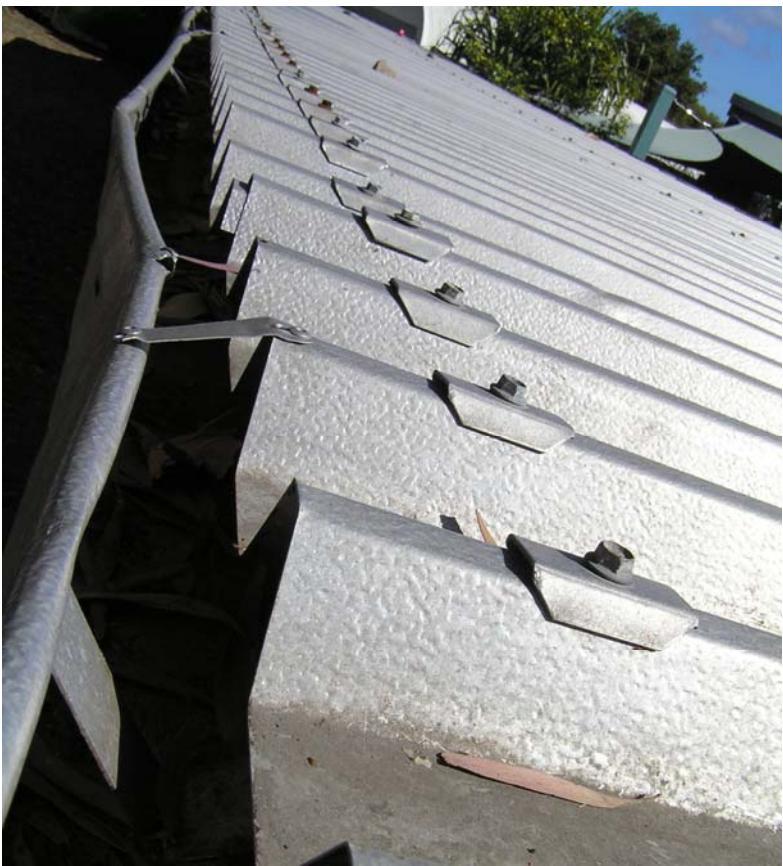
Figure 74 Exposed surface of aluminium walkway in good condition.

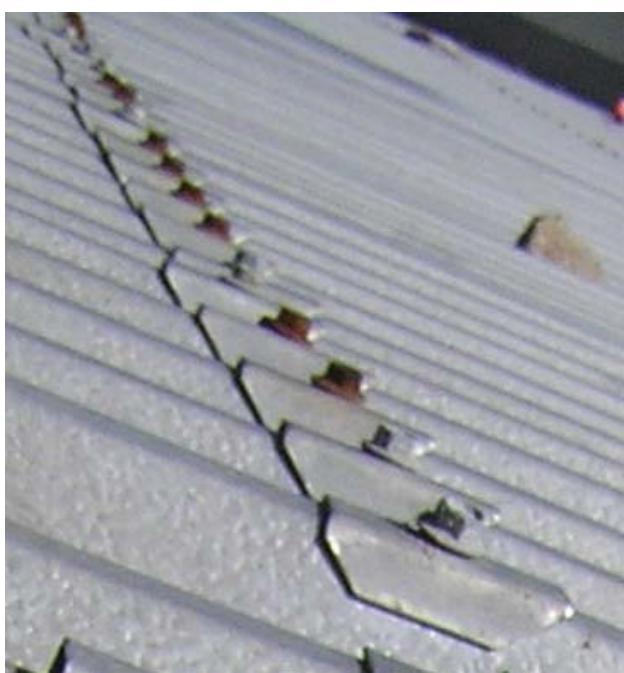
Figure 75 Close up of above figure showing fasteners with red rust.

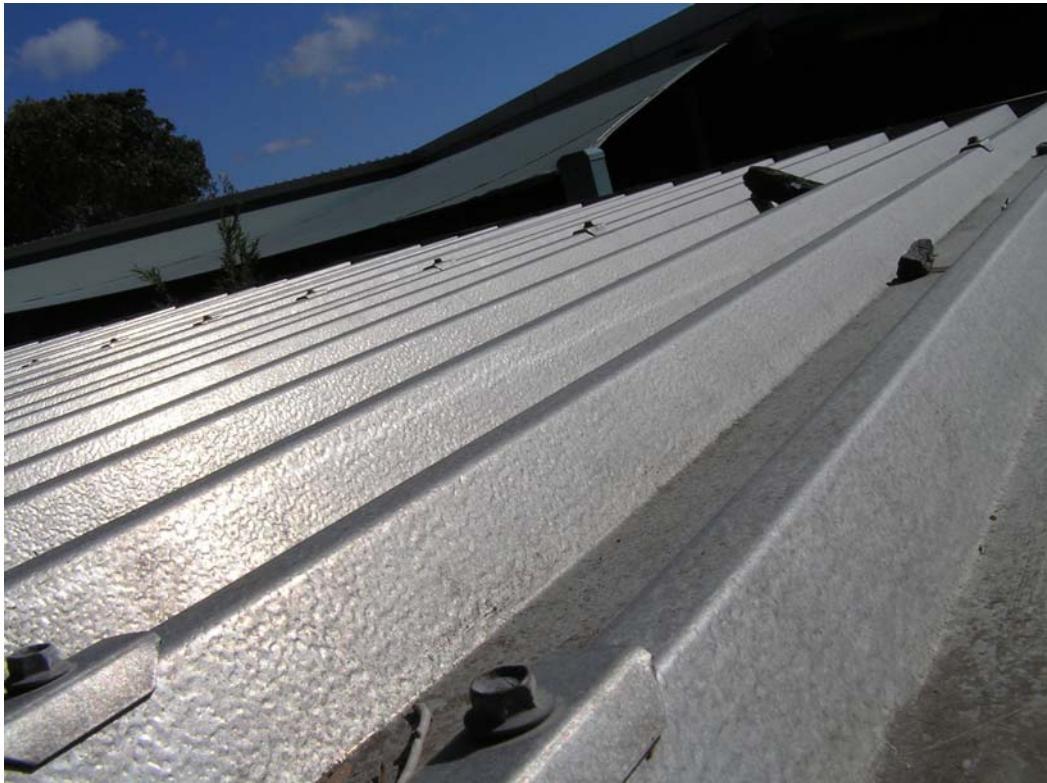
Figure 76 Exposed surface of aluminium walkway in good condition.

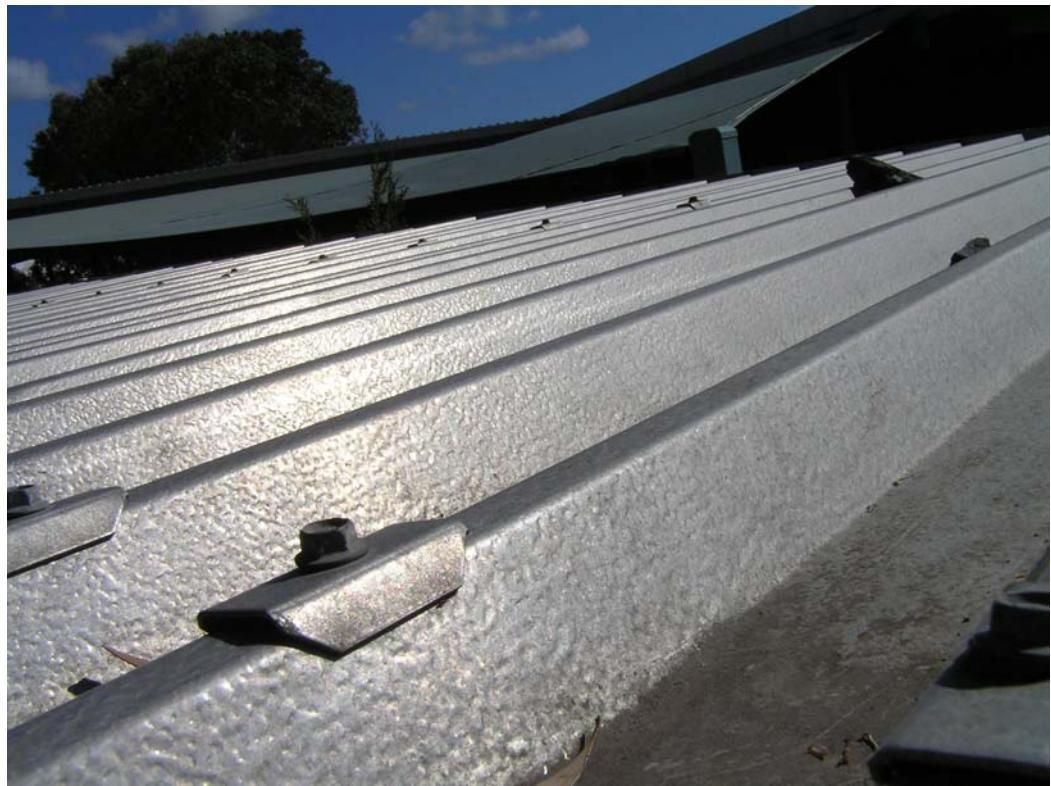
Figure 77 Exposed surface of aluminium walkway in good condition.

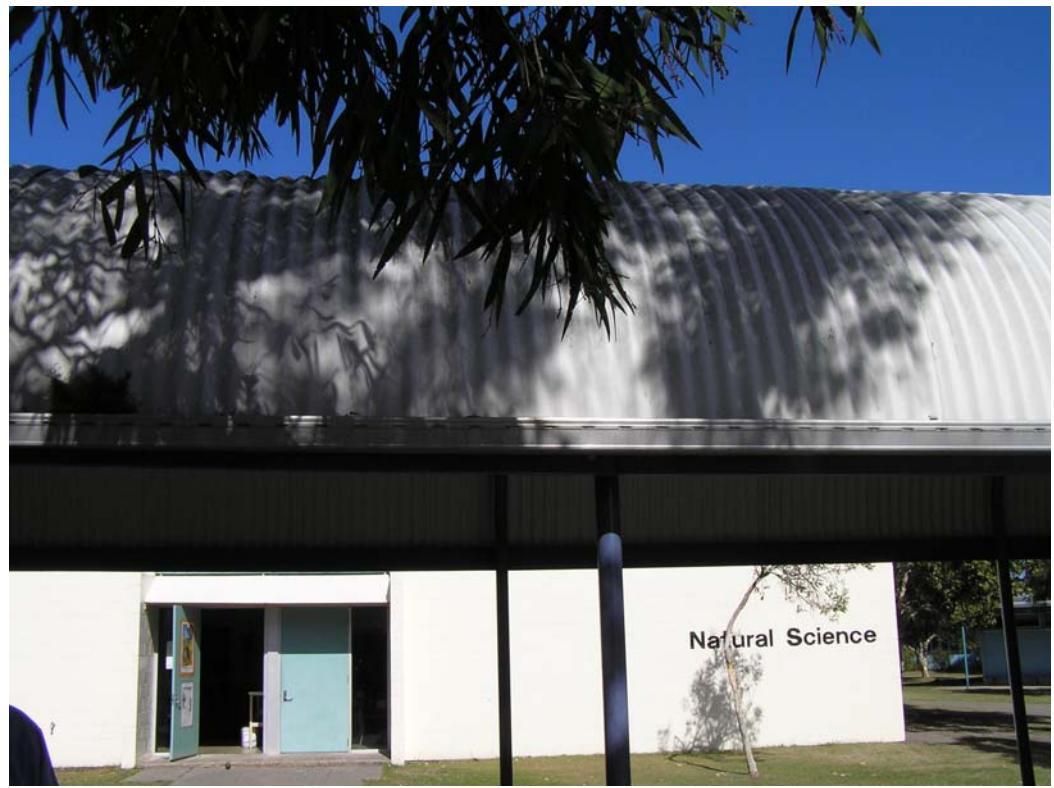
Figure 79 Colorbond walkways with aluminium gutters.

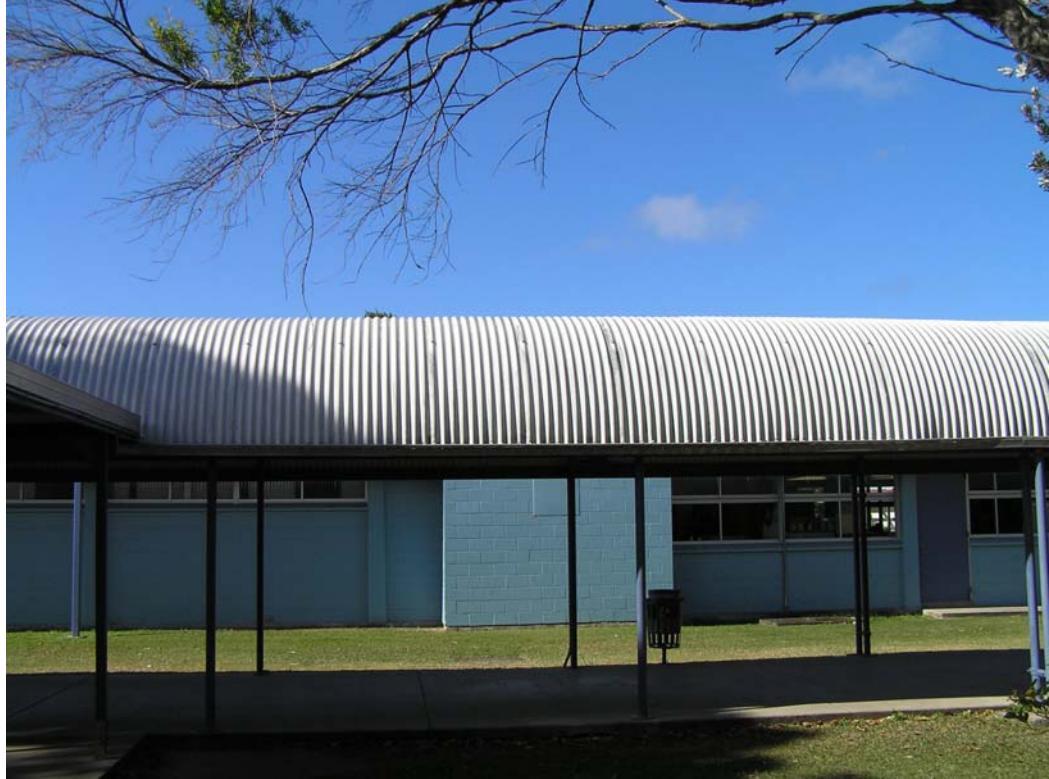
Figure 81, Colorbond walkway.

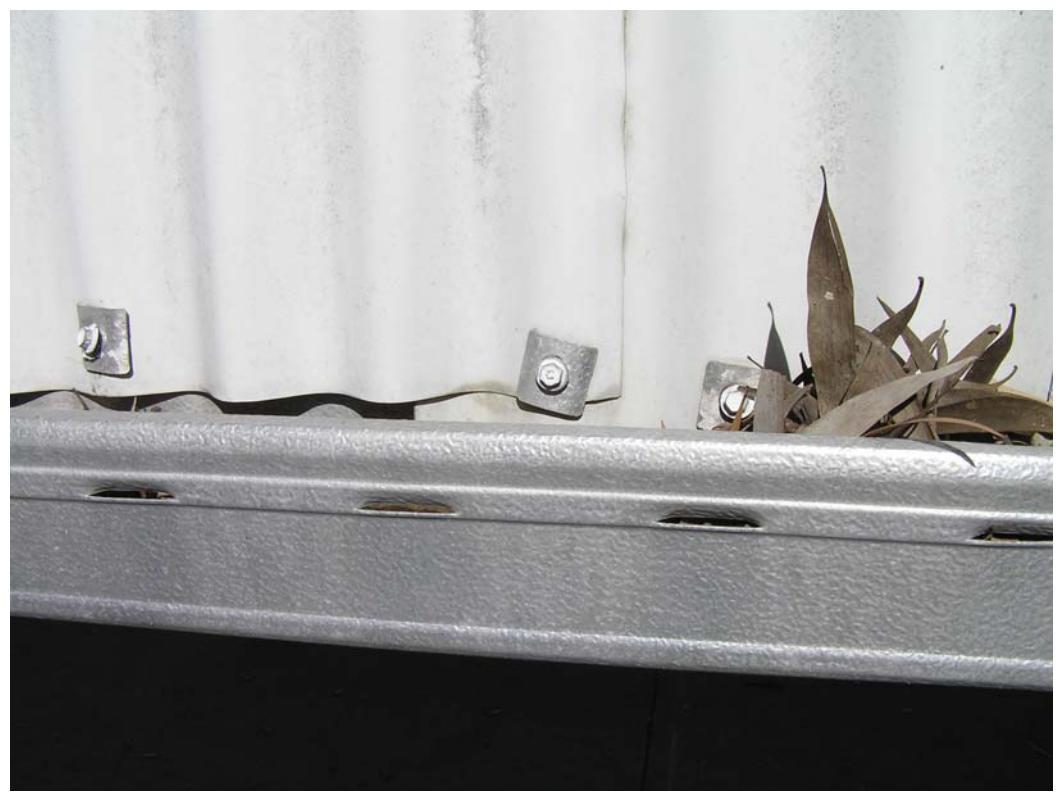
Figure 82 Colorbond walkway with aluminium gutters and stainless steel fasteners and aluminium cyclone plates.

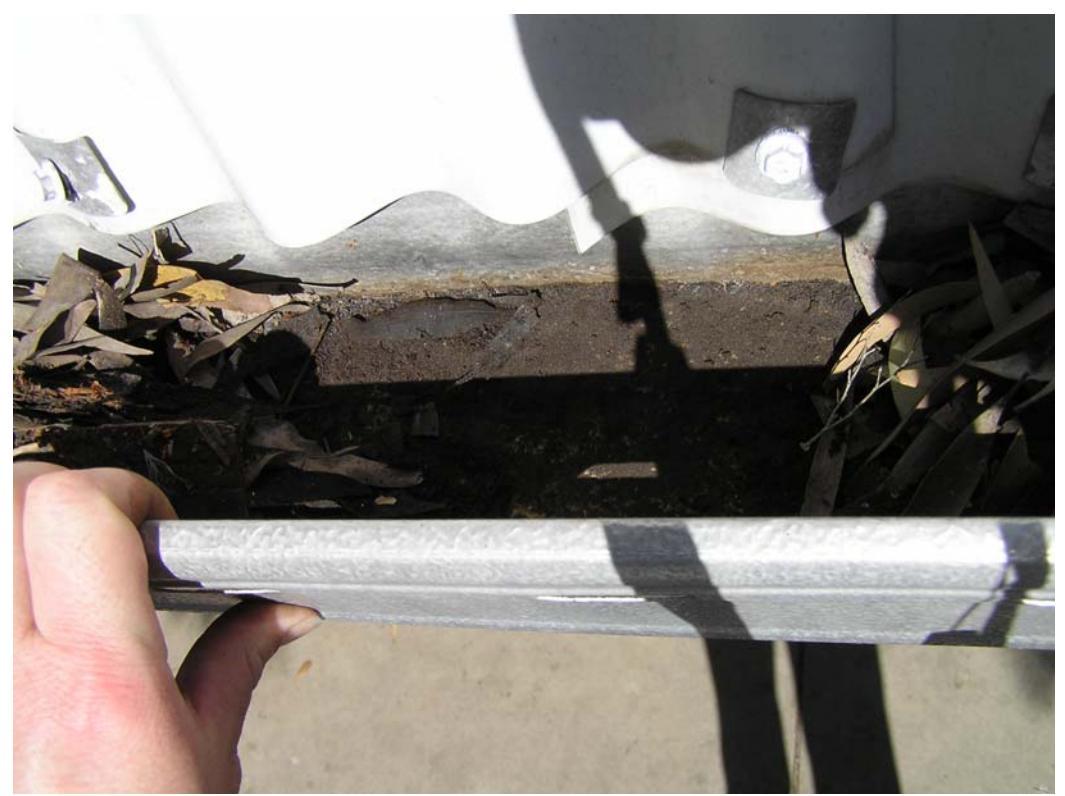
Figure 83 Inside gutters, although dirty, looked to be in OK condition.

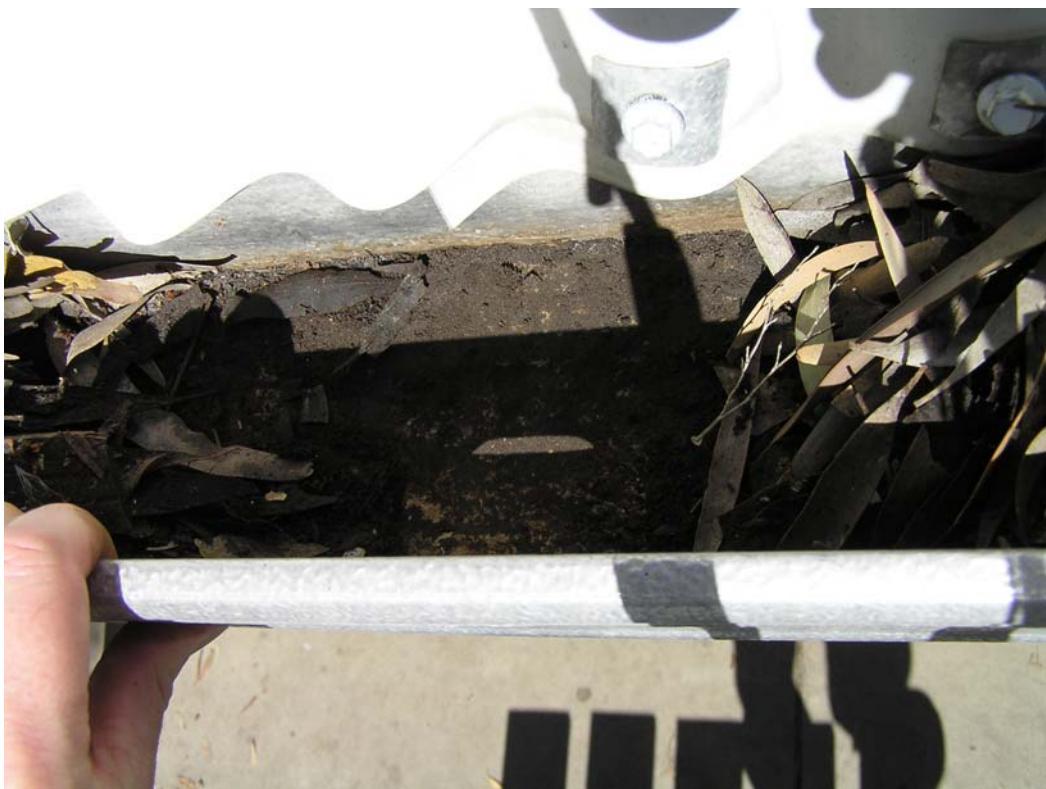
Figure 84 Inside gutters, although dirty, looked to be in OK condition.

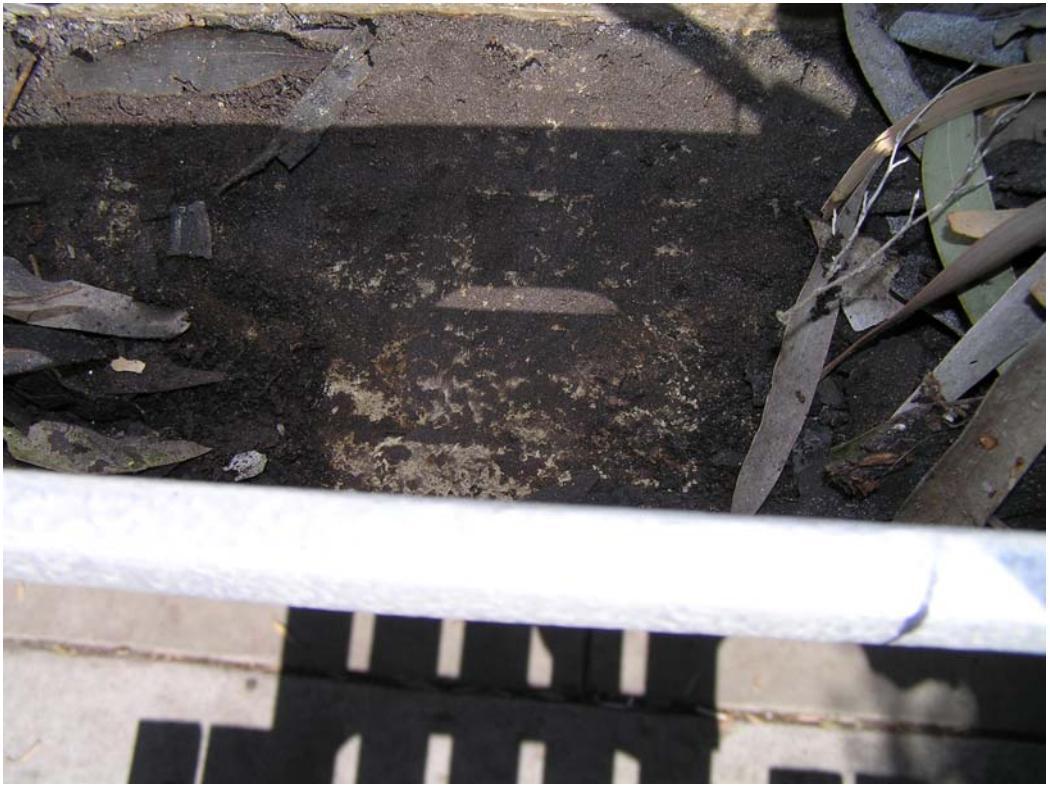
Figure 85 Inside gutters, although dirty, looked to be in OK condition.

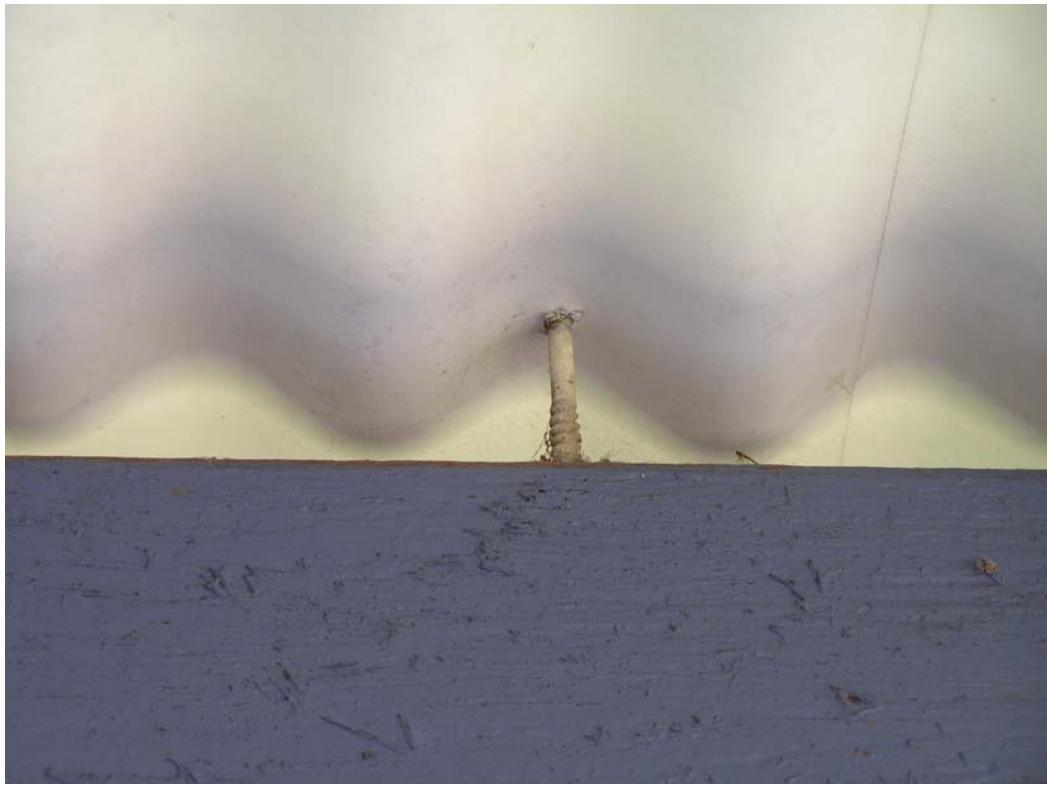
Figure 92 Shank of stainless steel fastener in Colorbond walkway, no deterioration.

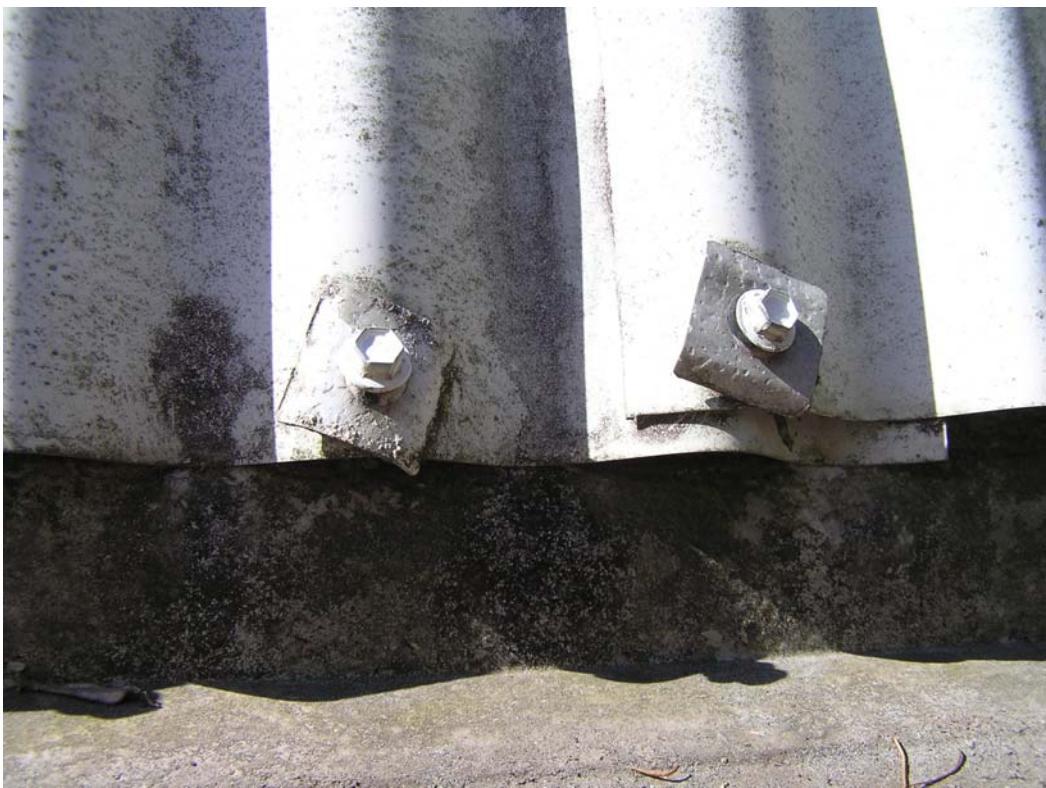
Figure 94 Colorbond sheeting and aluminium gutter showing significant growths.

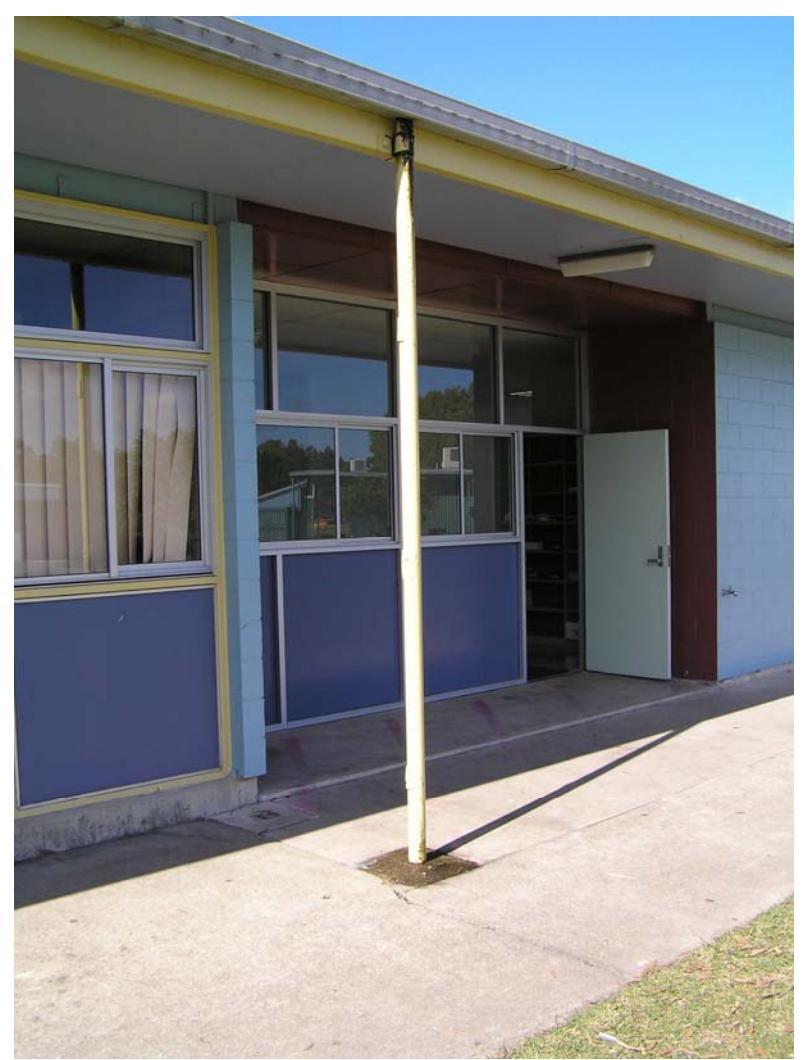
Another problem seen at this school is the use of structural downpipes. This is where as seen in the following figures the downpipe forms part of the structure holding up the eaves of the building. There is a steel U section around the edge of the eave with a piece of timber inside it. The U section is bolted to the downpipe. What seems to be happening is that the gutters, which are a fairly small diameter, block up. The water then overflows at the downpipe onto the U section and corrodes the U section and the timber is wet helping the corrosion. It was said that it costs \$80,000 to replace the steel U sections on one building.

Figure 96 Structural downpipes.
